# Inspection Report

SAMPLE INSPECTION - ACTUAL REPORT 100,000.00 in Damage  
Contractors wanted Open Checkbook  
Sample Nc 28201

**AHI Residential & Commercial Inspections, Inc**

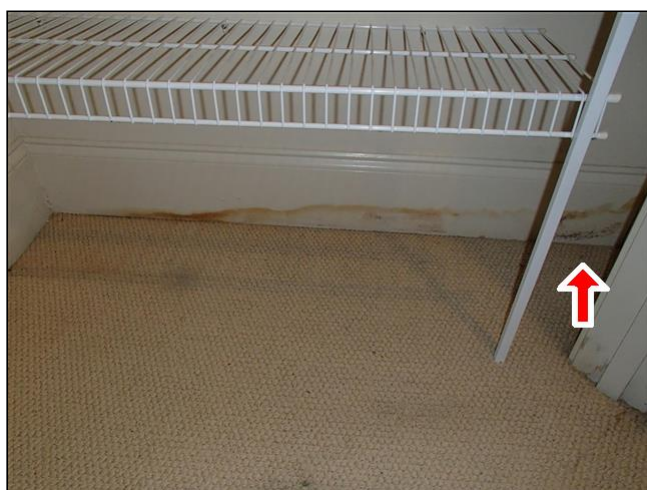
1. Discoloration and some type of microbial growth is present in the structure at several areas including but not limited to the basement and or interior spaces. Item 1(Picture) Item 2(Picture) Item 3(Picture) Item 4(Picture) This type of substance commonly results in the building and finish type materials becoming weakened and or compromised. Evidence suggest that this condition is from past or present elevated moisture conditions.

From Shower Pan Leak

We did not inspect, test or determine if this type of substance is or is not a health hazard. We recommend you contact a properly licensed expert for testing, investigation and or correction as deemed appropriate.

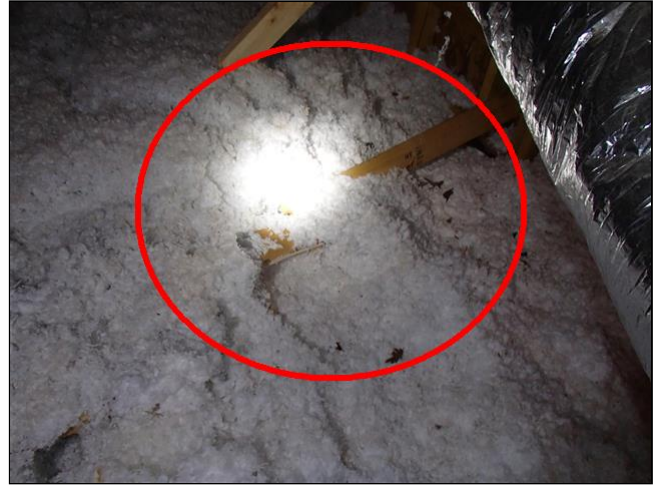
1. Evidence of rodent activity present in the attic, evidence suggest that they are entering the attic at rear soffits. Item 5(Picture) Item 6(Picture) Item 7(Picture) Repairs are needed to prevent damage from occurring. Further investigation and repairs are needed.

We recommend contacting a licensed pest control company regarding these conditions and have repairs made as deemed appropriate.

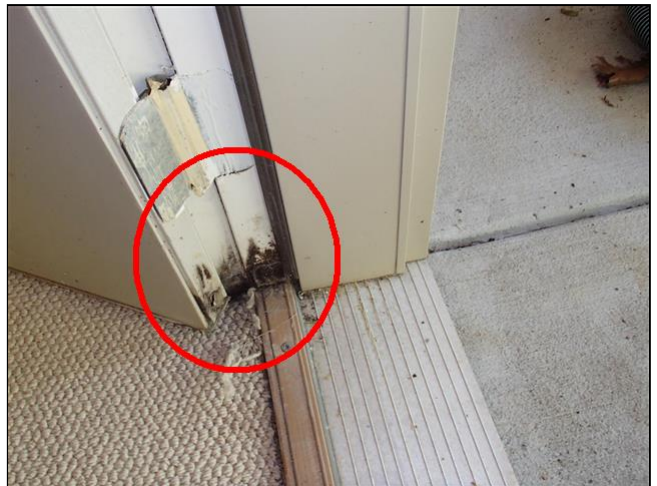
Rear Entry Door (Office)

1. The rear entry doors at all of the basement doors shows signs of active water intrusion at threshold. Item 1(Picture) Item 2(Picture) Item 3(Picture) Item 4(Picture) Water intrusion if not corrected can lead to significant repair costs. Further investigation and repairs by a licensed contractor are needed.
2. The dead bolt at the laundry room entrance is damaged. Item 5(Picture) A repair or replacement is needed.

We recommend contacting a properly licensed contractor regarding these conditions and have repairs made as deemed appropriate.

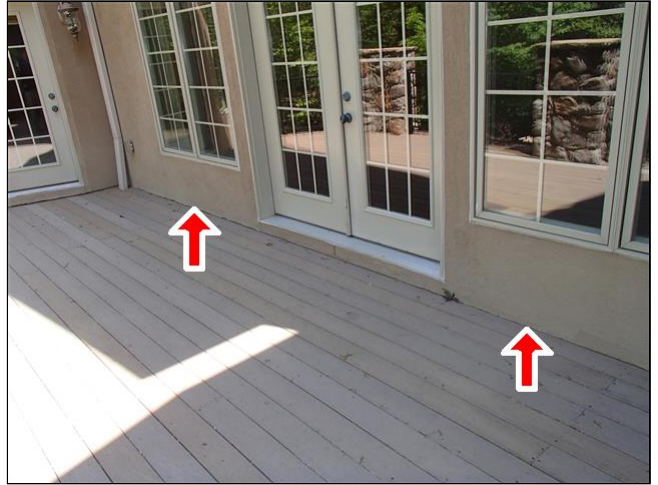
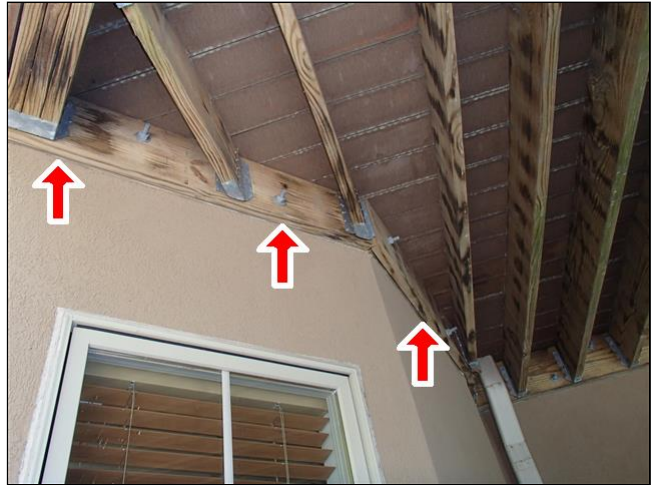
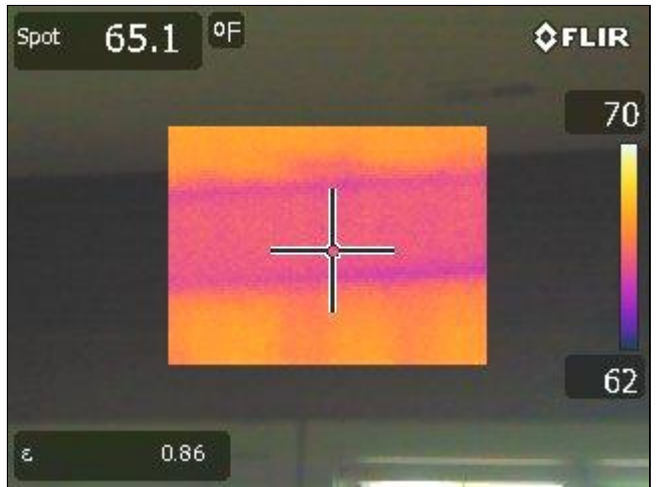
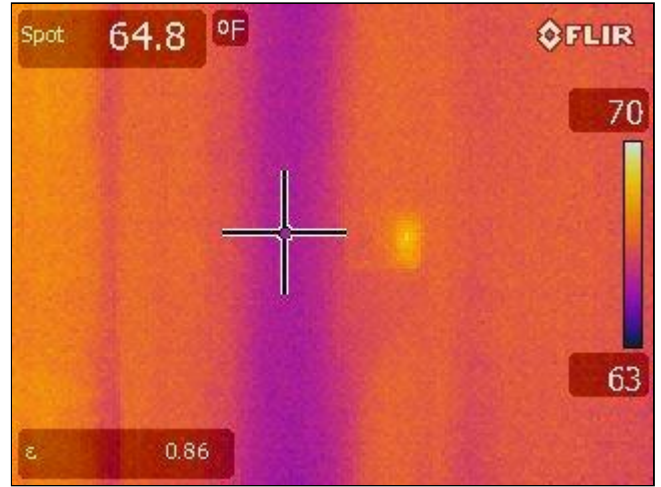
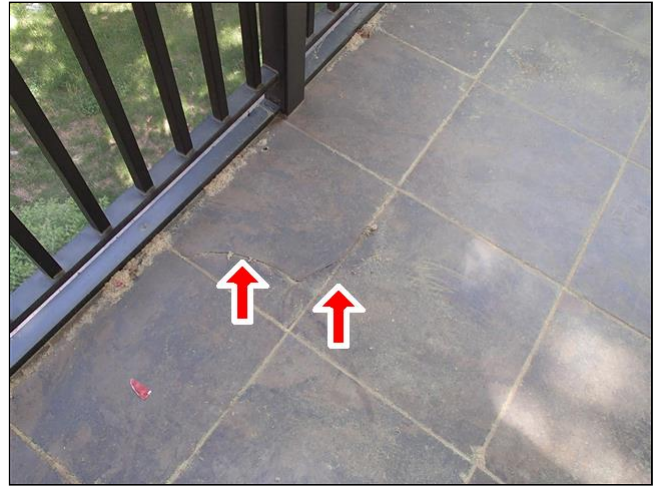
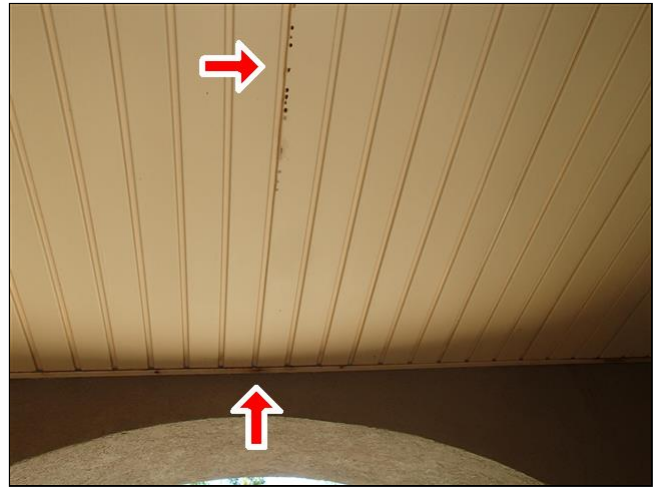
1. The rear deck ledger board has no visible signs of flashing present. Item 1(Picture) Item 2(Picture) Item 3(Picture) Item 4(Picture) Item 5(Picture) This can allow water intrusion to occur. A thermal camera was used on the interior of the home indicating that moisture intrusion is occurring. Item 6(Picture) Item 7(Picture) Item 8(Picture) Further investigation is needed.
2. The rear patio has damaged tiles and show signs of active water intrusion. Item 9(Picture) Item 10(Picture) Item 11(Picture) Item 12(Picture) Item 13(Picture) Item Further investigation and repairs are needed.

We recommend contacting a properly licensed contractor regarding these conditions and have repairs made as deemed appropriate.

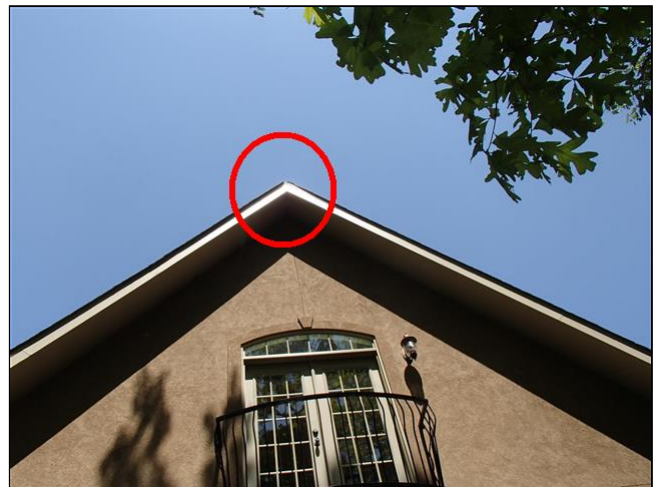
1. Evidence of repairs are present at the rear of the home. Item 1(Picture) A thermal camera indicated that the lower repair is still active. **(See Section 9.0)** Further investigation and repairs by a licensed roofing contractor is needed.
2. Several damaged shingles were observed at the left front side ridge and rear of the home. Item 3(Picture) Item 4(Picture) Item 5(Picture) Item 6(Picture) Item 7(Picture) This can allow water intrusion to occur. Further investigation and repairs are needed.

Ridge Cap Shingles Damaged

We recommend contacting a licensed roofing contractor regarding these conditions and have repairs made as deemed appropriate.

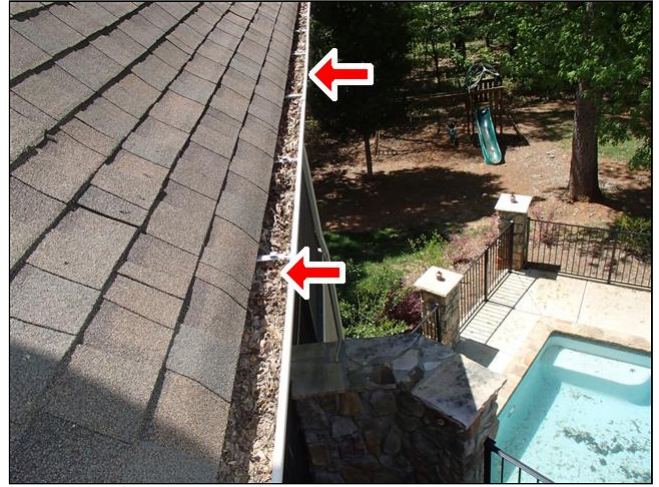
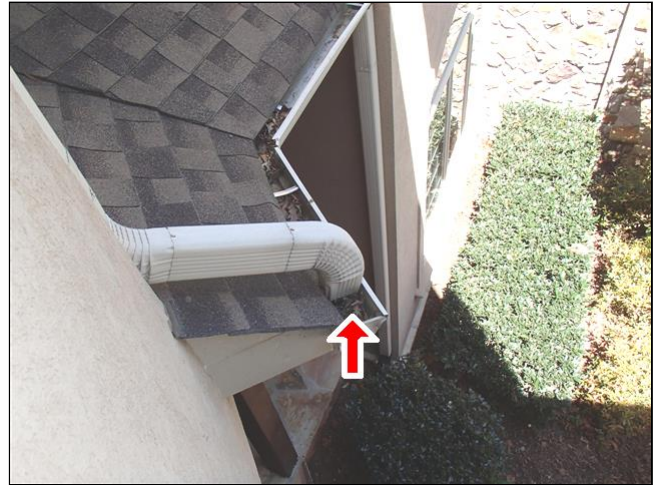
1. The gutter are clogged at the virtually all areas where gutters are installed.Item 1(Picture) Item 2(Picture) Item 3(Picture) Gutters that drain poorly or clogged can lead to many costly problems such as deterioration of fascia, soffit or roof edge. It can also cause gutters to pull loose and lead to possible water intrusion. Repairs are needed.
2. The downspouts are clogged. Item 4(Picture) Repairs are needed.
3. The downspouts at the rear of the home under deck are not extended away from the foundation of the home. Item 5(Picture) This can allow water intrusion to occur. The downspouts should extend away from the foundation of the home. Repairs are needed.

We recommend contacting a properly licensed contractor regarding these conditions and have repairs made as deemed appropriate.

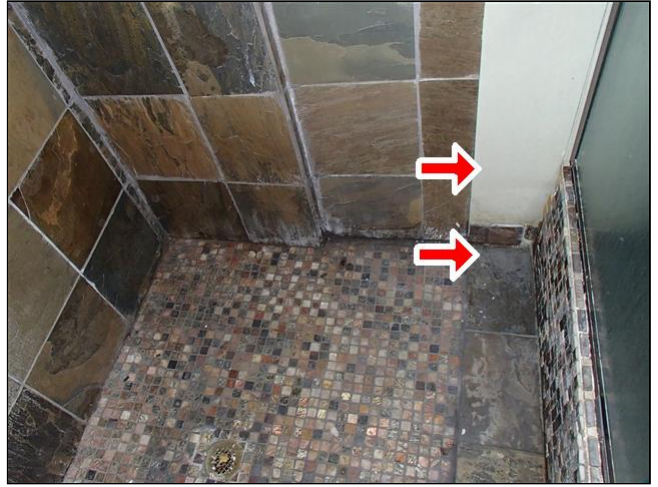
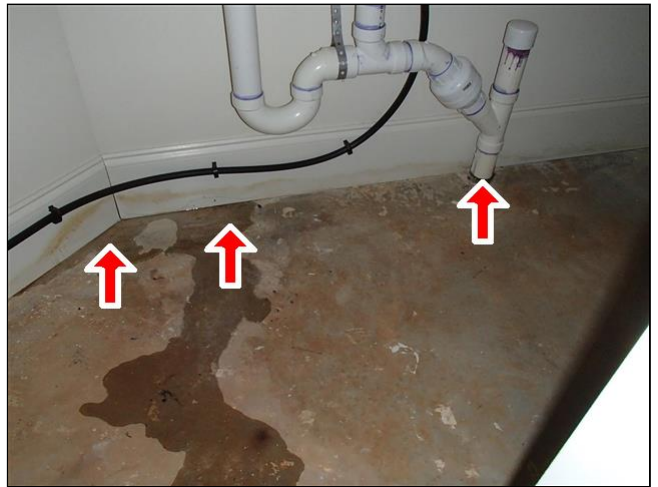
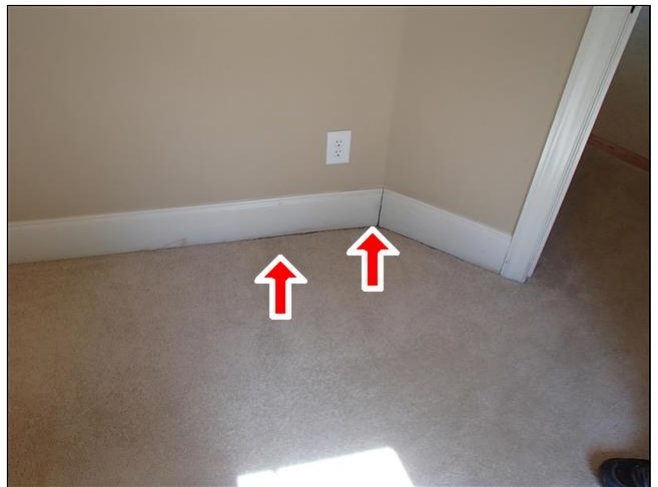
1. The basement guest bathroom shower pan is leaking. Item 1(Picture) Item 2(Picture) Item 3(Picture) Item 4(Picture) Evidence suggest that it was improperly expanded/installed. This pan collects the water from the bottom of the shower and directs it into the drain line piping. Typically the only way to repair this properly is to replace the pan which requires tearing out the floor of the shower and the lower portions of the walls. Based on the extent of the damage we suspect that there is framing damage behind the walls. Repairs are needed.

2. The 2nd floor front guest bathroom shower pan is leaking. Item 5(Picture) Item 6(Picture) Item 7(Picture) This pan collects the water from the bottom of the shower and directs it into the drain line piping. Typically the only way to repair this properly is to replace the pan which requires tearing out the floor of the shower and the lower portions of the walls. Repairs are needed.

We recommend contacting a licensed contractor regarding the conditions and have repairs made as deemed appropriate.

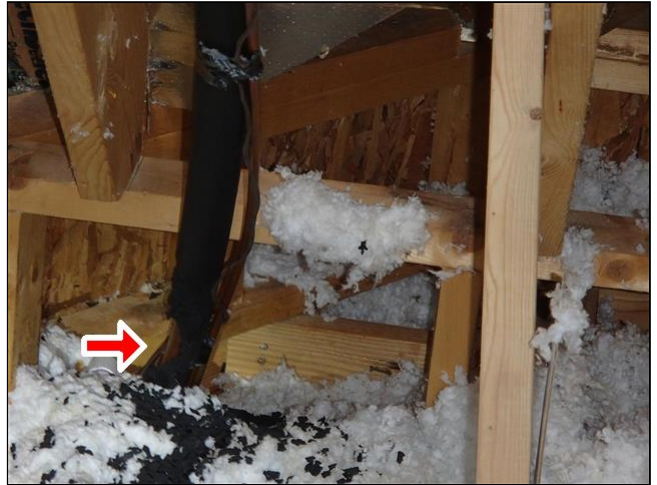
1. The evaporator coil has air leaks present at supply plenum. Item 1(Picture) Condensation and energy loss can occur as a result. Repairs are needed to prevent condensation.
2. The foam sleeve insulation on suction line has damaged insulation in the attic. Item 2(Picture) Item 3(Picture) Evidence suggest rodent/squirrel activity. The Missing foam insulation on suction line can cause energy loss and condensation. Repairs are needed to prevent condensation.

We recommend contacting a licensed HVAC contractor regarding these conditions and have repairs made as deemed appropriate.

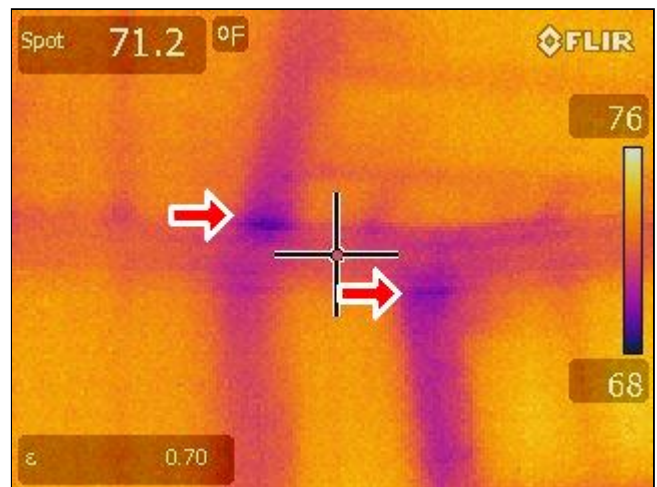
Master Bedroom

1. The Sheetrock on the ceiling reveals a water stain indicating a leak still exists at the Living Room and master Bedroom. Item 1(Picture) Item 2(Picture) Item 3(Picture) Item 4(Picture) A thermal camera was used and it indicated that the leak has not been corrected. Further investigation and repairs are needed. Due to the extent of the damage it is likely that framing damage has occurred. Coverings will likely need to be removed to uncover the extent of the damage. Further investigation and repairs are needed.
2. The sheetrock on the ceiling in the basement guest bathroom shows signs of repair. Item 5(Picture) We were unable to determine the cause of the damage.

We recommend contacting a properly licensed contractor regarding these conditions and have repairs made as deemed appropriate.

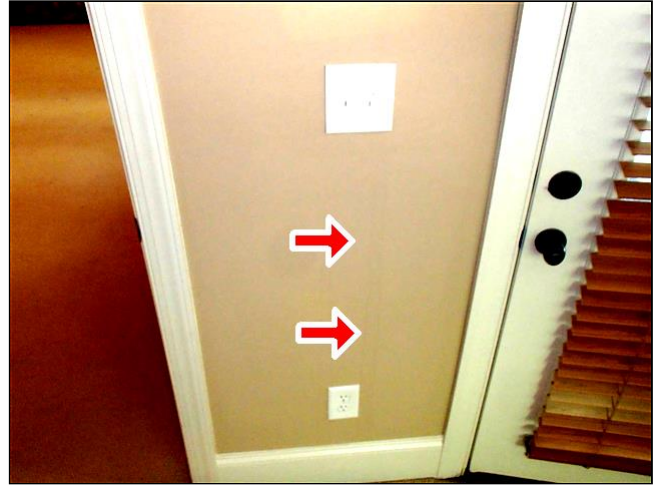
1. The Sheetrock on the ceiling reveals a water stain indicating a leak still exists at the basement office, Living Room and master Bedroom. Item 1(Picture) Item 2(Picture) Item 3(Picture) Further investigation and repairs are needed. Due to the extent of the damage it is likely that framing damage has occurred. Coverings will likely need to be removed to uncover the extent of the damage. Further investigation and repairs are needed.

We recommend contacting a properly licensed contractor regarding these conditions and have repairs made as deemed appropriate.

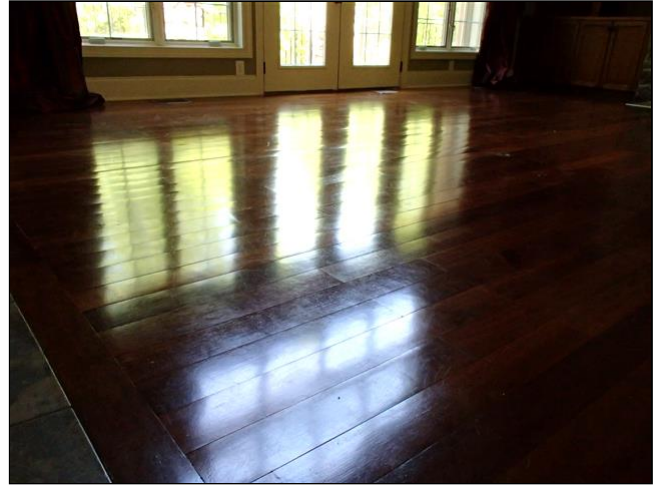
1. The hardwood floor in the living room shows signs of cupping. Item 1(Picture) Item 2(Picture) This is an indication of moisture. Cupping and crowning are common complaints that develop with high humidity. Both problems occur across the width of the flooring material. Cupping is when the edges of a board are higher than the center. It can occur after water spills onto the floor and is absorbed by the wood, but high humidity is more often the cause. If the wood expands significantly, compression can result as the boards are crushed together, deforming the boards at the edges. Cupping is caused by a moisture imbalance throughout the thickness of the wood: the wood is wetter on the bottom of the board than on the top. Further investigation by a licensed contractor is needed.

We recommend contacting a licensed contractor regarding these conditions and have repairs made as deemed appropriate.

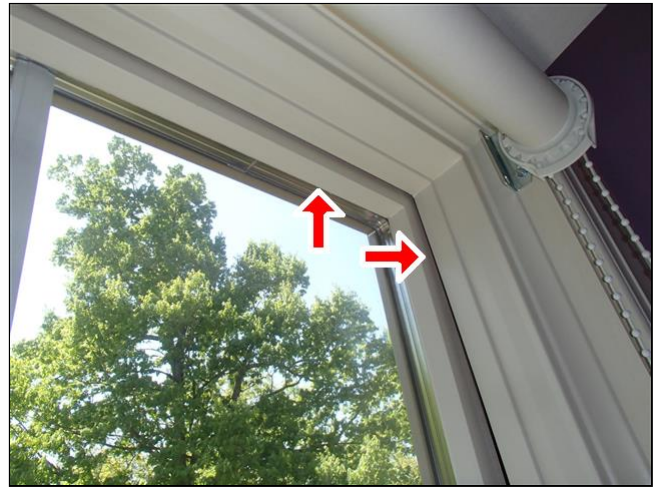
1. One window stuck shut at the 2nd floor rear guest bathroom. Item 1(Picture) Item 2(Picture)  
Repairs are needed.

We recommend contacting a licensed window technician regarding these conditions and have repairs made as deemed appropriate..

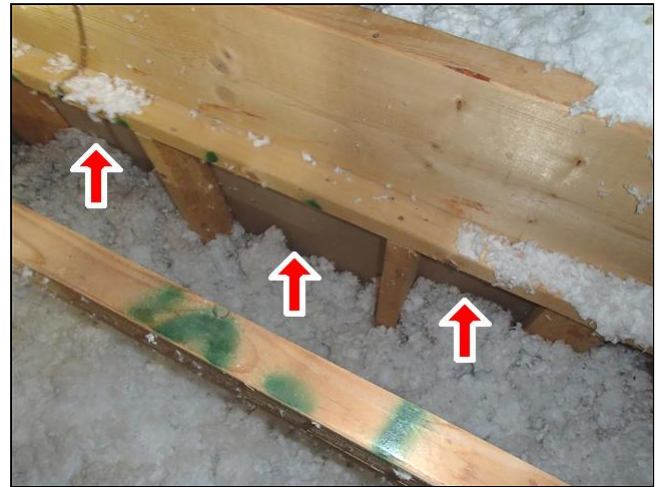
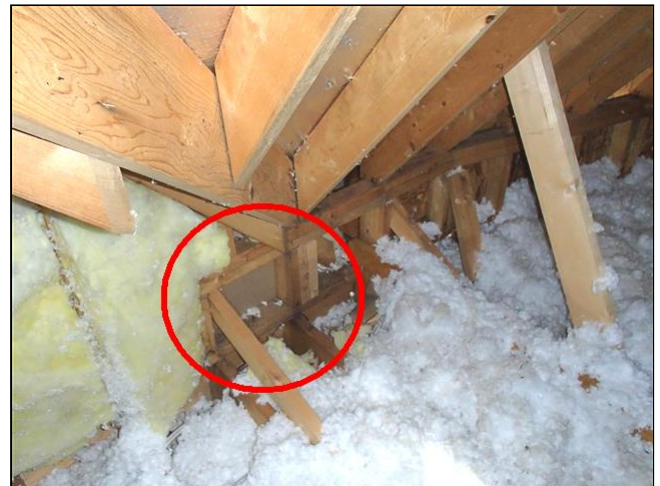
1. Fiberglass (loose-fill) insulation is compressed and missing in areas of the attic, exposed sheet rock visible in several areas. Item 1(Picture) Item 2(Picture) Item 3(Picture) Item 4(Picture) Item 5(Picture) Heat loss can occur more on this home than one that is properly insulated. Repairs are needed.

We recommend contacting a properly licensed contractor regarding these conditions and have repairs

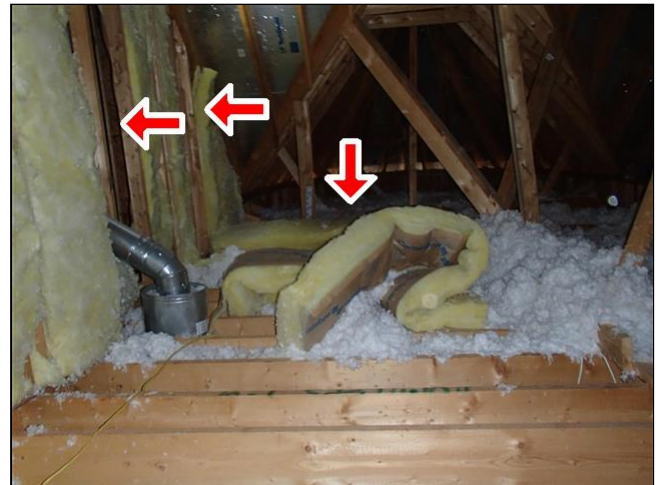
1. The wall insulation has fallen in areas. Item 1(Picture) Item 2(Picture) This can allow heat loss to occur. Repairs are needed.

We recommend contacting a properly licensed contractor regarding these conditions and have repairs made as deemed appropriate

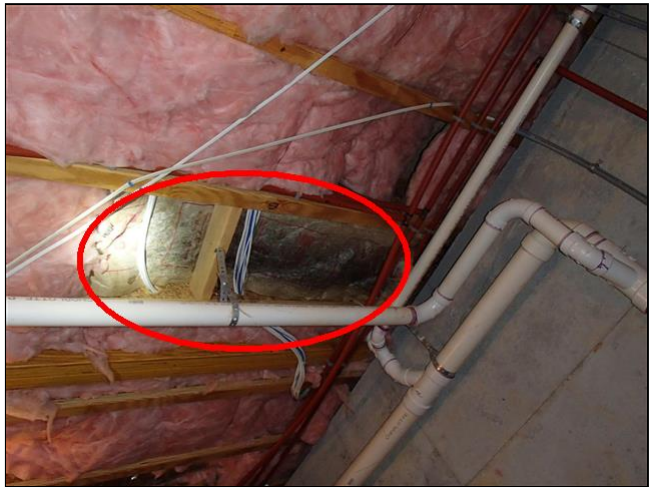
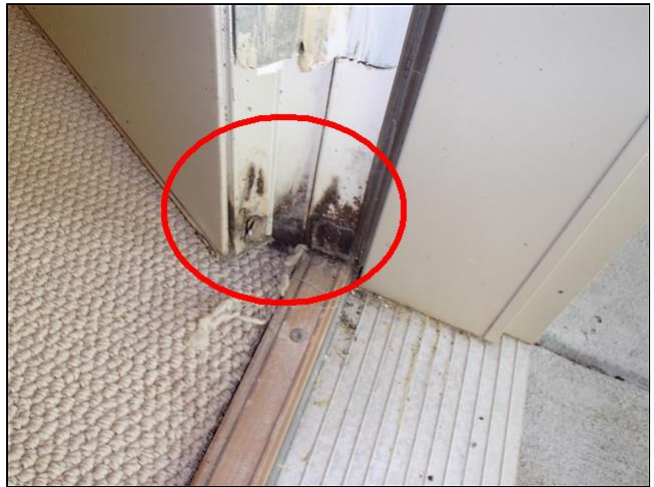
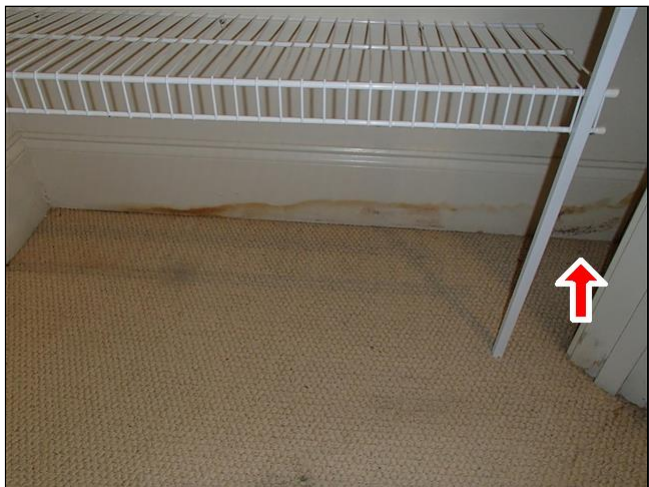
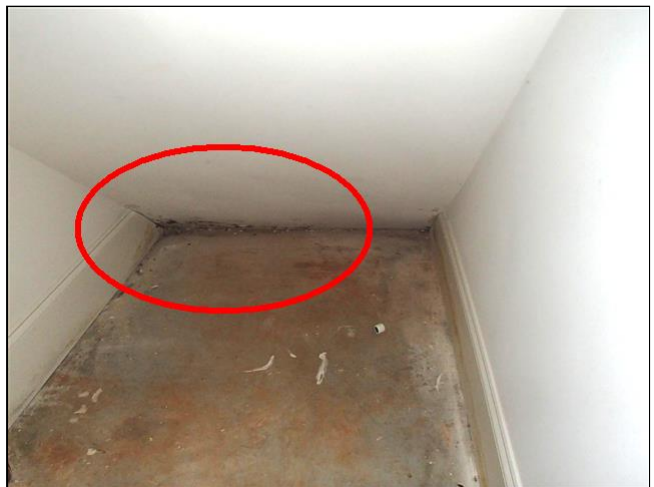
1. Discoloration and some type of microbial growth is present in the structure at several areas including but not limited to the basement and or interior spaces. Item 1(Picture) Item 2(Picture) Item 3(Picture) Item 4(Picture) This type of substance commonly results in the building and finish type materials becoming weakened and or compromised. Evidence suggest that this condition is from past or present elevated moisture conditions.

From Shower Pan Leak

We did not inspect, test or determine if this type of substance is or is not a health hazard. We recommend you contact a properly licensed expert for testing, investigation and or correction as deemed appropriate.

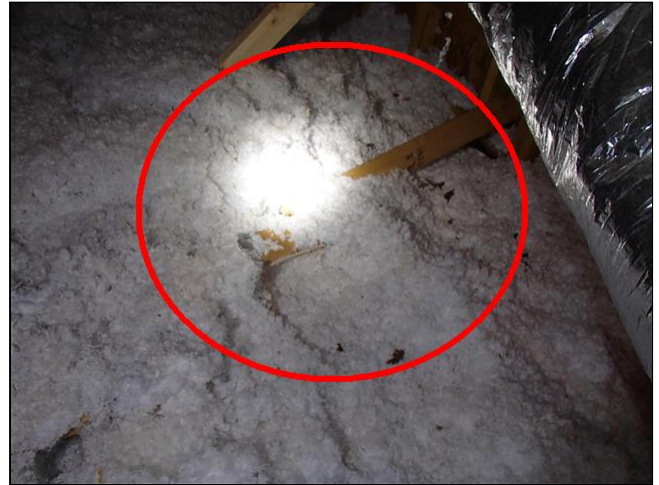
1. Evidence of rodent activity present in the attic, evidence suggest that they are entering the attic at rear soffits. Item 5(Picture) Item 6(Picture) Item 7(Picture) Repairs are needed to prevent damage from occurring. Further investigation and repairs are needed.

We recommend contacting a licensed pest control company regarding these conditions and have repairs made as deemed appropriate.

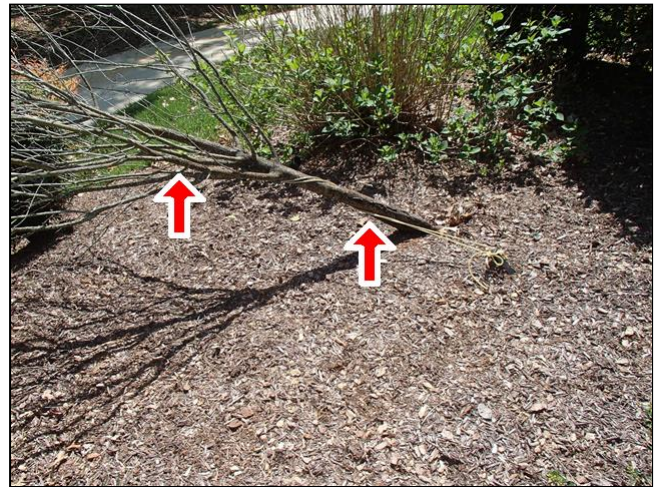
1. Tree in contact with home. Item 1(Picture) Trim all trees and shrubs to a minimum of 12 inches away from structure. This will help prevent premature deterioration of the building components. (This is a preventive maintenance item and is for your information)
2. Dead tree present at the front of the home. Item 2(Picture) Removal recommended.

We recommend contacting a licensed landscaper regarding these conditions and have repairs made as deemed appropriate.

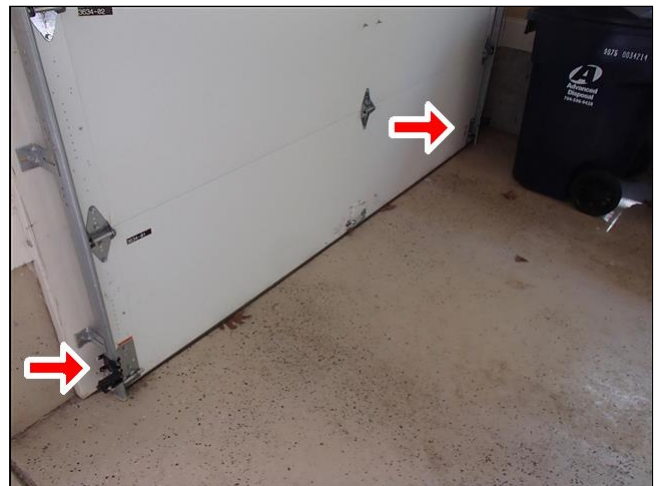
Left Garage Door Operator

1. The Garage door operator the basement garage door and main level garage door operator(s) safety reverse will not reverse properly when met with resistance. Item 1(Picture)Item 2(Picture) Item 3(Picture) (SAFETY ISSUE) Adjustments needed.
2. The sensors are in place for main level left garage door (Facing Front), however they will not reverse the door when sensors are tested. Item 4(Picture) (SAFETY ISSUE) Repairs are needed.

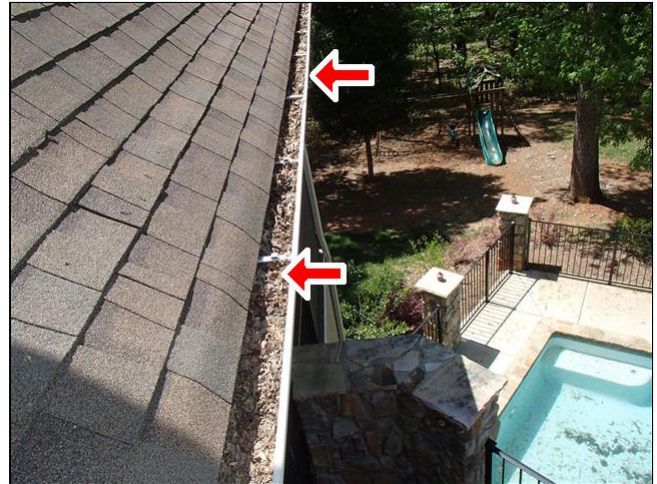
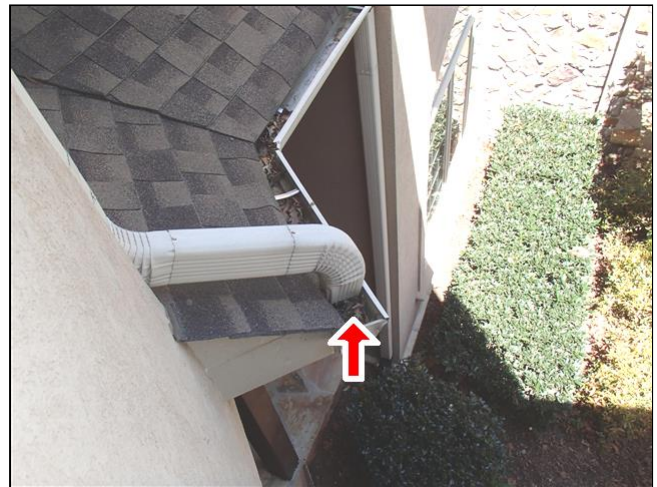
1. The gutter are clogged at the virtually all areas where gutters are installed. Item 1(Picture) Item 2(Picture) Item 3(Picture) Gutters that drain poorly or clogged can lead to many costly problems such as deterioration of fascia, soffit or roof edge. It can also cause gutters to pull loose and lead to possible water intrusion. Repairs are needed.
2. The downspouts are clogged. Item 4(Picture) Repairs are needed.
3. The downspouts at the rear of the home under deck are not extended away from the foundation of the home. Item 5(Picture) This can allow water intrusion to occur. The downspouts should extend away from the foundation of the home. Repairs are needed.

We recommend contacting a properly licensed contractor regarding these conditions and have repairs made as deemed appropriate.

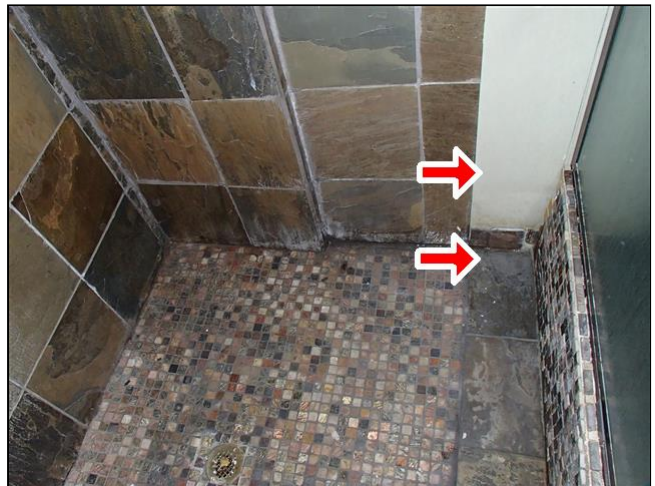
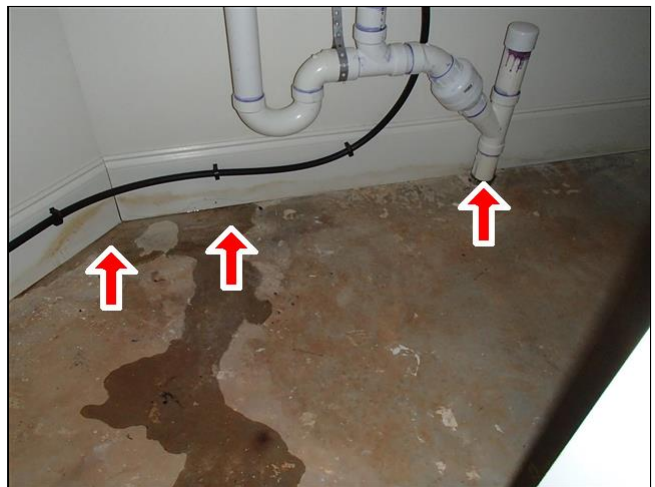
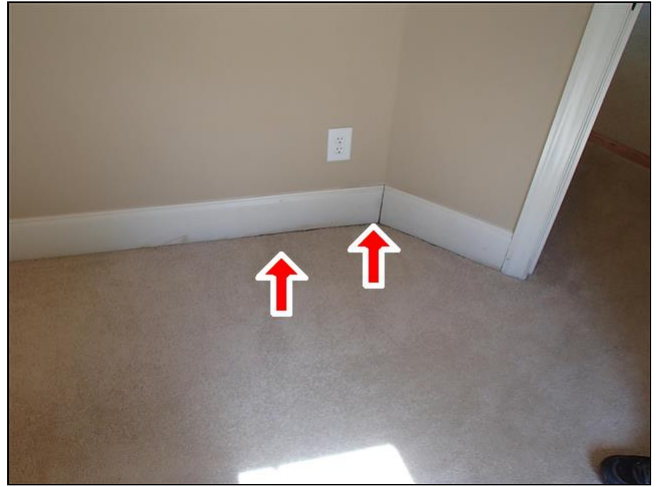
1. The basement guest bathroom shower pan is leaking. Item 1(Picture) Item 2(Picture) Item 3(Picture) Item 4(Picture) Evidence suggest that it was improperly expanded/installed. This pan collects the water from the bottom of the shower and directs it into the drain line piping. Typically the only way to repair this properly is to replace the pan which requires tearing out the floor of the shower and the lower portions of the walls. Based on the extent of the damage we suspect that there is framing damage behind the walls. Repairs are needed.

We recommend contacting a licensed contractor regarding the conditions and have repairs made as deemed appropriate.

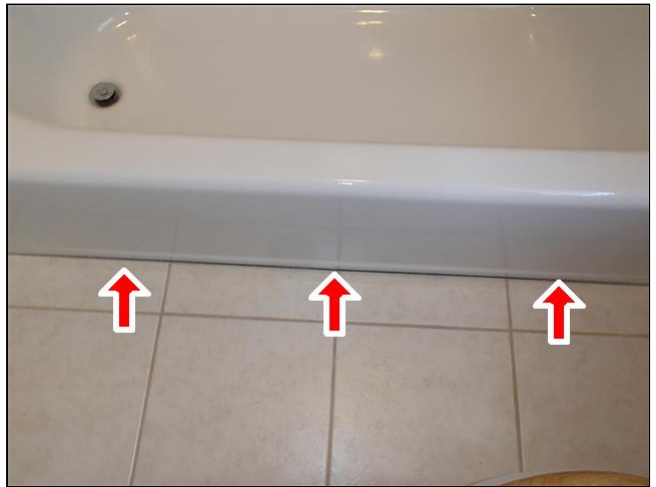
1. The Caulking is needed at/around the following bathroom tubs and or showers. Item 9(Picture)Item 10(Picture) Gaps between the tile and the tub can allow water damage to occur. Non-Visible moisture damage may be present in and around these areas. (This is a preventive maintenance item and is for your information)

We recommend contacting a qualified individual regarding these conditions and have repair made as deemed appropriate.

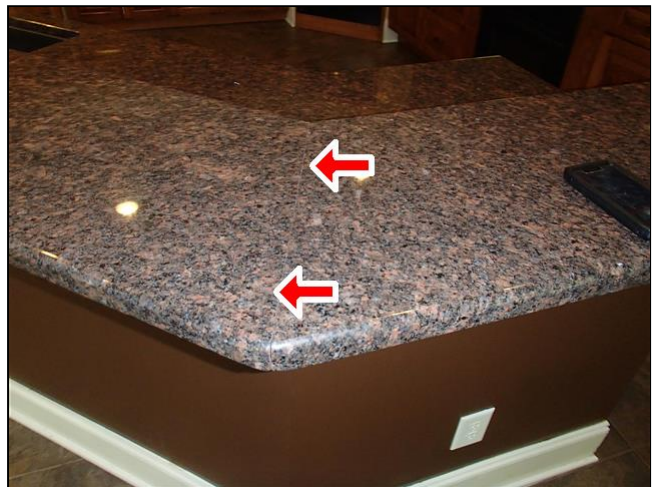
1. The granite countertop at the kitchen seams are coming apart. Item 1(Picture) Item 2(Picture) This is cosmetic and is for your information. Recommend repair or replace as necessary.
