# Inspection Report

**Prepared For:**  
Sample Commercial Inspection

**Property Address:**  
Sample Inspection  
Charlotte NC

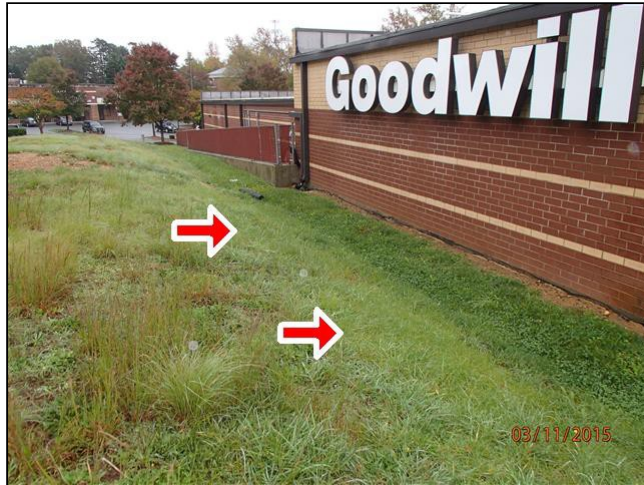
2.2 Item 1(Picture)

1. The grading at the rear of the property (behind goodwill) does not promote positive drainage away from foundation, as a result erosion is occurring. Item 1(Picture) Item 2(Picture) (SEE SECTION 3.6) Repairs are needed.

We recommend contacting a licensed contractor regarding these conditions and have repair made as deemed appropriate.

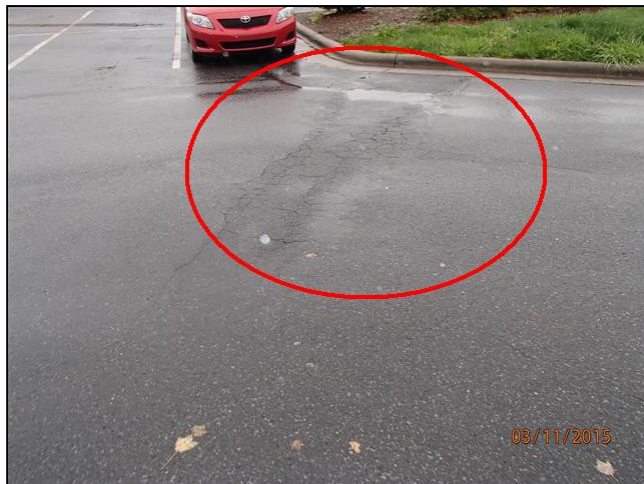
2.5 Item 1(Picture)

1. The asphalt parking surface exhibits signs of wear and aging. Several cracks and pot holes are beginning to form. Item 1(Picture) Item 2(Picture) Item 3(Picture) Item 4(Picture) After long, wet winters potholes can become a huge problem for many asphalt parking lots. they can also cause the damaged asphalt area to become much larger if left untreated and have constant traffic driving over them. Deterioration of asphalt increases more rapidly when cracks develop because more water penetrates the material and vegetation can take root. Repairs are recommended .

We recommend contacting a licensed asphalt company regarding these conditions and have repairs made as deemed appropriate

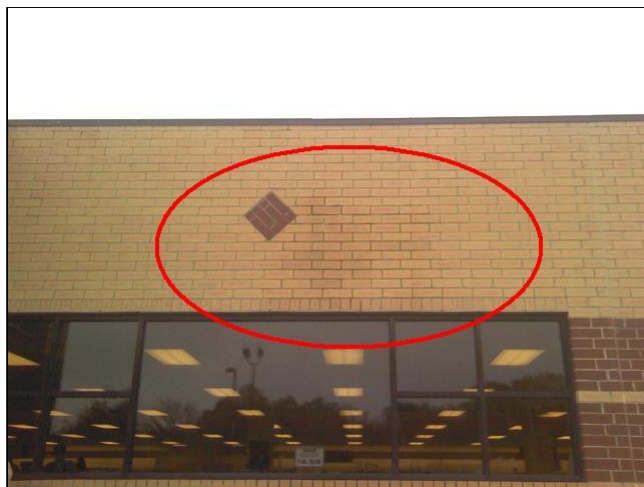
3.0 Item 1(Picture)

1. The masonry show signs of moisture intrusion from roof at front of building in areas. Item 1(Picture) Item 2(Picture) Item 3(Picture) Item 4(Picture) (SEE SECTION 4.0) Further investigation and repairs are needed.

We recommend contacting a licensed commercial roofing contractor regarding these conditions and have repairs made as deemed appropriate.

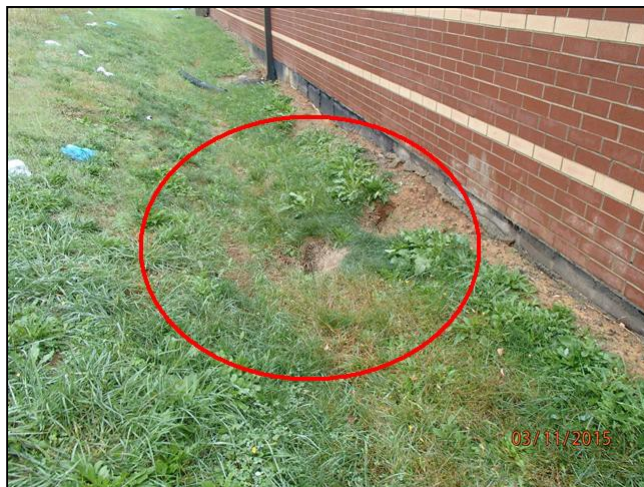
3.6 Item 1(Picture)

1. The grading at the rear of the property (behind goodwill) does not promote positive drainage away from foundation, as a result erosion is occurring. Item 1(Picture) Item 2(Picture) Item 3(Picture) Item 4(Picture) Voids in soil (possible sinkhole) are present as a result. Further deterioration will occur if not corrected. Foundation issues could occur if not corrected. Further investigation and repairs are needed.

We recommend contacting a licensed contractor regarding these conditions and have repair made as deemed appropriate.

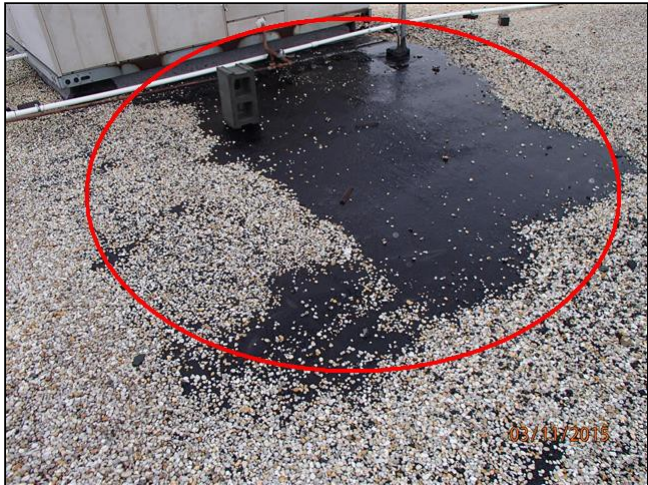
4.0 Item 1(Picture)

1. Active roof leaks are present at Suite 3710 (Goodwill). Item 1(Picture) Item 2(Picture) Item 3(Picture) The gravel on roof is missing in areas. As a result cracking is occurring this is an indication of UV damage. Item 4(Picture) Current conditions will water intrusion to occur. Evidence suggest that the gravel has been removed / pushed away from areas to try and repair roof leaks. Once roof leaks have been repaired gravel should be replaced to protect roof coverings from UV damage. Repairs are needed.

We recommend contacting a licensed commercial roofing contractor regarding these conditions for further evaluation and repair.

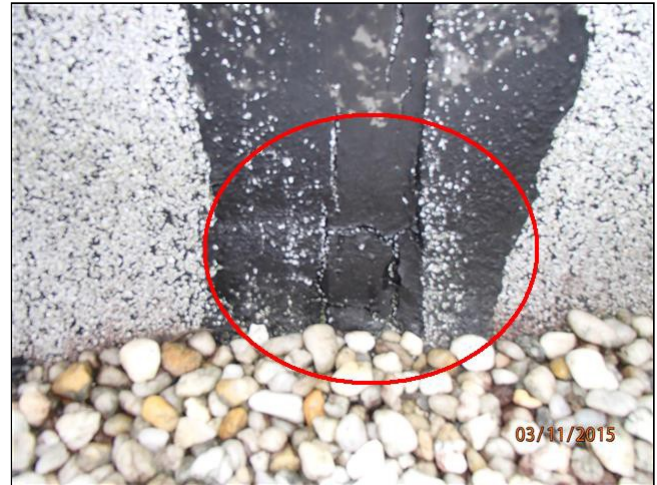
4.0 Item 8(Picture)

3. Cracking is occurring at the seams at Parapets-Where Roofs meet front walls. Item 7(Picture) Item 8(Picture) Item 9(Picture) . Visible signs of water intrusion present due to water staining on masonry side at front of building.Further investigation and repair by a licensed roofing contractor is needed.

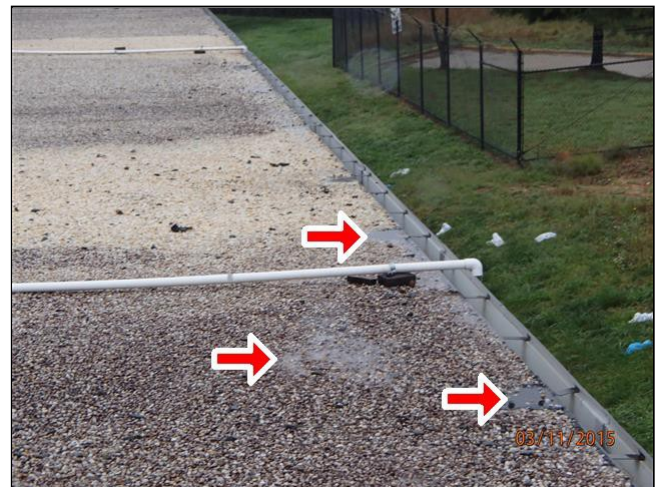
4.0 Item 10(Picture)

4. Ponding is occurring at several areas. Item 10(Picture) Ponding can lead to premature deterioration of the roof covering, resulting in leaks. Soft spot present this in an indication of past or present leak. Repairs are needed.

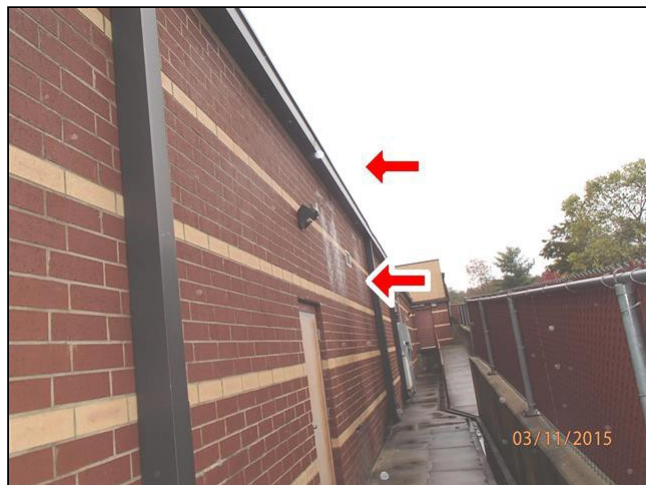
4.4 Item 1(Picture)

1. The gutter at rear of unit 3710-B not draining properly and over flowing. Item 1(Picture) Item 2(Picture) This can lead to water intrusion. Evidence of water intrusion is present. Repairs are needed.

We recommend contacting a licensed contractor regarding these conditions and have repairs made as deemed appropriate..

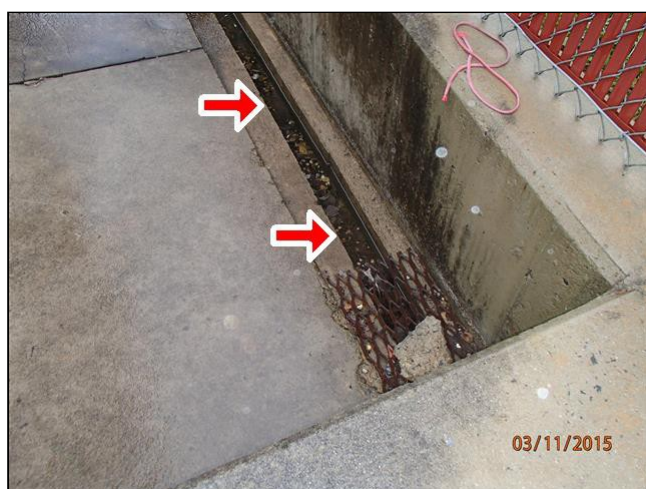
4.4 Item 5(Picture)

4. The concrete drainage trench at rear of structure appears clogged. Item 5(Picture) Item 6(Picture) Repairs are recommended.

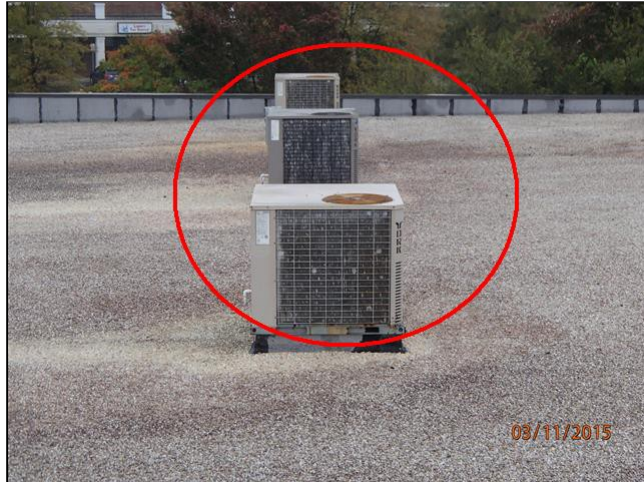
1. Three heat pumps and all package units show signs of hail damage to coils/fins. Item 1(Picture)  
Item 2(Picture) Further investigation is recommended.

8.0 Item 1(Picture) Heat Pump

Due to the nature of commercial HVAC systems, we recommend that an annual service contractor the a licensed commercial hvac contractor is maintained.

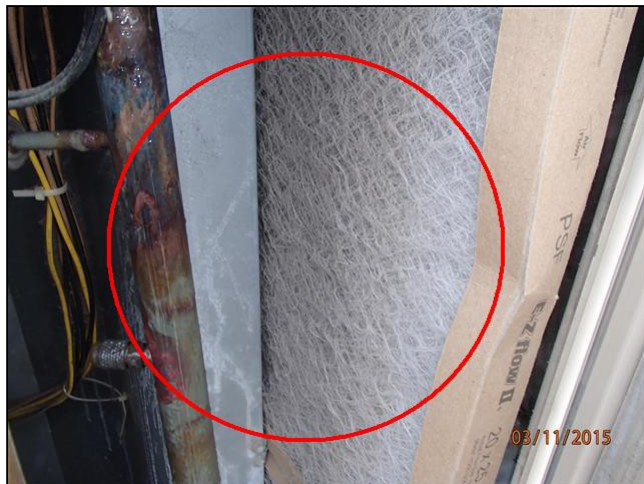
8.6 Item 1(Picture)

1. The disposable filters is dirty. Item 1(Picture) Item 2(Picture) The filter needs to be replaced. (This is a maintenance item and is for your information) Repairs are recommended

A qualified licensed HVAC (Heat/Ventilation/Air conditioning Contractor) should inspect further and repair as needed

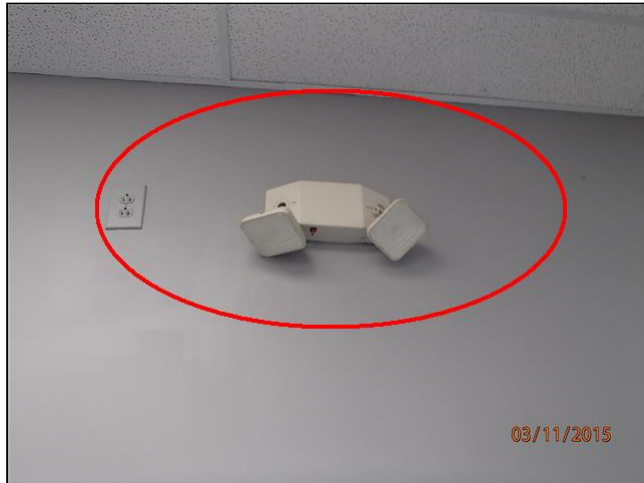
9.5 Item 1(Picture)

1. The emergency lighting throughout the units were damaged and would not operate when tested. Item 1(Picture) Item 2(Picture) (Safety Issue) Repairs are needed.

We recommend contacting a licensed contractor regarding these conditions and have repairs made as deemed appropriate.

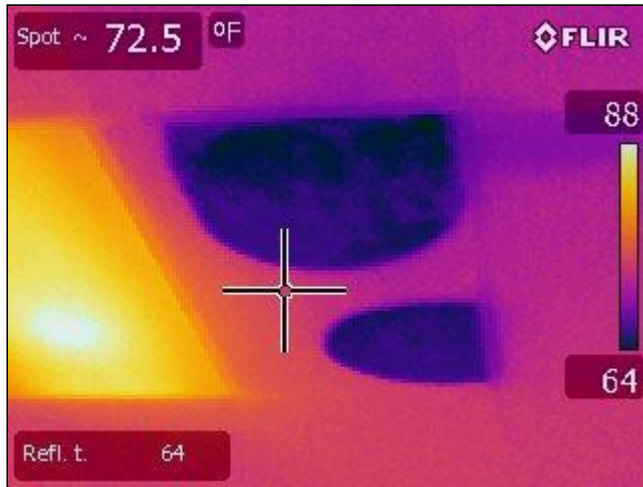
10.0 Item 1(Picture)

1. Active water intrusion is occurring at unit 3710 (Goodwill). Item 1(Picture) Item 2(Picture) A thermal camera indicated that active leaks are present. Further investigation and repairs are needed.

We recommend contacting a licensed commercial roofing contractor and or licensed commercial HVAC regarding these conditions and have repairs made as deemed appropriate.

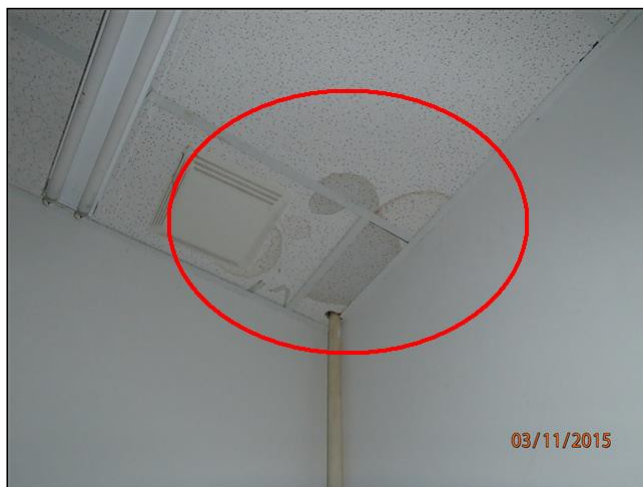
12.0 Item 1(Picture)

1. Active roof leaks present at center and rear of unit 3710-B. Item 1(Picture) Item 2(Picture) Item 3(Picture) (See Section 4.0) A thermal camera indicated that active leaks are present. Further investigation and repairs are needed.

We recommend contacting a licensed commercial roofing contractor and or licensed commercial HVAC regarding these conditions and have repairs made as deemed appropriate.

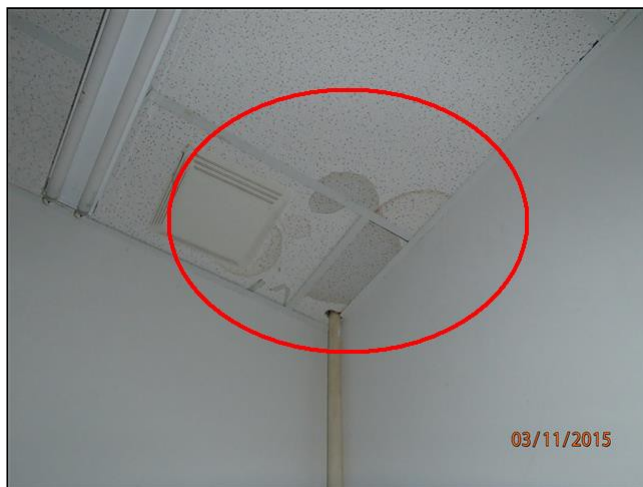
12.0 Item 1(Picture)

1. Active roof leaks present at center and rear of unit 3710-B. Item 1(Picture) Item 2(Picture) Item 3(Picture) (See Section 4.0) A thermal camera indicated that active leaks are present. Further investigation and repairs are needed.

We recommend contacting a licensed commercial roofing contractor and or licensed commercial HVAC regarding these conditions and have repairs made as deemed appropriate.

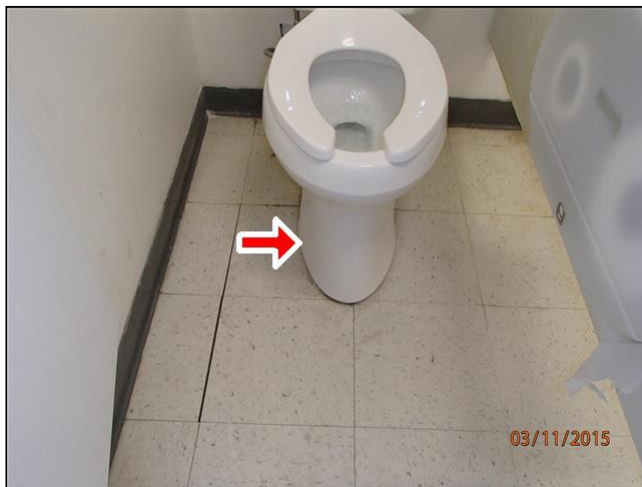
13.6 Item 1(Picture)

1. The Men's bathroom for toilet's for unit 3710 (Goodwill) not flush with floor and are loose. Item 1(Picture) Item 2(Picture) Excessive gaps due to shims present. This can damage the toilet. Repairs may involve re-setting the toilet on a new wax seal.

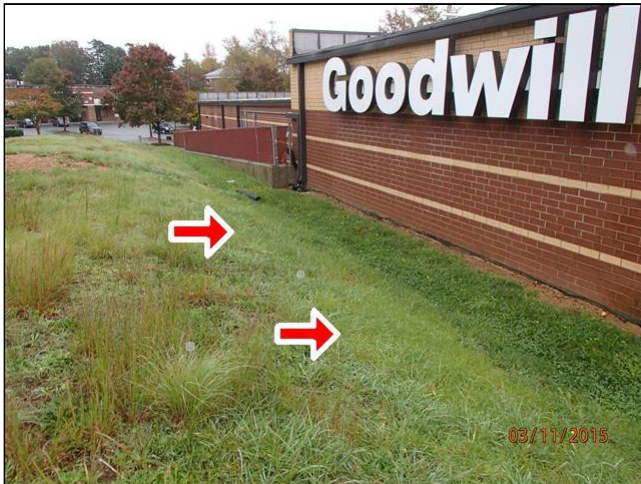
2.2 Item 1(Picture)

1. The grading at the rear of the property (behind goodwill) does not promote positive drainage away from foundation, as a result erosion is occurring. Item 1(Picture) Item 2(Picture) (SEE SECTION 3.6) Repairs are needed.

We recommend contacting a licensed contractor regarding these conditions and have repair made as deemed appropriate.

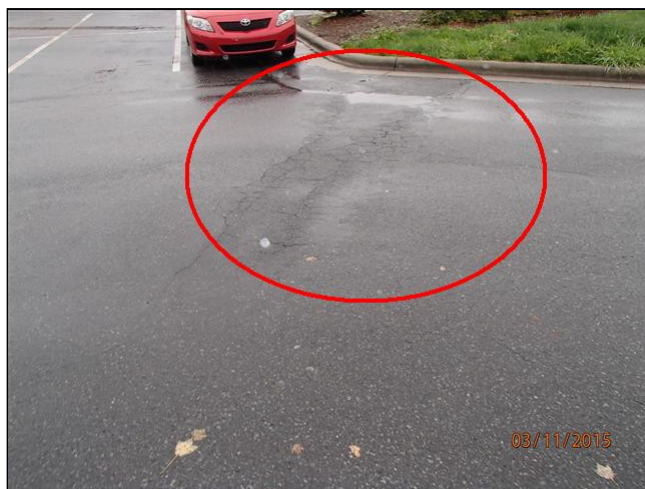
2.5 Item 1(Picture)

1. The asphalt parking surface exhibits signs of wear and aging. Several cracks and pot holes are beginning to form. Item 1(Picture) Item 2(Picture) Item 3(Picture) Item 4(Picture) After long, wet winters potholes can become a huge problem for many asphalt parking lots. hey can also cause the damaged asphalt area to become much larger if left untreated and have constant traffic driving over them. Deterioration of asphalt increases more rapidly when cracks develop because more water penetrates the material and vegetation can take root. Repairs are recommended .

We recommend contacting a licensed asphalt company regarding these conditions and have repairs made as deemed appropriate

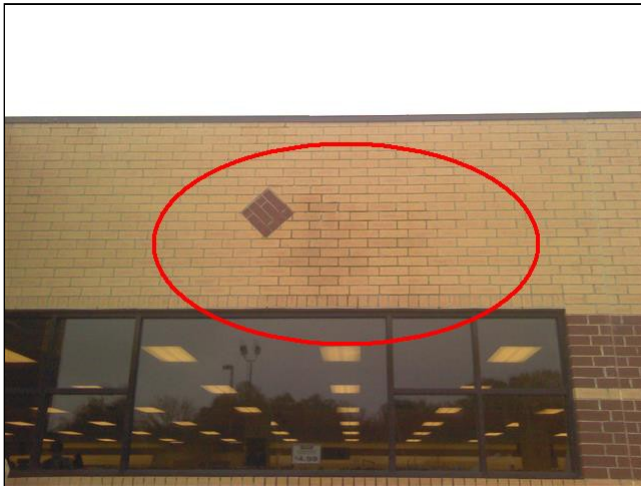
3.0 Item 1(Picture)

1. The masonry show signs of moisture intrusion from roof at front of building in areas. Item 1(Picture) Item 2(Picture) Item 3(Picture) Item 4(Picture) (SEE SECTION 4.0) Further investigation and repairs are needed.

We recommend contacting a licensed commercial roofing contractor regarding these conditions and have repairs made as deemed appropriate.

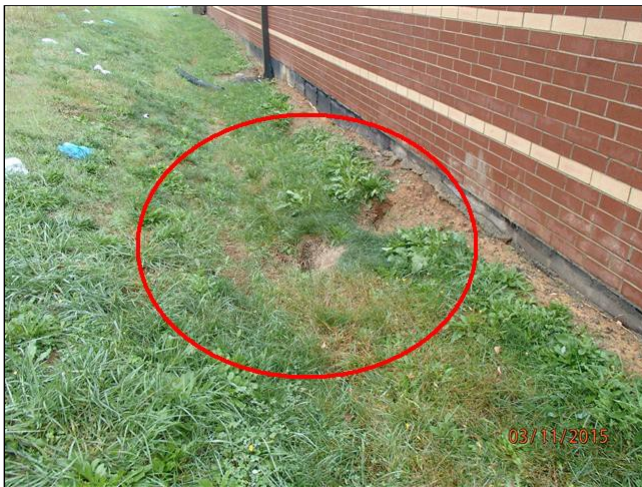
3.6 Item 1(Picture)

1. The grading at the rear of the property (behind goodwill) does not promote positive drainage away from foundation, as a result erosion is occurring. Item 1(Picture) Item 2(Picture) Item 3(Picture) Item 4(Picture) Voids in soil (possible sinkhole) are present as a result. Further deterioration will occur if not corrected. Foundation issues could occur if not corrected. Further investigation and repairs are needed.

We recommend contacting a licensed contractor regarding these conditions and have repair made as deemed appropriate.

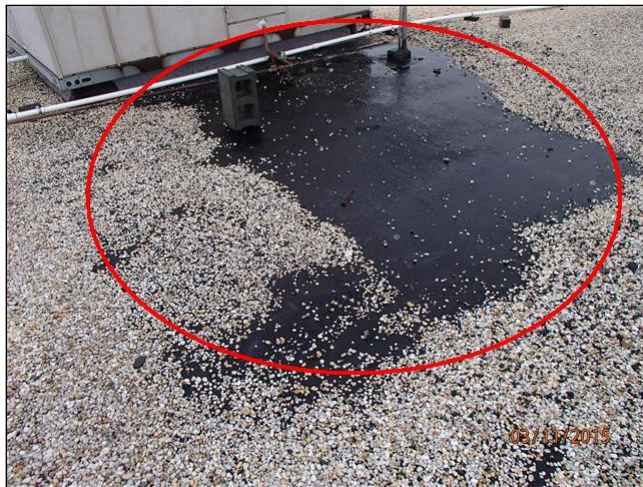
4.0 Item 1(Picture)

1. Active roof leaks are present at Suite 3710 (Goodwill). Item 1(Picture) Item 2(Picture) Item 3(Picture) The gravel on roof is missing in areas. As a result cracking is occurring this is an indication of UV damage. Item 4(Picture) Current conditions will water intrusion to occur. Evidence suggest that the gravel has been removed / pushed away from areas to try and repair roof leaks. Once roof leaks have been repaired gravel should be replaced to protect roof coverings from UV damage. Repairs are needed.

We recommend contacting a licensed commercial roofing contractor regarding these conditions for further evaluation and repair.

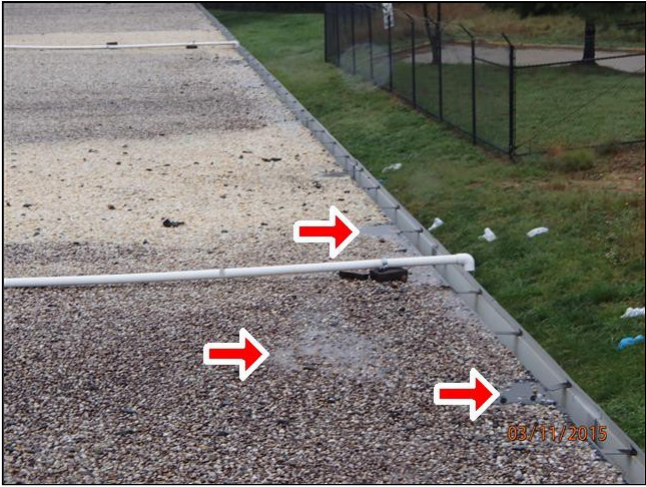
4.0 Item 10(Picture)

4. Ponding is occurring at several areas. Item 10(Picture) Ponding can lead to premature deterioration of the roof covering, resulting in leaks. Soft spot present this in an indication of past or present leak. Repairs are needed.

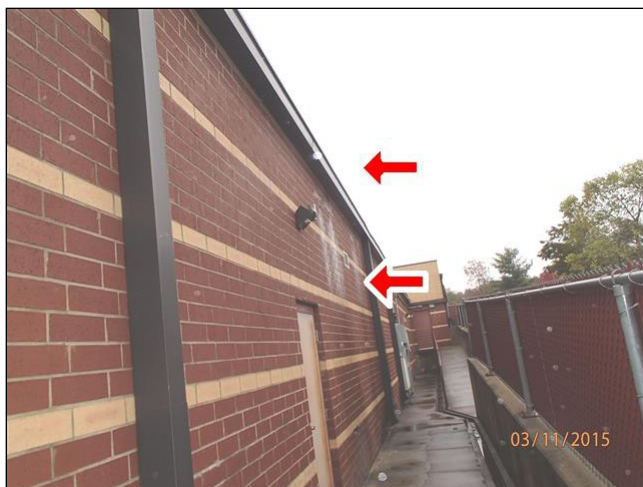
4.4 Item 1(Picture)

1. The gutter at rear of unit 3710-B not draining properly and over flowing. Item 1(Picture) Item 2(Picture) This can lead to water intrusion. Evidence of water intrusion is present. Repairs are needed.

We recommend contacting a licensed contractor regarding these conditions and have repairs made as deemed appropriate..

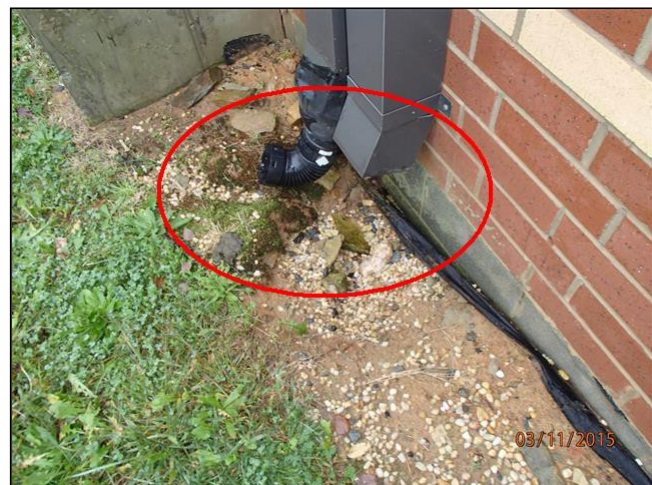
4.4 Item 4(Picture)

3. The downspout at rear of Unit 3710 (Goodwill) shows signs of erosion below downspout as extension is missing. Item 4(Picture) Erosion will continue if not corrected. This can lead to water intrusion and or foundation issues if not corrected. Repairs are needed.

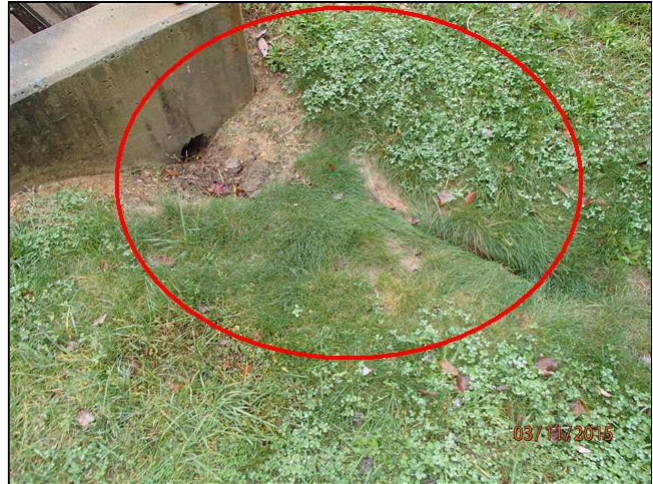
4.4 Item 6(Picture)

4. The concrete drainage trench at rear of structure appears clogged. Item 5(Picture) Item 6(Picture) Repairs are recommended.

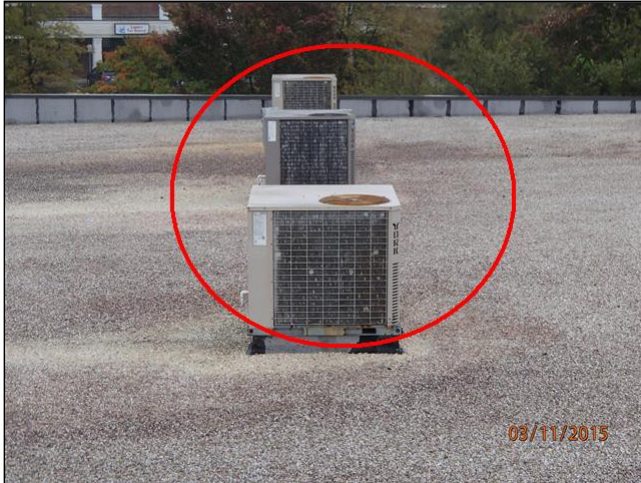
1. Three heat pumps and all package units show signs of hail damage to coils/fins. Item 1(Picture)  
Item 2(Picture) Further investigation is recommended.

8.0 Item 1(Picture) Heat Pump

Due to the nature of commercial HVAC systems, we recommend that an annual service contractor the a licensed commercial hvac contractor is maintained.

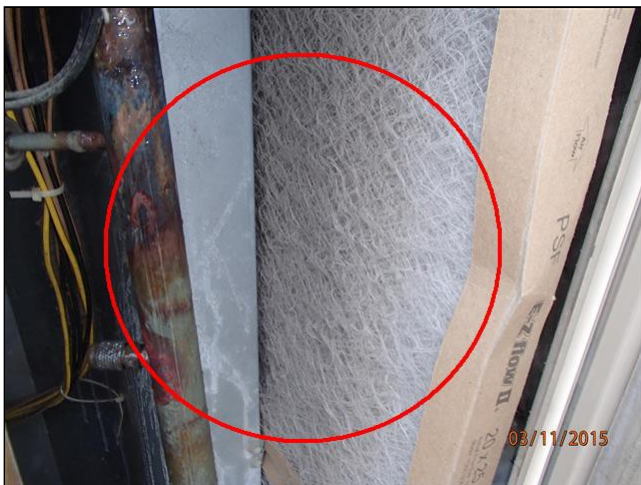
8.6 Item 1(Picture)

1. The disposable filters is dirty. Item 1(Picture) Item 2(Picture) The filter needs to be replaced.  
(This is a maintenance item and is for your information) Repairs are recommended

A qualified licensed HVAC (Heat/Ventilation/Air conditioning Contractor) should inspect further and repair as needed

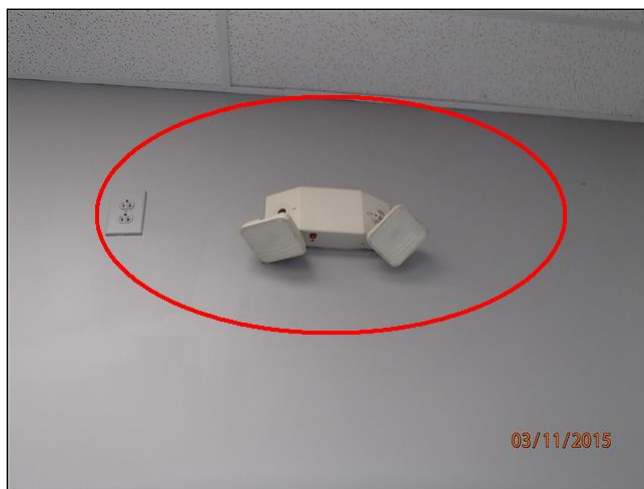
9.5 Item 1(Picture)

1. The emergency lighting throughout the units were damaged and would not operate when tested. Item 1(Picture) Item 2(Picture) (Safety Issue) Repairs are needed.

We recommend contacting a licensed contractor regarding these conditions and have repairs made as deemed appropriate.

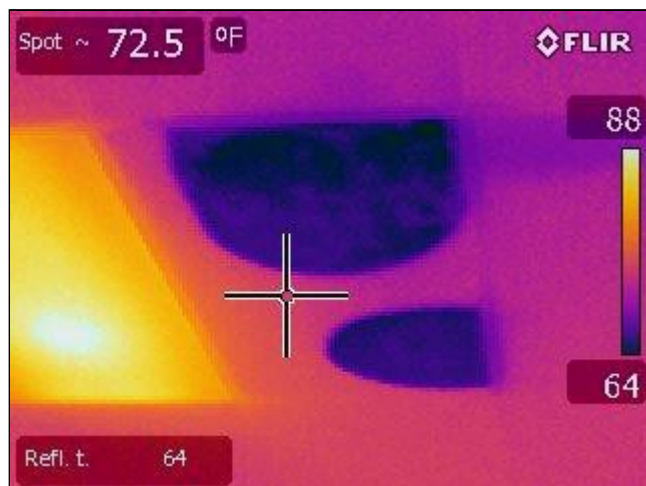
10.0 Item 1(Picture)

- Active water intrusion is occurring at unit 3710 (Goodwill). Item 1(Picture) Item 2(Picture) A thermal camera indicated that active leaks are present. Further investigation and repairs are needed.

We recommend contacting a licensed commercial roofing contractor and or licensed commercial HVAC regarding these conditions and have repairs made as deemed appropriate.
