Table of Contents

**AHI Residential & Commercial Inspections, Inc**

Sample Commercial

123 Sample Inspection Rd  
Sample City NC

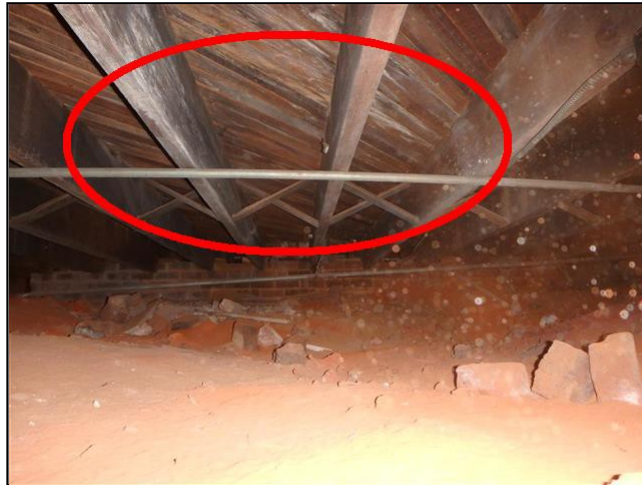
1.4 Item 1(Picture)

1. Discoloration and some type of Fungal / microbial growth is present in the structure at several areas including but not limited to the crawl space. Item 1(Picture) This type of substance commonly results in the building and finish type materials becoming weakened and or compromised. Evidence suggest that this condition is from past or present elevated moisture conditions. We did not inspect, test or determine if this type of substance is or is not a health hazard.

We recommend you contact a properly licensed expert for testing, investigation and or correction as deemed appropriate.

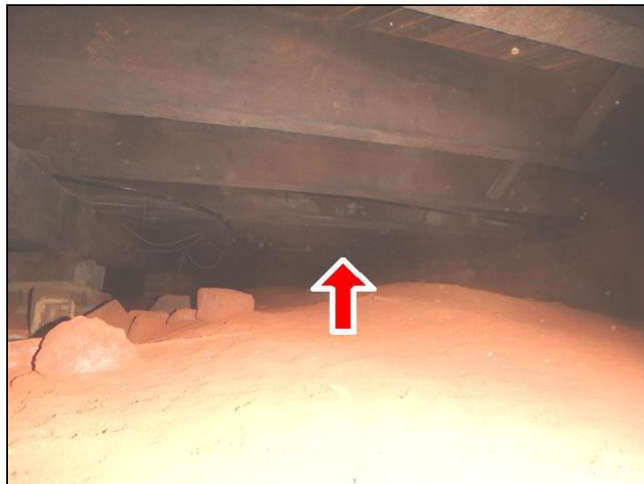
1.5 Item 1(Picture)

1. The clearance is limited at the front of building and left side due to low clearance issues. Item 1(Picture) Item 2(Picture) Item 3(Picture) Item 4(Picture) As a result we could not crawl this location. These areas were not inspected as a result. Hidden damage may be present. Further investigation is recommended.

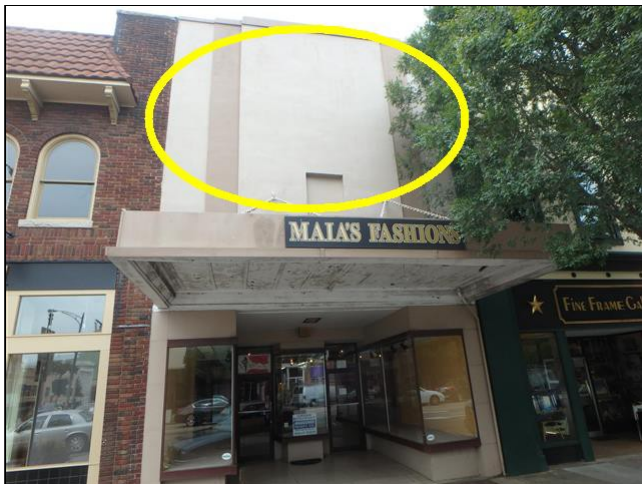
3.0 Item 1(Picture)

1. Hairline cracking is the masonry stucco coating present at front. Item 1(Picture) This is an indication of moisture behind coating. Repairs are recommended.
2. 1/4 cracking is the masonry stucco coating present at rear of building. Item 2(Picture) This is an indication of past movement. Repairs are recommended.

We recommend contacting a licensed contractor regarding these conditions and have repairs made as deemed appropriate.

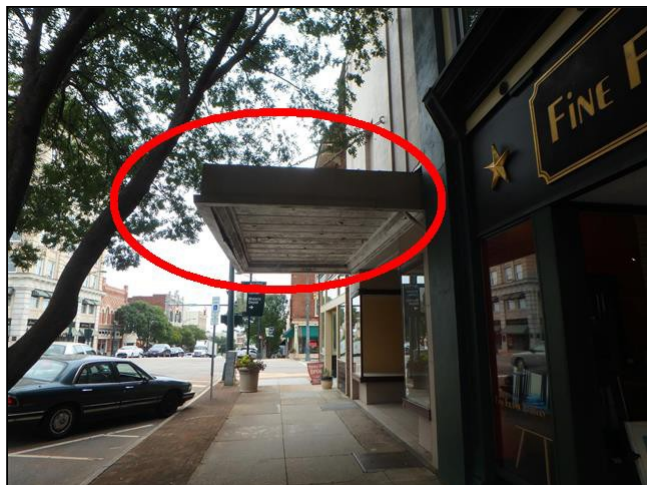
3.2 Item 1(Picture)

1. The canopy on the front of building shows signs of improper and framing damage present as result. Item 1(Picture) Item 2(Picture) Item 3(Picture) Item 4(Picture) Item 5(Picture) Visible signs of water damage is present at interior of building indicate that general replacement is likely.

Repairs are needed.

We recommend contacting a licensed contractor for complete evaluation of canopy and have repairs made as deemed appropriate..

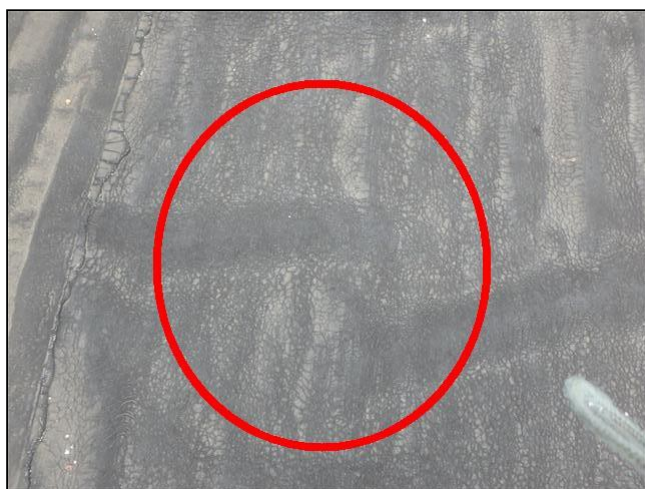
4.0 Item 1(Picture)

The following concerns were noted during the inspection of the roof. The roof covering appear to be at the end of its useful service life for the following reasons.

1. Alligatoring of rubber membrane is present. Item 1(Picture) Alligatoring is a crazed cracking pattern in the roof's surfacing. Alligatoring is a sign that your roof is aged. The sun's UV rays dry and damage the roof's surface, sunlight and the heating and cooling shifts between day and night will all cause new cracks to appear while widening the existing cracks. This will allow leaks to occur. Repairs are needed.

We recommend contacting a licensed commercial roofing company to evaluate entire roof and have repairs made as deemed appropriate.

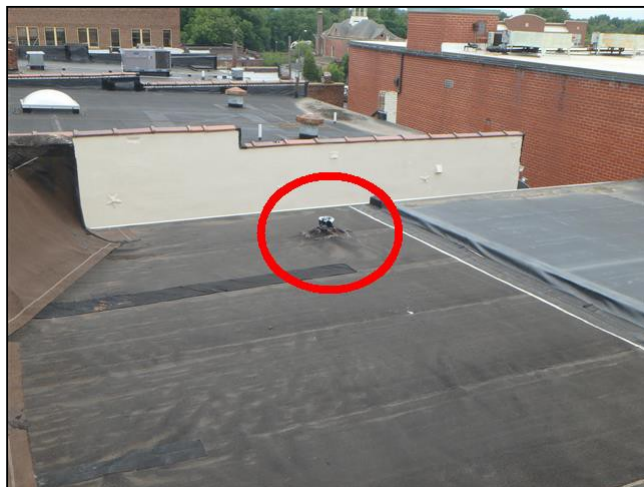
4.2 Item 1(Picture)

1. The (through roof) plumbing vent pipes need to have their flashings/boots repaired/replaced. Item 1(Picture) Split, damage and or uplifted boots will allow water to penetrate into the roof framing/sheathing system and cause moisture damage. Thermal camera and water stains to roof sheathing indicated that active leaks is present. Item 2(Picture) Repairs are needed.

We recommend contacting a licensed commercial roofing company to evaluate entire roof and have repairs made as deemed appropriate.

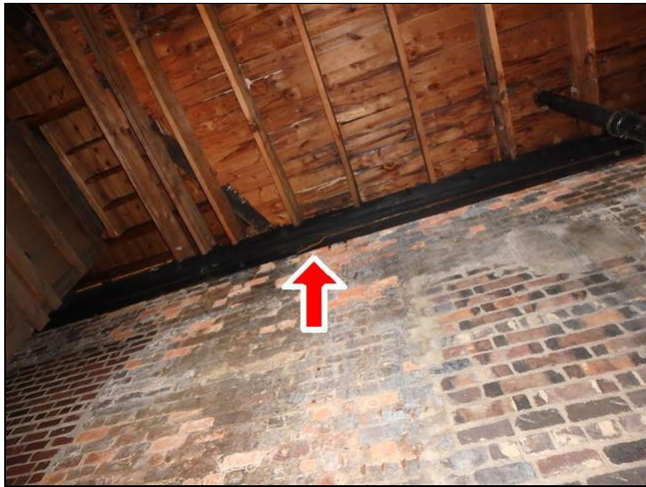
4.5 Item 1(Picture)

1. Rafters and sheathing inside attic indicates evidence of a previous fire. Item 1(Picture) Item 2(Picture) Item 3(Picture) The rear support beam is split/cracked near center of roof line. No signs of repairs to beam are present. Structural failure could occur if not addressed. Repairs are needed.
2. Visible signs of water intrusion in the attic are present from water stains on wood slats in numerous areas. Item 4(Picture) Item 5(Picture) Item 6(Picture) Due to recent weather conditions we were unable to determine if leaks are active. Please note: children's plastic pool present to likely catch water is present. Item 7(Picture) Further investigation is needed.

We recommend contacting a nc licensed commercial contractor regarding these conditions and have repairs made as deemed appropriate.

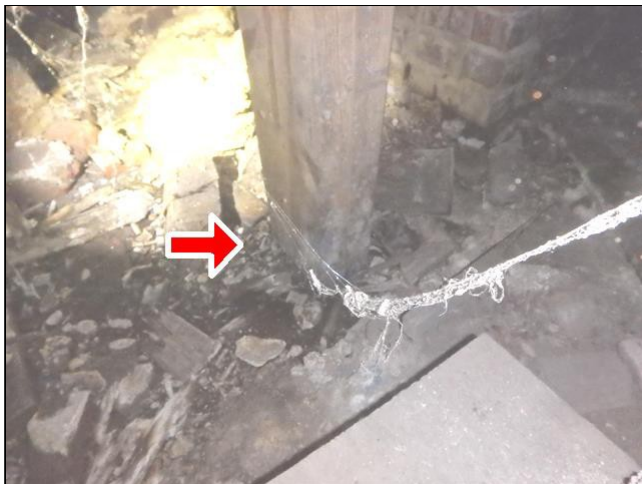
5.2 Item 1(Picture)

1. The wood supports in contact with crawl space dirt floor as a result deterioration is present. Item 1(Picture) Item 2(Picture) Item 3(Picture) Item 4(Picture) Wood to soil contact is not recommended as the can allow wood destroying insect activity and deterioration to occur. Best practice is to use masonry piers set on concrete footings. Further evaluation and repairs are needed.

A licensed general contractor should be consulted to determine the extent of the damage and necessary repairs.

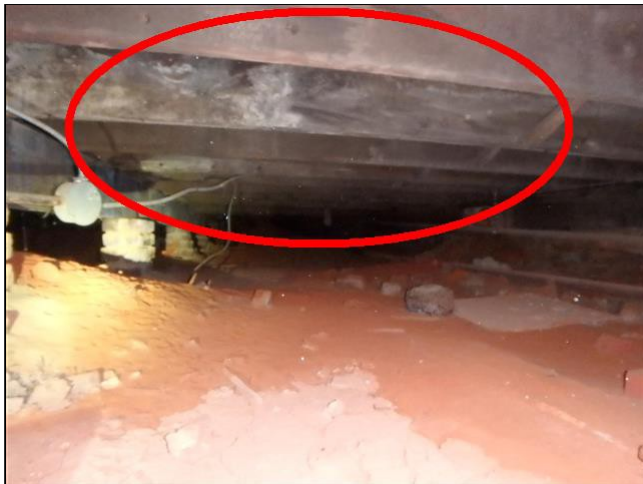
5.3 Item 1(Picture)

1. In the crawl space area along the rear and center of building the wood floor joist and subflooring for the floor system were noticeably deteriorated and found to be soft and decayed when probed. This type of damage indicates that the wood components have been subjected to excessive moisture. Moisture meter readings were from 20% to 26% in crawl space. Deterioration of the floor joists can result in movement or sagging of the floor system.

A licensed general contractor should be consulted to determine the extent of the damage, the source of the water penetration, and necessary repairs.

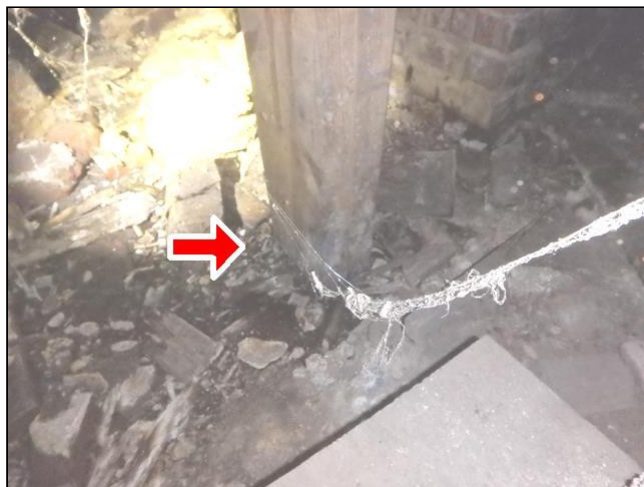
5.2 Item 1(Picture)

1. The wood supports in contact with crawl space dirt floor as a result deterioration is present. Item 1(Picture) Item 2(Picture) Item 3(Picture) Item 4(Picture) Wood to soil contact is not recommended as the can allow wood destroying insect activity and deterioration to occur. Best practice is to use masonry piers set on concrete footings. Further evaluation and repairs are needed.

A licensed general contractor should be consulted to determine the extent of the damage and necessary repairs.

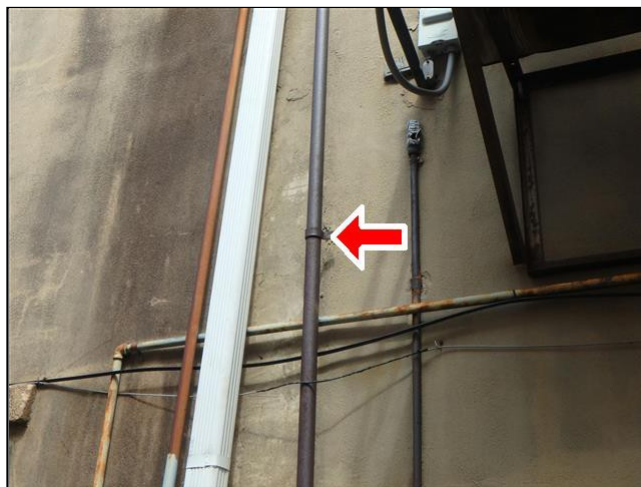
6.1 Item 1(Picture)

1. The wall anchor for the service mast not secured to structure. Item 1(Picture) This can allow electrical failure to occur. Repairs are needed.

We recommend contacting the local utility company regarding these conditions and have repairs made as deemed appropriate.

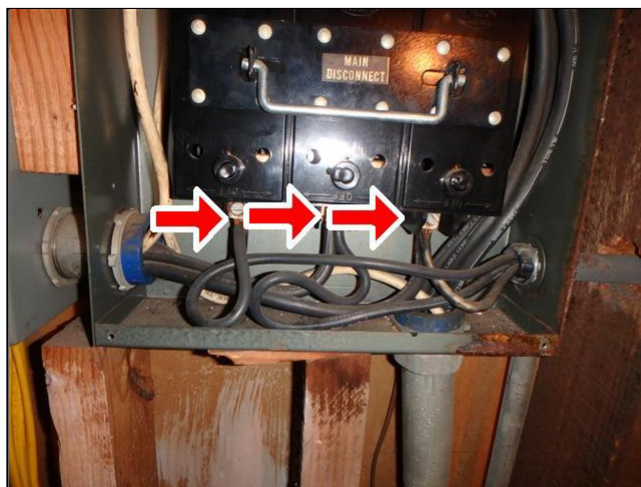
6.2 Item 1(Picture)

1. The main fuse service lugs are double tapped. Item 1(Picture) While often done, this is not permitted unless the device is so labeled. Double tapping often leads to overloaded circuits and loose connections that can overheat. Repairs are needed.

We recommend contacting a licensed electrician regarding these conditions and have repairs made as deemed appropriate.

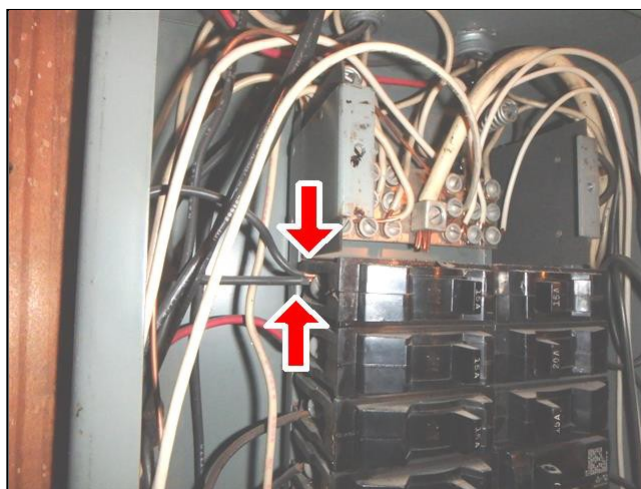
6.3 Item 1(Picture)

1. Two wires were observed to be connected to one or more circuit breakers in the panel. Item 1(Picture) While often done, this is not permitted unless the device is so labeled. Double tapping often leads to overloaded circuits and loose connections that can overheat. Repairs are needed.

We recommend contacting a licensed electrician regarding these conditions and have repairs made as deemed appropriate.

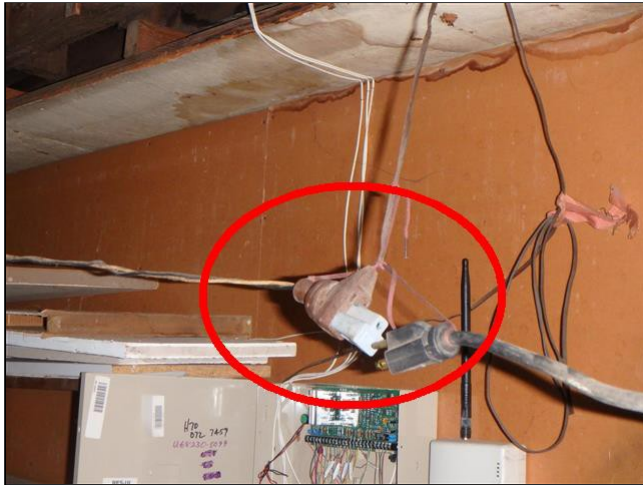
6.4 Item 1(Picture)

1. Extension cord used as permanent wiring at the rear upper storage room and front display area. Item 1(Picture) Item 2(Picture) Extension cords are not considered safe to use as permanent wiring. Exposed wiring is considered unsafe until repaired. (Fire Safety Issue) Repairs are needed.
2. The fluorescent light fixtures at the front display area were not operable at time of inspection.

We recommend contacting a licensed electrician regarding these conditions and have repairs made as deemed appropriate..

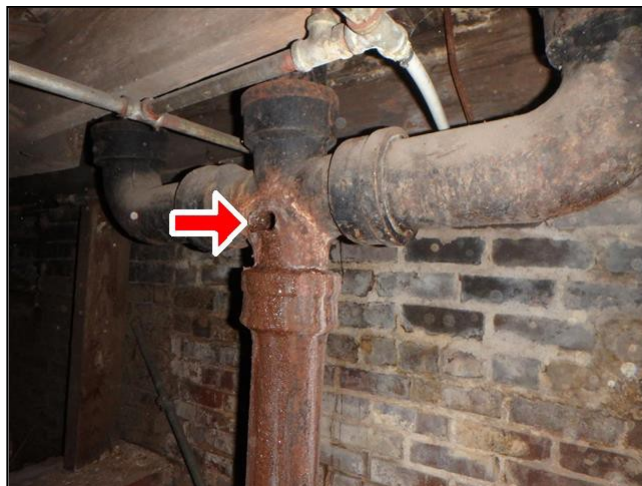
7.4 Item 1(Picture)

1. The cast iron main waste line for the half bathroom's are damaged and has active sewage leaks. Item 1(Picture) As a result raw sewage leaks are present in crawl space. While the repair cost strain and potential for further damage to your property is a troublesome thought, even more so is the risk of health problems severe leaks can cause, not limited to pathogens, mold, etc. REPAIRS ARE NEEDED.

We recommend contacting a licensed plumber regarding these conditions and have the entire plumbing waste line system evaluated and have repairs/replacements made as deemed appropriate

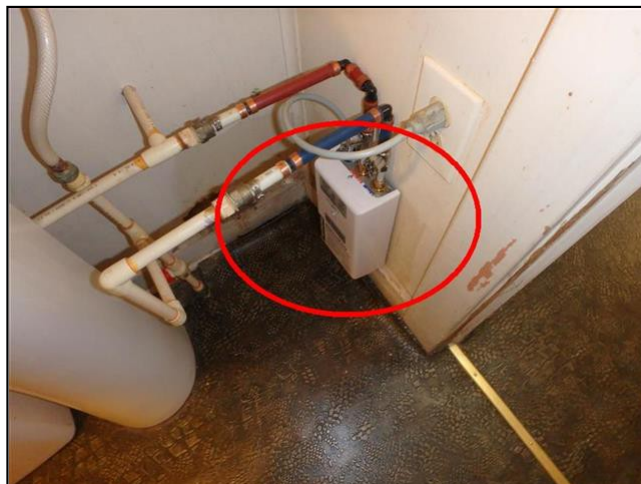
7.2 Item 1(Picture)

1. The water heater did not work (no hot water). Item 1(Picture) Circuit breaker was already "on" before we inspected. Failure likely due to the condition of the supply lines in the crawl space. Further investigation and repairs are needed.

We recommend contacting a qualified licensed plumber regarding these conditions and have repairs

made as deemed appropriate..

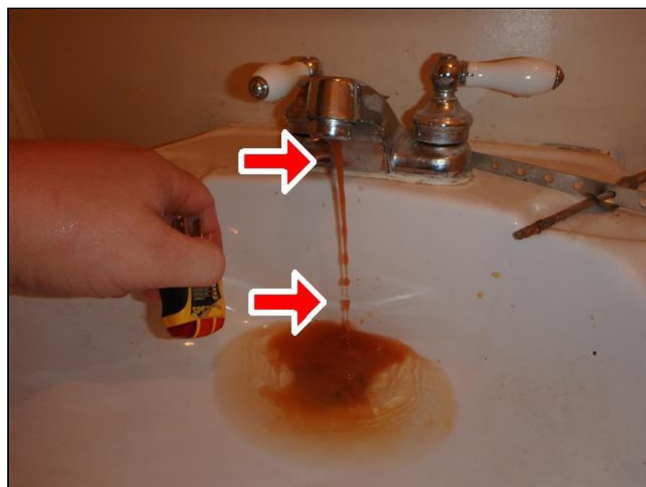
7.3 Item 1(Picture)

1. The hot and cold galvanized main water and supply lines throughout the building has rust present in water supply. Item 1(Picture) Item 2(Picture) General replacement of the galvanized supply piping throughout the building is likely do the conditions present as the water pressure over-all is poor and would not pass "functional flow." Item 1(Picture) The reason for weak volume or pressure is old galvanized piping that is corroded inside. Repairs are needed.

We recommend contacting a licensed plumber regarding these conditions and have the entire plumbing supply and distribution system evaluated and have repairs/replacements made as deemed appropriate

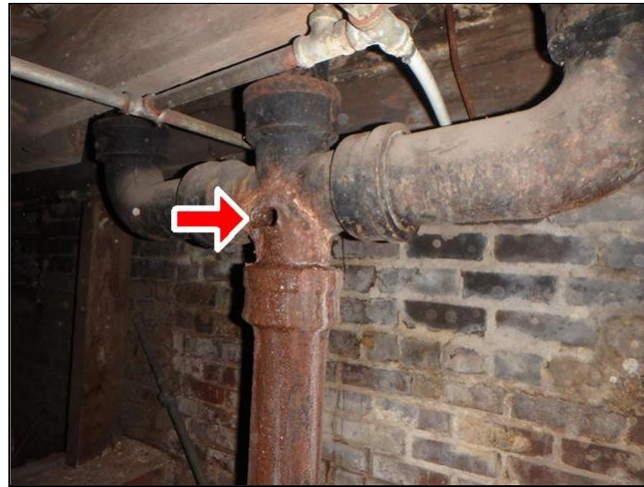
7.4 Item 1(Picture)

1. The cast iron main waste line for the half bathroom's are damaged and has active sewage leaks. Item 1(Picture) As a result raw sewage leaks are present in crawl space. While the repair cost strain and potential for further damage to your property is a troublesome thought, even more so is the risk of health problems severe leaks can cause, not limited to pathogens, mold, etc. REPAIRS ARE NEEDED.

We recommend contacting a licensed plumber regarding these conditions and have the entire plumbing waste line system evaluated and have repairs/replacements made as deemed appropriate

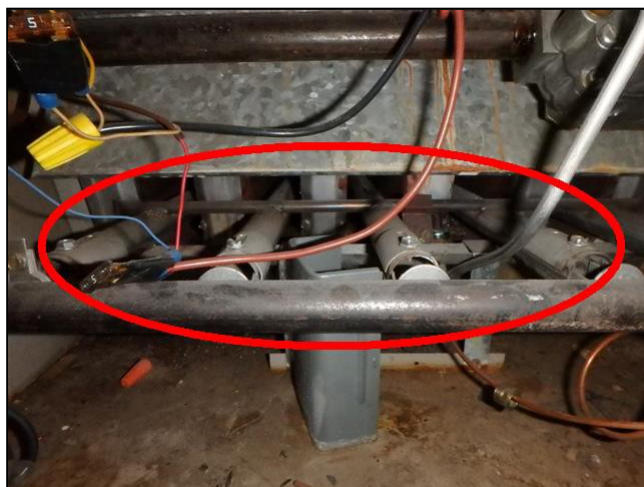
8.0 Item 1(Picture)

1. The furnace combustion chamber shows is rusted with rust particles and flakes on the burners and at the bottom of the chambers. Item 1(Picture) Item 2(Picture) Item 3(Picture) Item 4(Picture)  
This is a typical sign of a possibly failed heating system / heat exchanger. General replacement of furnace likely due to age and condition.
2. The ignitor for the gas furnace is not installed properly. Item 5(Picture)

We recommend contacting a properly licensed (HVAC) heating and air contractor regarding these conditions and have repairs made as deemed appropriate

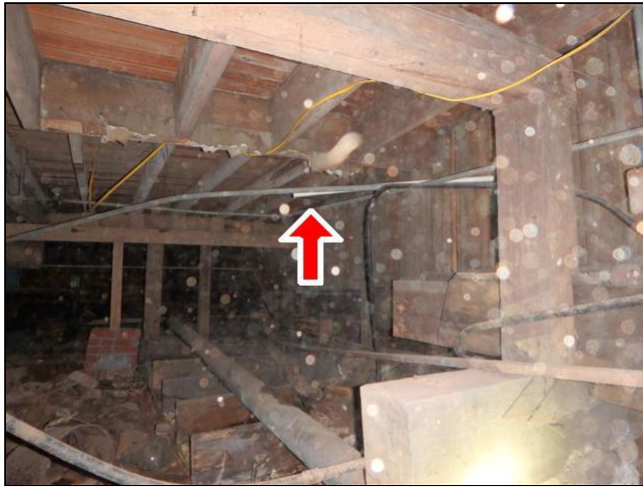
8.2 Item 1(Picture)

1. The primary condensate drain line is routed to the crawl space and is dumping water onto the crawl space dirt floor. Item 1(Picture) Item 2(Picture) This is contributing to elevated moisture conditions in the crawl space. (See Section 1.4) Repairs are needed.

We recommend contacting a licensed HVAC contractor regarding these conditions and have repairs made as deemed appropriate.

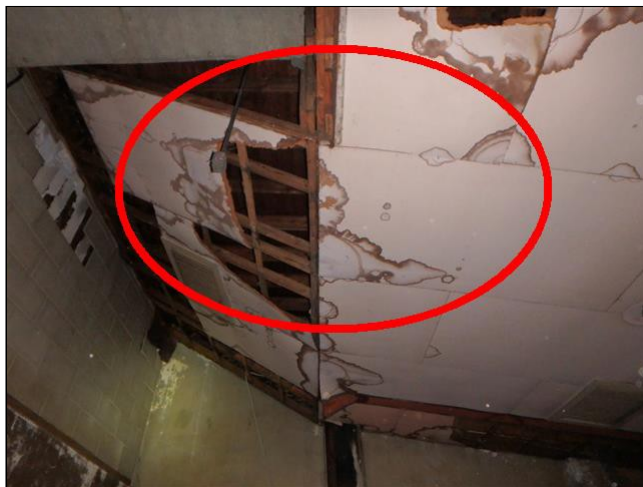
10.0 Item 1(Picture)

1. The ceiling tile on the ceiling reveals a water stain indicating a leak did or still exists at the interior and both upper and lower ceilings. Item 1(Picture) Item 2(Picture) Item 3(Picture) Item 4(Picture) Due to recent dry weather, we are unable to determine if the leak still exists. Further investigation is needed.

We recommend contacting a licensed roofing contractor regarding these conditions and have repairs made as deemed appropriate..

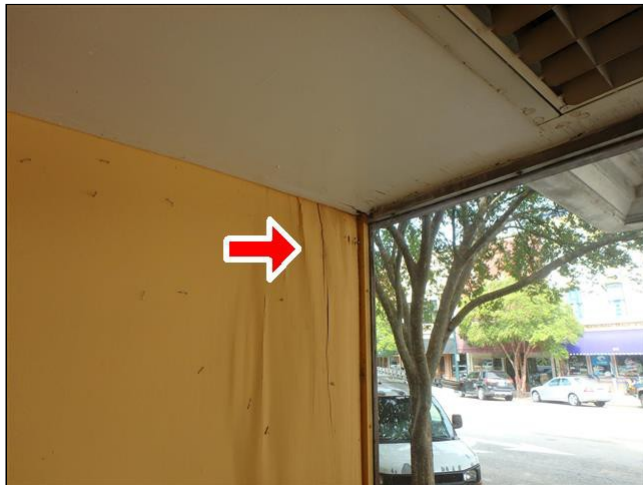
10.1 Item 1(Picture)

1. The paneling on the wall shows wet stains indicating moisture or intrusion did or still may occur at the front of store. Item 1(Picture) Item 2(Picture) Item 3(Picture) Due to recent dry weather, we are unable to determine if the leak still exists. Further investigation is needed.

We recommend contacting a roofing contractor regarding these conditions and have repairs made as deemed appropriate..

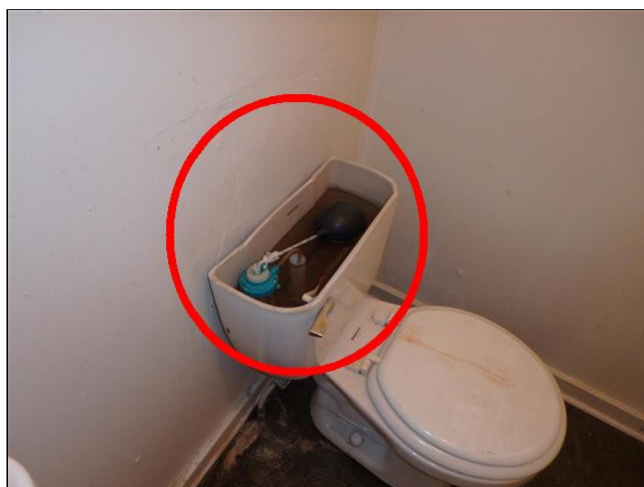
11.5 Item 1(Picture)

1. The toilet tank lid is missing at the right side 1/2 bath. Repairs are needed.
2. The toilet tank at the right side half bath has active leaks at bolts. Item 2(Picture) Repairs are needed to prevent water damage to structure.
3. The toilet will not flush at the right side half bathroom. Item 3(Picture) The Flush Valve, Flapper & or Tank Lever likely need replacing. Repairs are needed.
4. Both half bathroom sink stopper is missing or does not function as intended. Item 4(Picture) Item 5(Picture) A Repair or Replacement is needed.
5. The toilet tank at the right side half bath has active leaks at bolts. Item 6(Picture) Repairs are needed to prevent water damage to structure

We recommend contacting a qualified licensed plumber regarding these conditions and have repairs made as deemed appropriate..

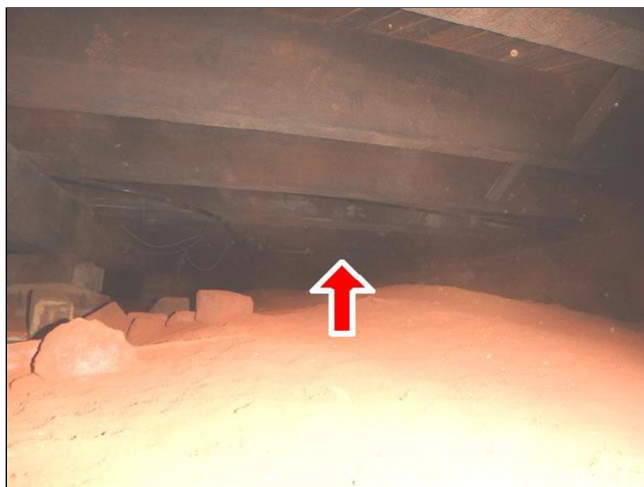
1.5 Item 1(Picture)

1. The clearance is limited at the front of building and left side due to low clearance issues. Item 1(Picture) Item 2(Picture) Item 3(Picture) Item 4(Picture) As a result we could not crawl this location. These areas were not inspected as a result. Hidden damage may be present. Further investigation is recommended.
