# Inspection Report

Mrs. Jane Doe

Sample Final Inspection

**AHI Residential & Commercial Inspections, Inc**

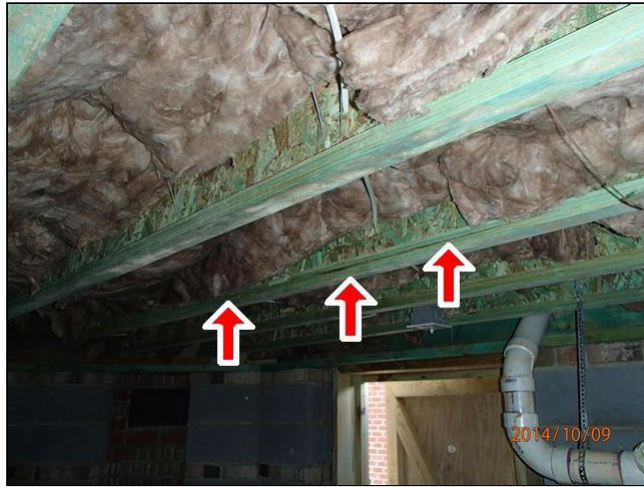
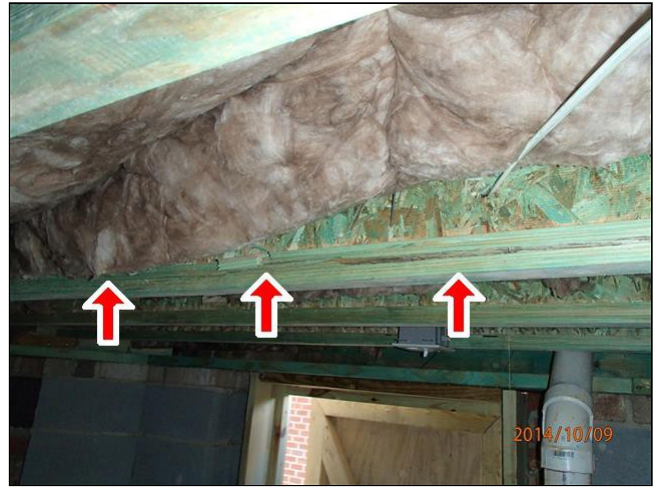
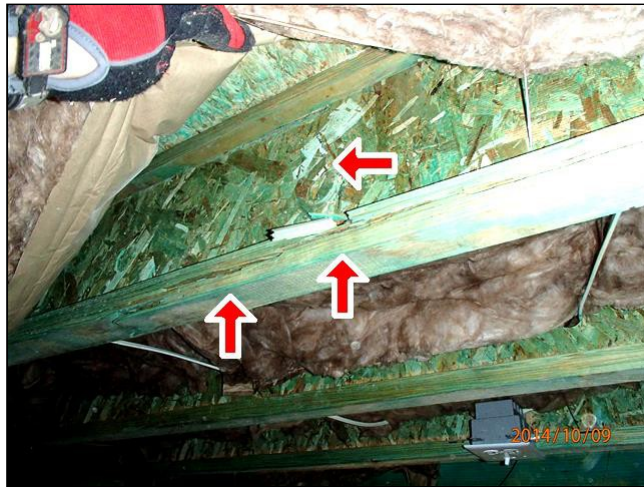
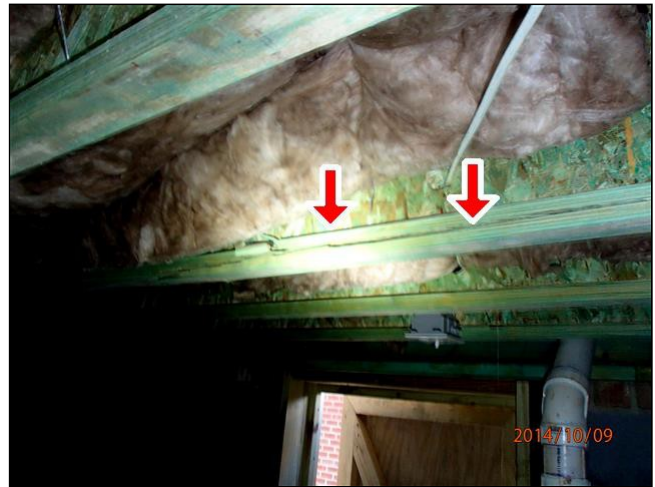
1. One split or cracked under the breakfast nook. Item 1(Picture) Item 2(Picture) Item 3(Picture) Item 4(Picture) This can caused a soft spot in the floor (See Section 9.2) Repairs are needed.

A licensed general contractor should be consulted to determine the necessary repairs. If the repair is beyond the scope of the NC Building code, the contractor should consult a professional structural engineer.. .

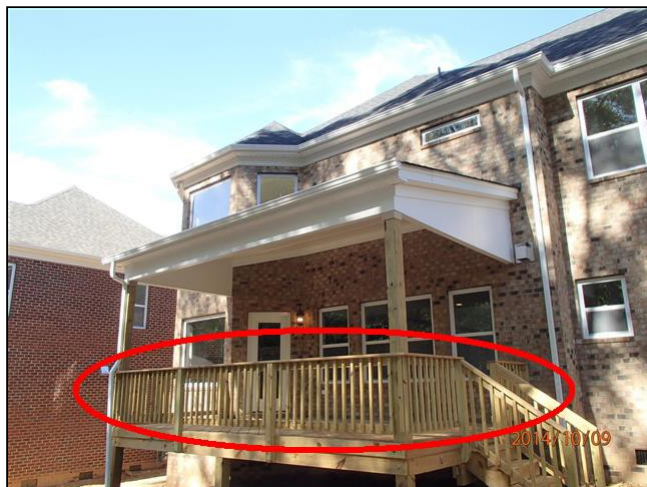
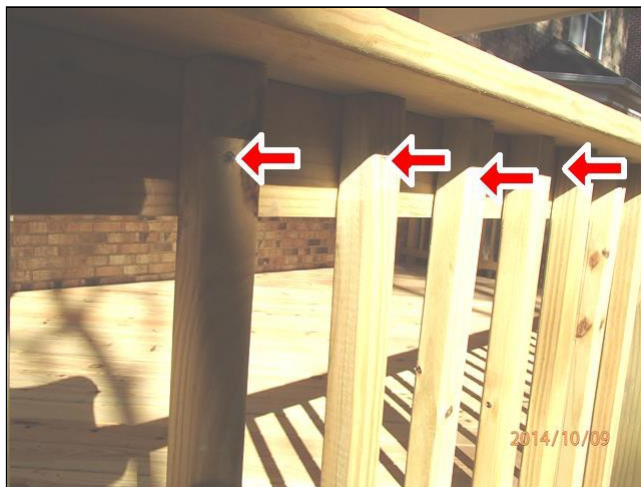
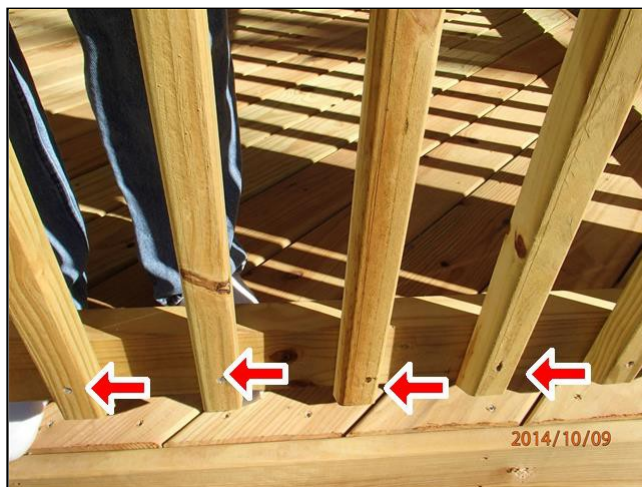
1. The pickets on deck at the rear of home not properly nailed per 2006 deck code. Item 1(Picture) Item 2(Picture) Item 3(Picture) Pickets should be installed with 2 nails at top and bottom of each picket or one screw. (See Attachment) A fall or injury could occur if not corrected. A repair is needed.

We recommend contacting a properly licensed contractor regarding these conditions and have repairs made as deemed appropriate

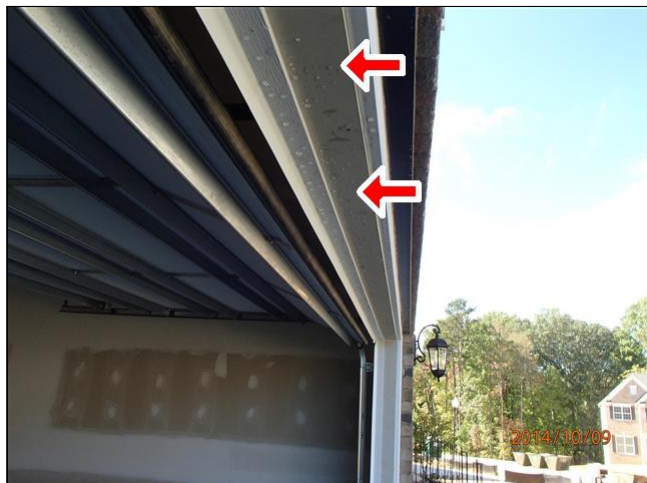
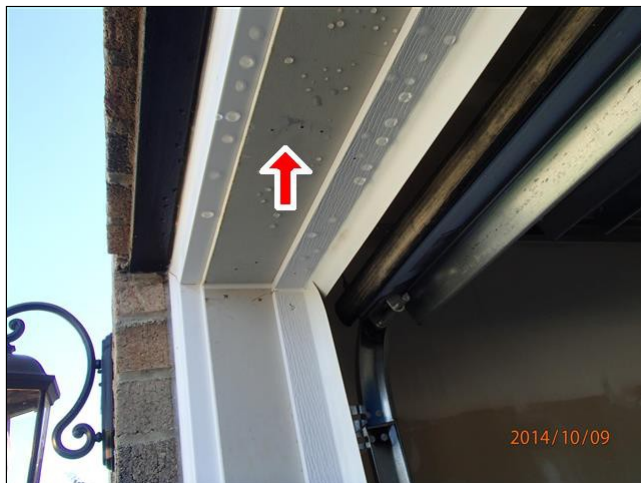
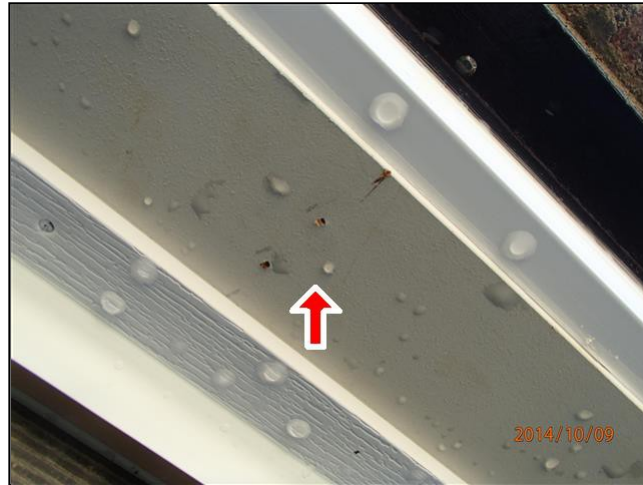
1. The garage door trim at the front of home not painted. Item 1(Picture) Item 2(Picture) Item 3(Picture) This can allow deterioration to occur if not corrected This is a small repair.

We recommend contacting a properly licensed contractor regarding these conditions and have repairs made as deemed appropriate.

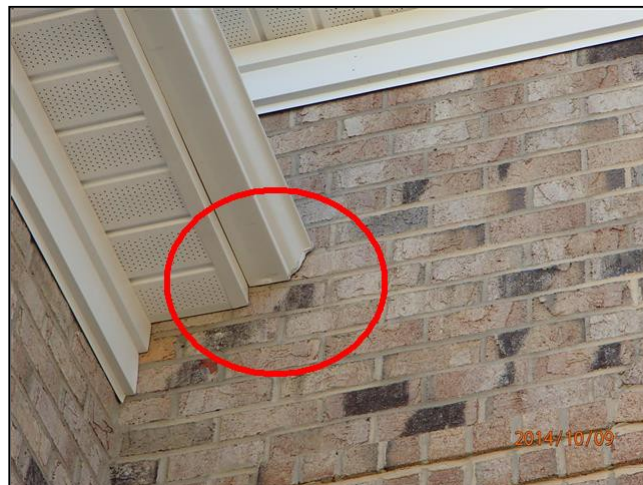
1. The gutter at the front home is in contact with the brick siding. Item 1(Picture) Clearance of 1/2 to one inch is needed in case gutter overflows. Repairs are needed.

We recommend contacting a properly licensed contractor regarding these conditions and have repairs made as deemed appropriate.

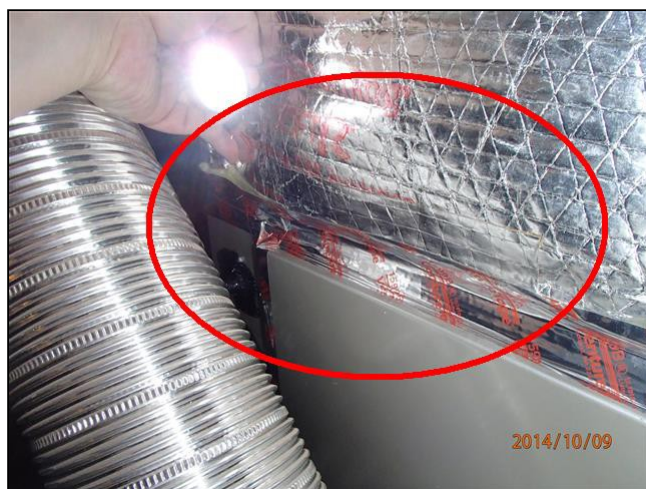
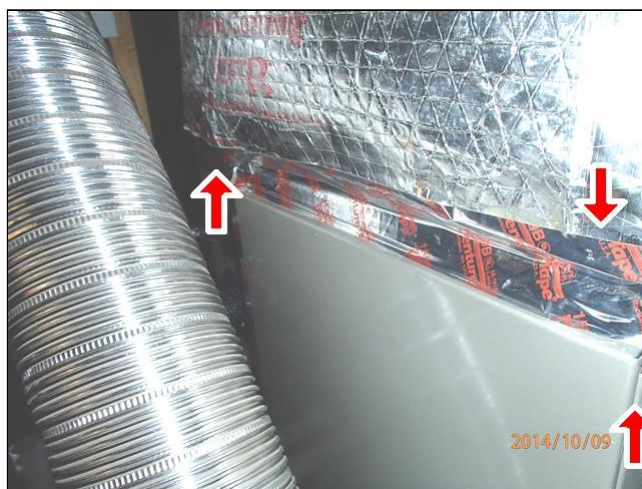
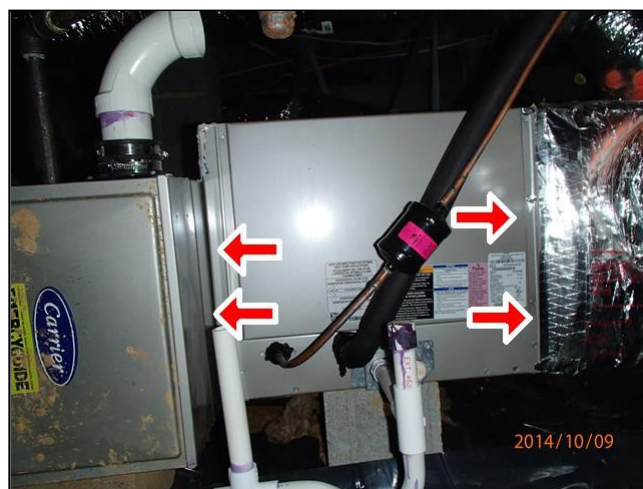
1. The both evaporator coils in the attic and crawl space have air leaks present where unit connects to air handler. Item 1(Picture) Item 2(Picture) Item 3(Picture) Repairs are needed to prevent condensation and energy loss. All seams should be taped with mastic and tape to prevent air leaks.

We recommend contacting a properly licensed HVAC contractor and make repairs as deemed appropriate..

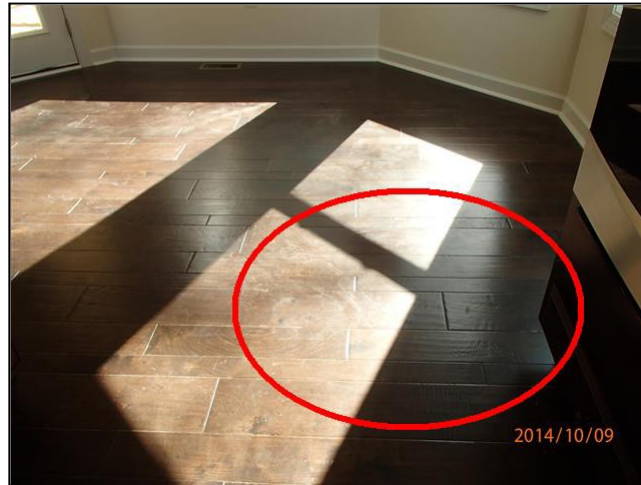
1. The Wood floor is weak and not supported from underneath at the kitchen/breakfast nook. Item 1(Picture) (SEE STRUCTURAL SECTION) Repairs are needed.

We recommend contacting a properly licensed contractor regarding these conditions and have repairs made as deemed appropriate.

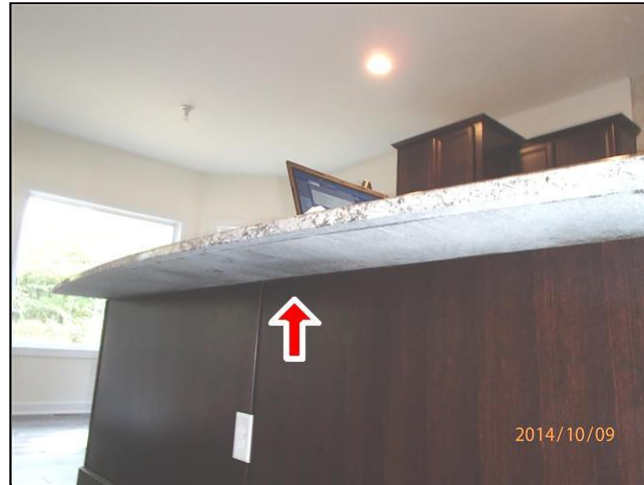
1. The granite is not supported to the kitchen island cabinetry. Item 1(Picture) Concerning the safety of extended overhangs in granite countertops, below you will find the recommendations of the Marble Institute of America:

*"It is not recommended to project any unsupported stone past the base more than 6", for stone of 3/4" or less."* 1 The common practice in the stone industry is up to 8" overhang.

*"Stone thicker than 3/4" can have a greater unsupported span."* 1 The common practice in the stone industry is up to 10" overhang. Repairs are recommended.

We recommend contacting a licensed contractor regarding these conditions and have repairs made as deemed appropriate.

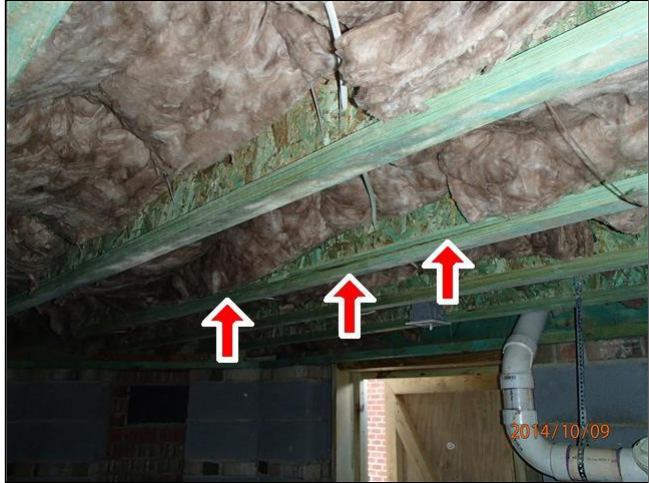
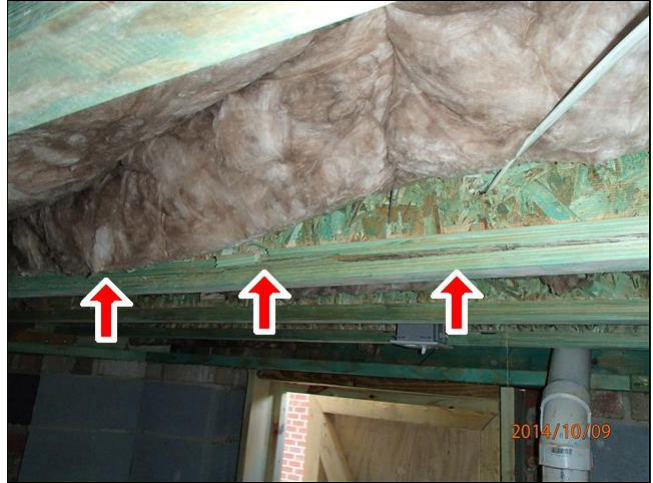
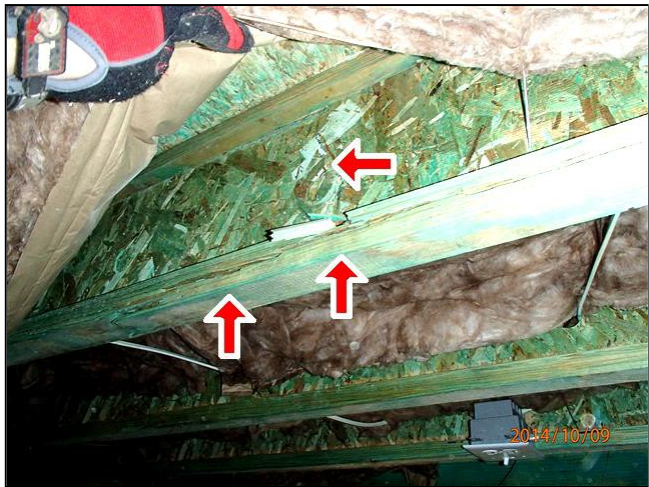
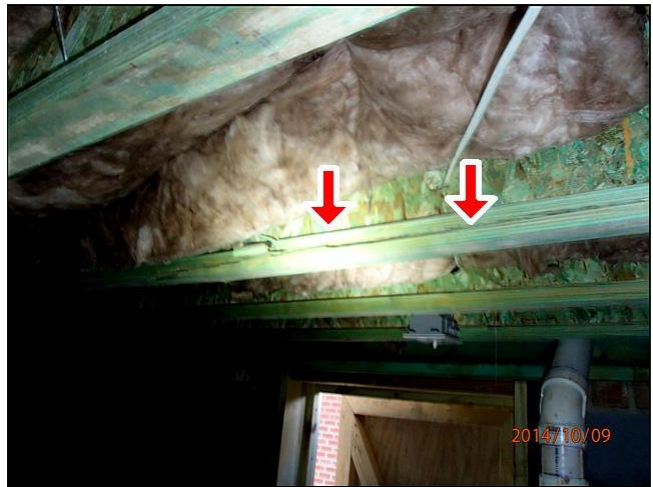
1. One split or cracked under the breakfast nook. Item 1(Picture) Item 2(Picture) Item 3(Picture) Item 4(Picture) This can caused a soft spot in the floor (See Section 9.2) Repairs are needed.

A licensed general contractor should be consulted to determine the necessary repairs. If the repair is beyond the scope of the NC Building code, the contractor should consult a professional structural engineer..

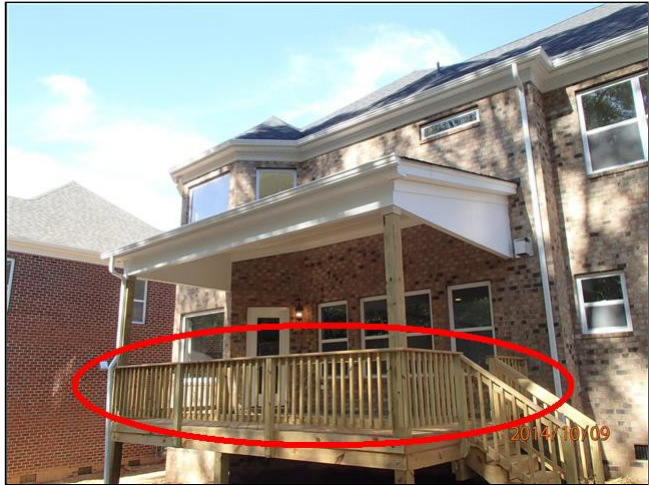
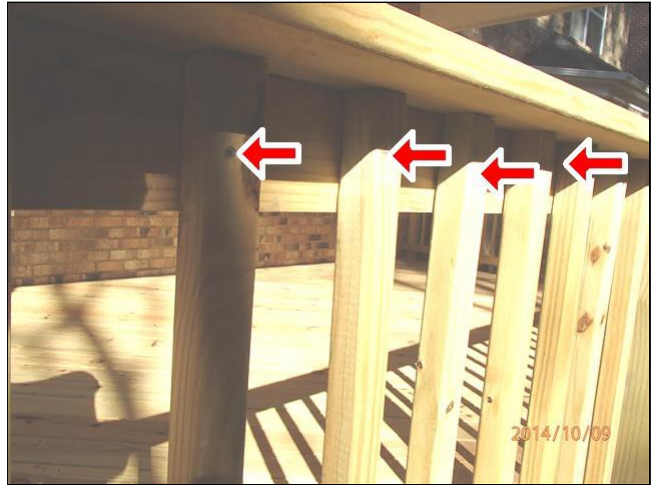
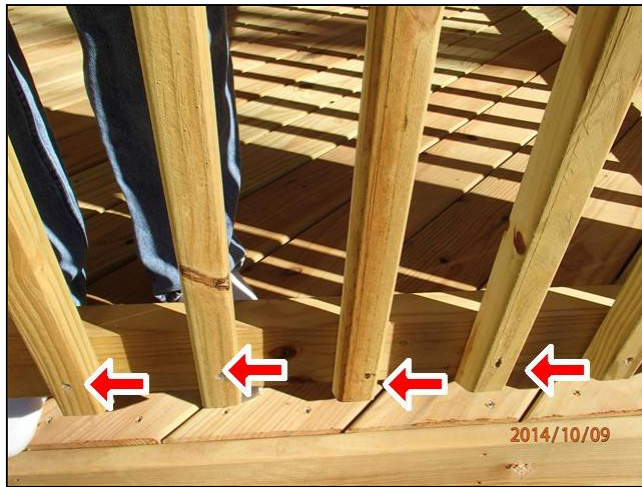
1. The pickets on deck at the rear of home not properly nailed per 2006 deck code. Item 1(Picture) Item 2(Picture) Item 3(Picture) Pickets should be installed with 2 nails at top and bottom of each picket or one screw. (See Attachment) A fall or injury could occur if not corrected. A repair is needed.

We recommend contacting a properly licensed contractor regarding these conditions and have repairs made as deemed appropriate

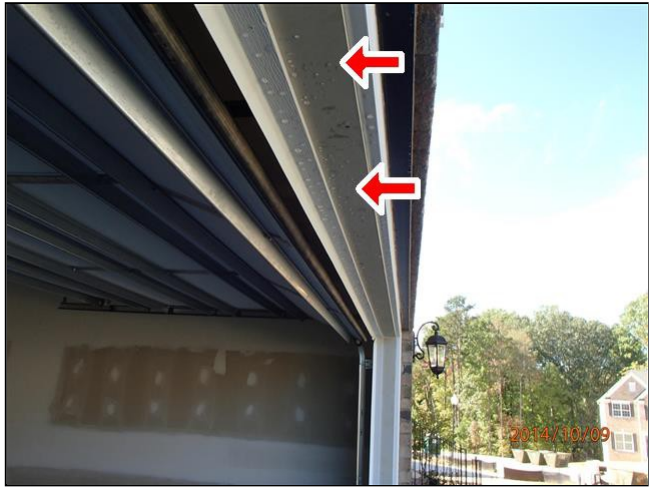
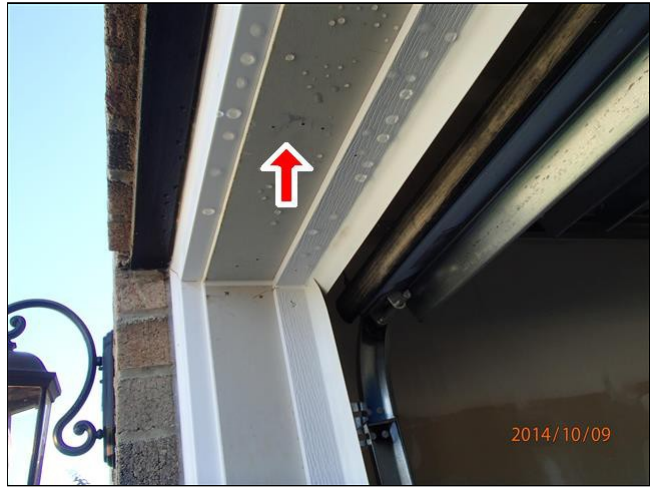
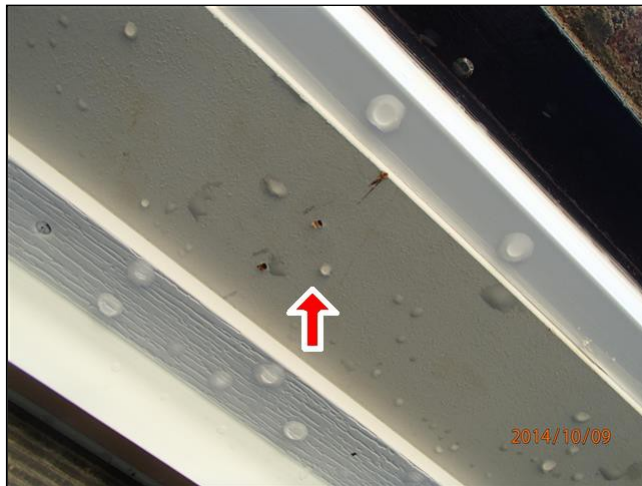
3.8

1. The garage door trim at the front of home not painted. Item 1(Picture) Item 2(Picture) Item 3(Picture)  
This can allow deterioration to occur if not corrected This is a small repair.

We recommend contacting a properly licensed contractor regarding these conditions and have repairs made as deemed appropriate.

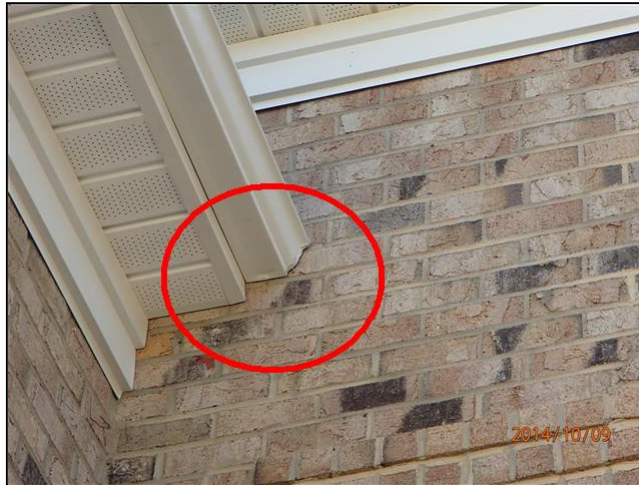
1. The gutter at the front home is in contact with the brick siding. Item 1(Picture) Clearance of 1/2 to one inch is needed in case gutter overflows. Repairs are needed.

We recommend contacting a properly licensed contractor regarding these conditions and have repairs made as deemed appropriate.

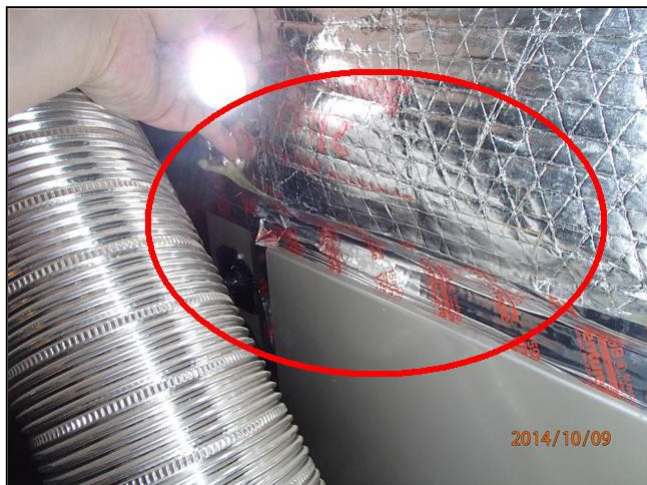
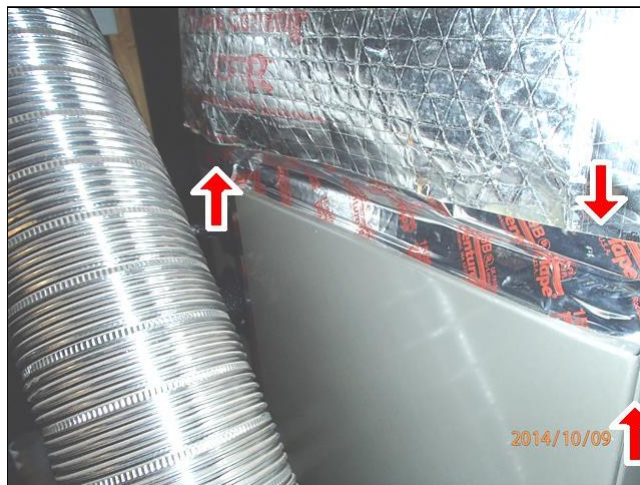
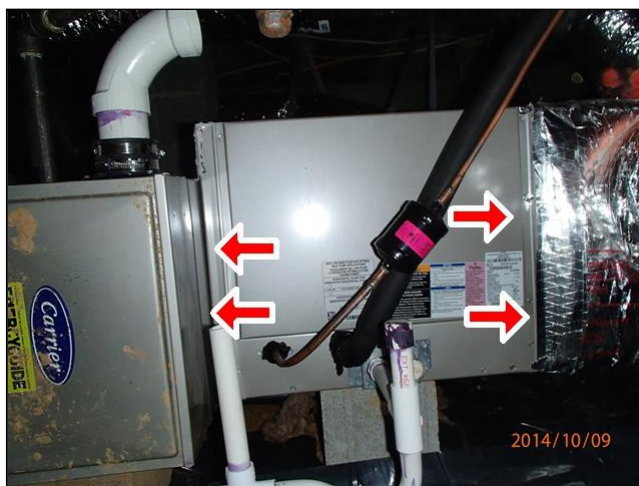
1. The both evaporator coils in the attic and crawl space have air leaks present where unit connects to air handler. Item 1(Picture) Item 2(Picture) Item 3(Picture) Repairs are needed to prevent condensation and energy loss. All seams should be taped with mastic and tape to prevent air leaks.

We recommend contacting a properly licensed HVAC contractor and make repairs as deemed appropriate..

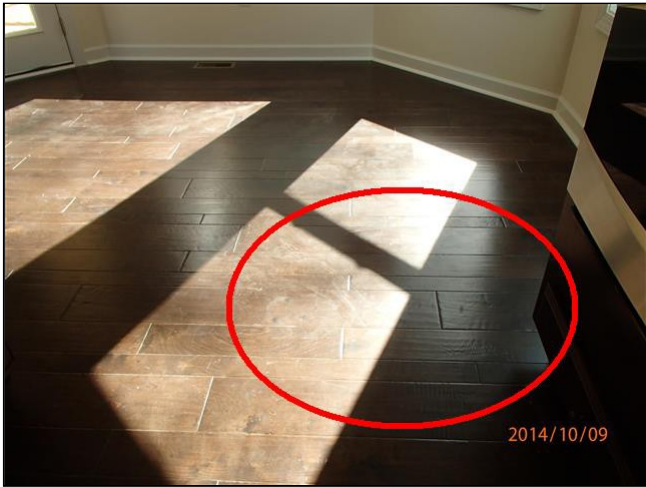
9.2
1. The Wood floor is weak and not supported from underneath at the kitchen/breakfast nook.Item 1(Picture) (SEE STRUCTURAL SECTION) Repairs are needed.

We recommend contacting a properly licensed contractor regarding these conditions and have repairs made as deemed appropriate.

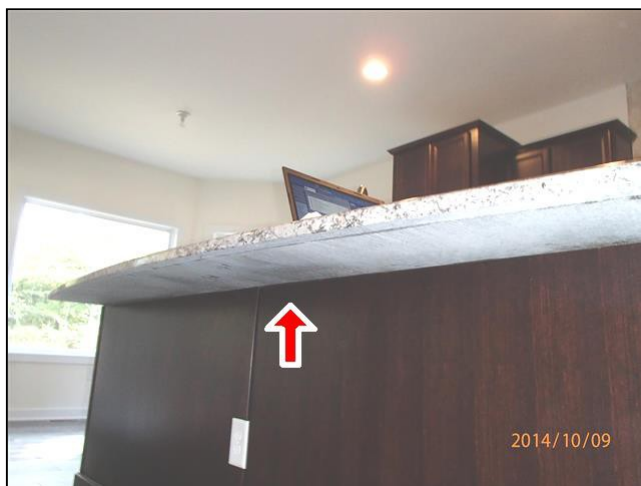
## 9.4

1. The granite is not supported to the kitchen island cabinetry. Item 1(Picture) Concerning the safety of extended overhangs in granite countertops, below you will find the recommendations of the Marble Institute of America:

*"It is not recommended to project any unsupported stone past the base more than 6", for stone of 3/4" or less." 1* The common practice in the stone industry is up to 8" overhang.

*"Stone thicker than 3/4" can have a greater unsupported span." 1* The common practice in the stone industry is up to 10" overhang. Repairs are recommended.

We recommend contacting a licensed contractor regarding these conditions and have repairs made as deemed appropriate.
