# Inspection Report

**Prepared For:**  
Sample Pre-Drywall

**Property Address:**  
Sample Rd  
Sample City NC 22222

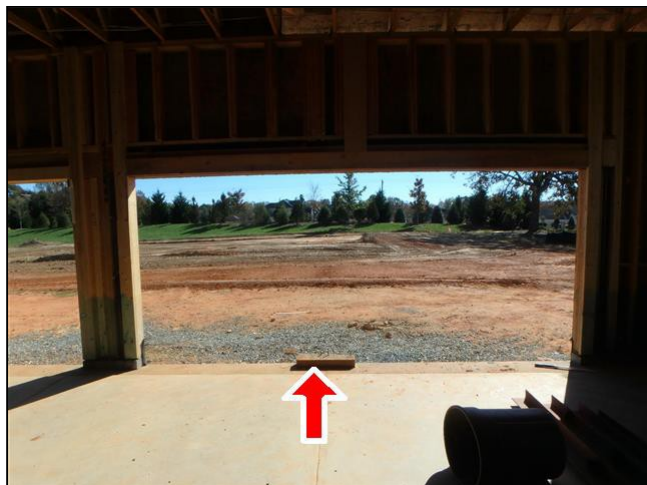
4.1 Item 1(Picture)

1. Evidence suggest garage door placement has changed, the slab has been poured with foundation bolts. Item 1(Picture) Item 2(Picture) As a result there is now an obstruction present in the garage doorway. Repairs are needed.

We recommend contacting a licensed contractor regarding these conditions and have repairs made as deemed appropriate.

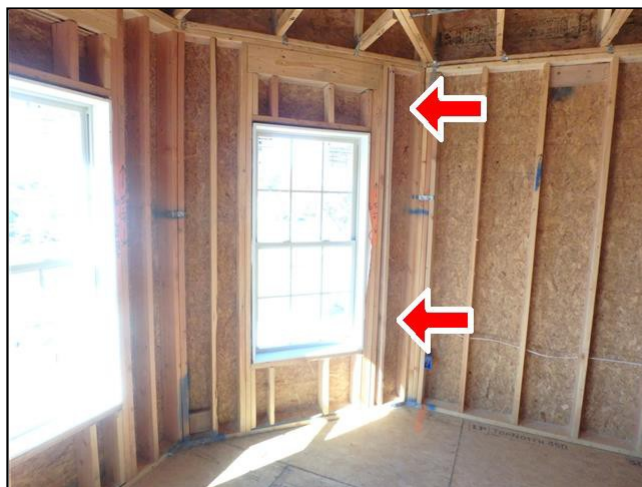
4.3 Item 1(Picture)

1. One 2x6 exterior stud at the 2nd floor guest bedroom is not secured to structure to the right of window. Item 1(Picture) Repairs are needed.

We recommend contacting a licensed contractor regarding these conditions and have repairs made as deemed appropriate.

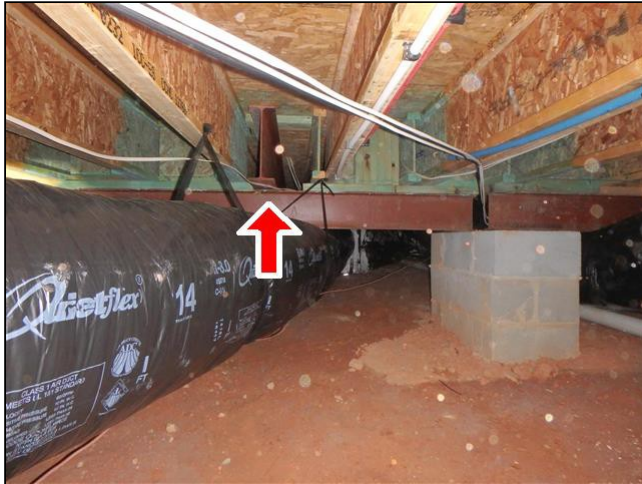
4.4 Item 1(Picture)

1. The Steel "I" Beam end in the crawl space under the kitchen / living room rest between two piers sitting on top of another smaller steel "I" beam. Item 1(Picture) Item 2(Picture) There is no block pier directly under this load point. Engineered Floor system layout was not provided to us or used by us (this inspector) to determine if the layout of pier locations and installations are correct. Improper end bearing of the "I" beam could allow floor system movement and or failure to occur if the floor system. Further evaluation is needed.

A licensed general contractor should be consulted to determine the necessary repairs. If the repair is beyond the scope of the NC Building code, the contractor should consult a professional structural engineer.

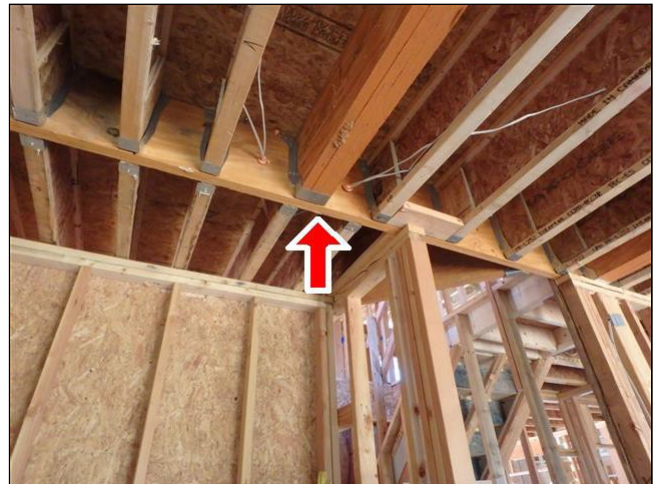
4.4 Item 4(Picture)

2. The LVL beam for second floor at the kitchen not sitting on an interior bearing wall / or support. Item 3(Picture) Item 4(Picture) Engineered Floor system layout was not provided to us or used by us (this inspector) to determine if the layout locations and installations are correct. Improper end bearing of beams could allow movement or failure to occur if the floor system. Further evaluation is needed.
3. The Simpson Strong-tie hangers for "I" joists for living room "I" Joists are not nailed properly, as missing nails present. Item 5(Picture) Item 6(Picture) Item 7(Picture) See Video [http://youtu.be/gIK\\_dgXUWQU](http://youtu.be/gIK_dgXUWQU) per the manufacture incorrect installation can cause failure. "I" Joist should not be nailed they are required to have hangers. Repairs are needed. Repairs are needed.

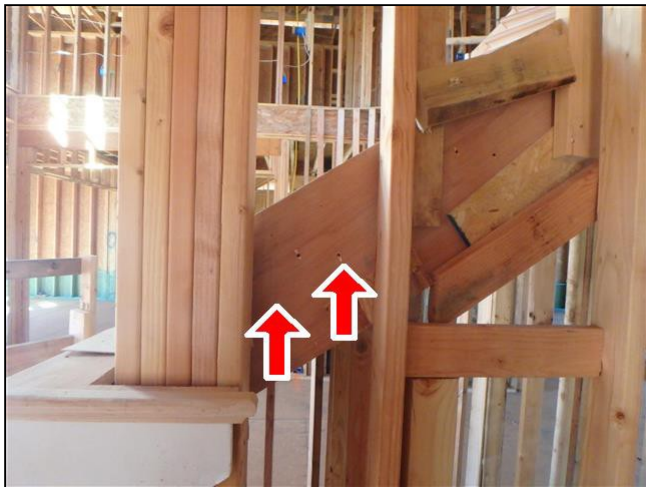
4.5 Item 1(Picture)

1. The fire blocking is incomplete and or missing at stairs. Item 1(Picture) Item 2(Picture) Item 3(Picture) Item 4(Picture) Item 5(Picture) Stairways are another space that fire blocking is required. The main reason for fire blocking at stairways is to protect the strength of the stairway so it will remain strong as long as possible during a fire so people can get out of the basement or down from up stairs. Install wood blocking in the cells between studs along the side of the stair stringer. Repair are needed.

We recommend contacting a licensed contractor regarding these conditions and have repairs made as deemed appropriate.

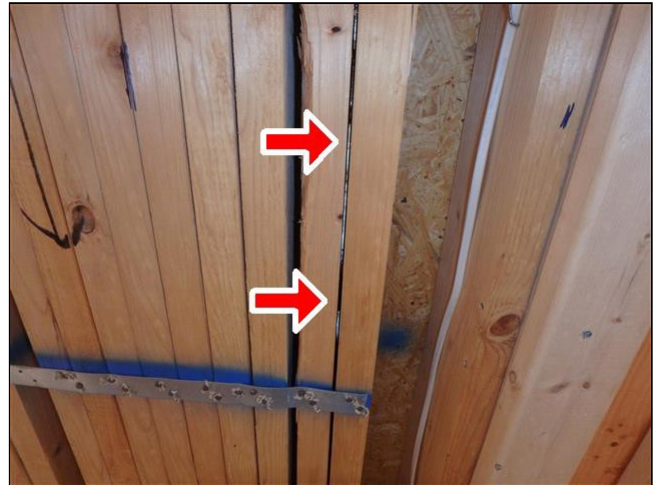
4.5 Item 8(Picture)

3. Visible daylight present in numerous areas due to lack of sealant / spray foam.Item 7(Picture) Item 8(Picture) Item 9(Picture) This should be addressed prior to installing installation. Current conditions will allow air infiltration to occur. Repairs are needed.

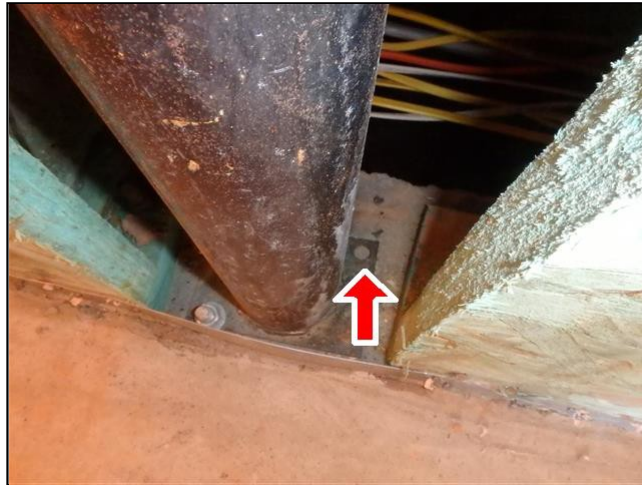
4.6 Item 1(Picture)

1. One steel column at the garage is not properly bolted to the slab in garage between dinning room and garage, as bolt and nut is missing. Item 1(Picture) Repairs are needed.

A licensed general contractor should be consulted to determine the necessary repairs. If the repair is beyond the scope of the NC Building code, the contractor should consult a professional structural engineer.

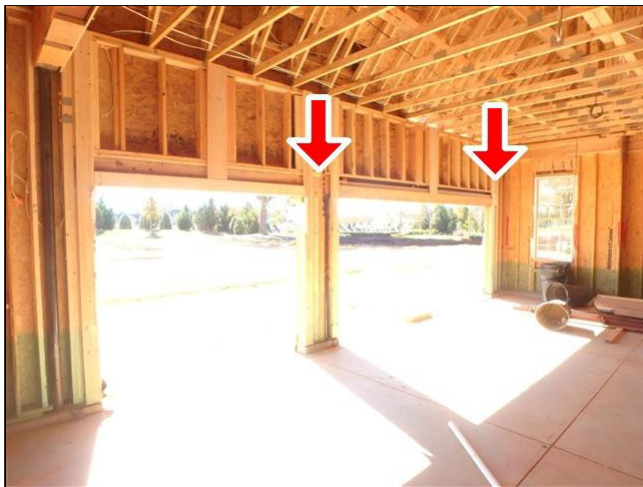
4.8 Item 1(Picture)

1. The steel posts for steel header at garage door opening doesn't appear to be welded. Item 1(Picture) Item 2(Picture) This could allow movement to occur once a load is applied by the brick. Further investigation and repairs are needed.
2. The 2x6 framing above garage door has been installed undersized, shims have been added to try and correct framing detail. Item 3(Picture) This is not best practice. Repairs are recommended.

We recommend contacting a licensed contractor regarding these conditions and have repairs made as deemed appropriate.

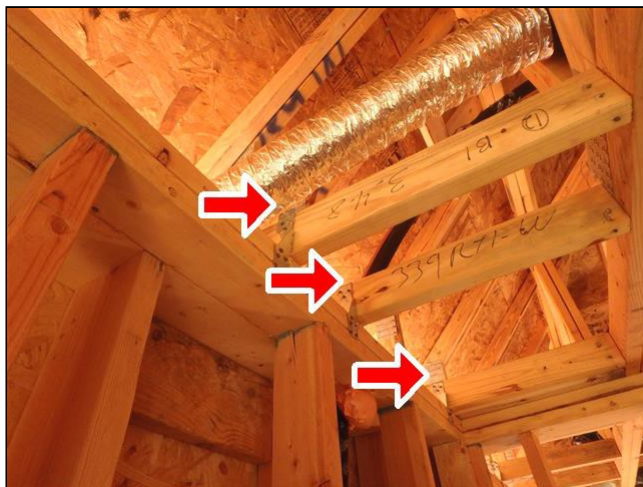
4.10 Item 1(Picture)

1. Several hurricane clips at second floor right side master bathroom for the roof trusses has missing nails that secure the truss to the exterior wall. Item 1(Picture) These clips secure the roof framing to the structure to resist uplift from high winds. Hurricane clips are required for roof truss systems. Repairs are needed.
2. The hip roof truss system has been nailed at the study. Item 2(Picture) Item 3(Picture) Item 4(Picture) Item 5(Picture) This is not best practice. Nailing is not as strong or reliable as nailing. See Web Link: <http://seblog.strongtie.com/2016/11/new-hanger-strengthens-jack-rafter-connections/> Repairs are recommended.

We recommend contacting a licensed contractor regarding these conditions and have repairs made as deemed appropriate.

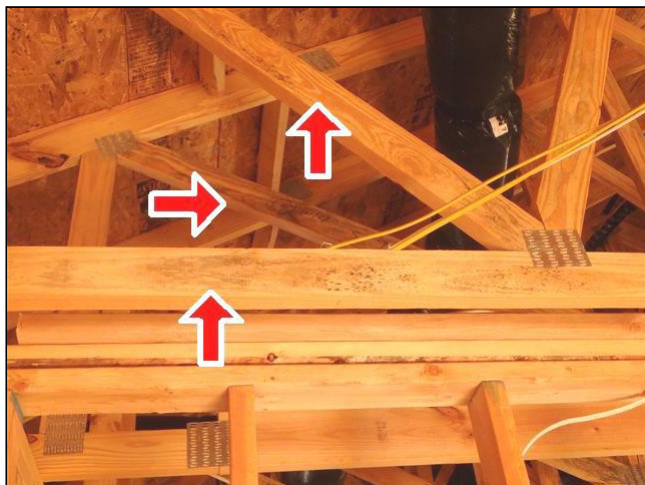
4.10 Item 6(Picture)

1. Discoloration and some type of light growth of a Simple Mold (Microbial) is present on attic trusses. Item 6(Picture) Item 7(Picture) Item 8(Picture) Item 9(Picture) Item 10(Picture) Evidence suggest that this condition is from past or present elevated moisture conditions. We did not inspect, test or determine if this type of substance is or is not a health hazard. Further investigation is needed.

We recommend you contact a properly licensed expert for testing, investigation and or correction as deemed appropriate.

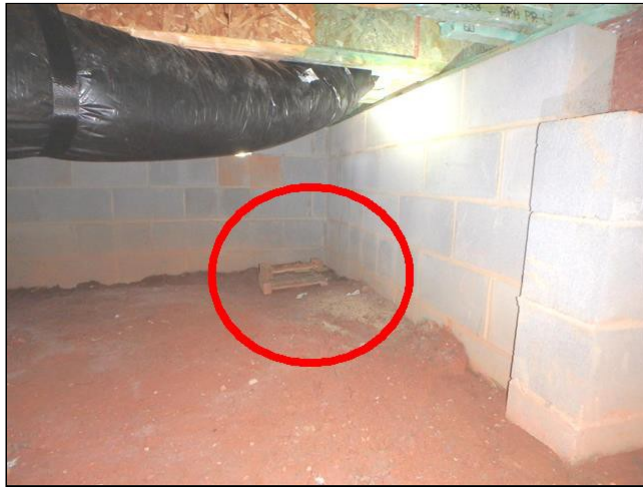
4.12 Item 1(Picture)

1. Wood debris is in contact with the crawl space dirt floor in numerous areas throughout the crawl space. Item 1(Picture) Item 2(Picture) This can attract wood destroying organism. Removal is needed.

We recommend contacting a properly licensed contractor regarding these conditions and have repairs made as deemed appropriate

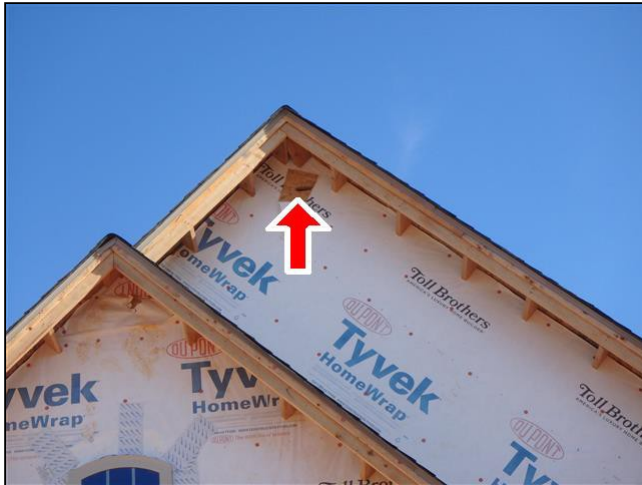
6.0 Item 1(Picture)

1. The House wrap is not installed per manufactures recommendation at the front, sides and rear of home as damage is present. As exposed osb sheathing and damage areas are present. Item 1(Picture) Item 2(Picture) Item 3(Picture) Item 4(Picture) Item 5(Picture) Item 6(Picture) It is recommended that all house wrap issues be addressed prior to the installation of the siding. (See Web-link below for more information) Repairs are needed prior to the installation of siding.
2. The exterior sheathing below master bedroom windows is damaged. Item 4(Picture) Item 5(Picture) Improper installation of plywood and flashing could allow water intrusion to occur. Repairs are needed.

We recommend contacting a licensed contractor regarding these conditions and have repairs made as deemed appropriate.

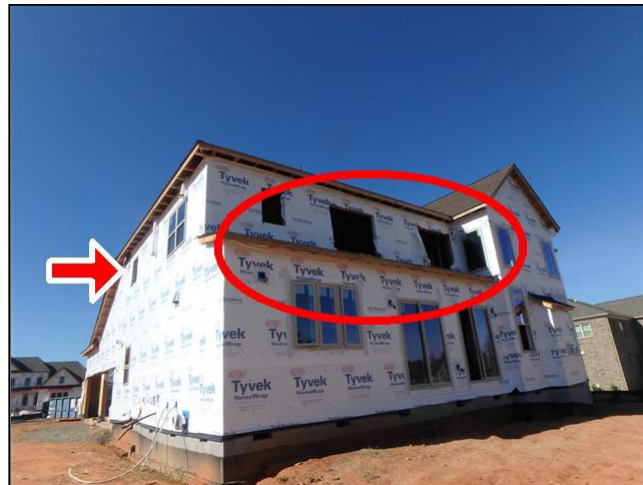
6.2 Item 1(Picture)

- Four windows were not installed at time of pre-drywall inspection. Item 1(Picture) Damage to the exterior sheathing present. Please insure windows are properly flashed and installed. Improperly installed windows will allow water intrusion to occur. Repairs are needed.

We recommend contacting licensed contractor regarding these conditions and have repairs made as deemed appropriate.

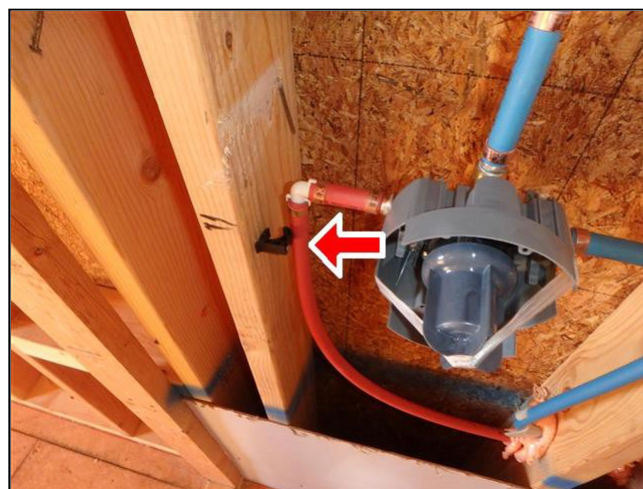
7.1 Item 1(Picture)

1. The pex supply lines for 2nd floor front guest bathroom shower improperly supported. Item 1(Picture) This can cause undue stress on supply line. Repairs are needed.

We recommend contacting a licensed plumber regarding these conditions and have repairs made as deemed appropriate.

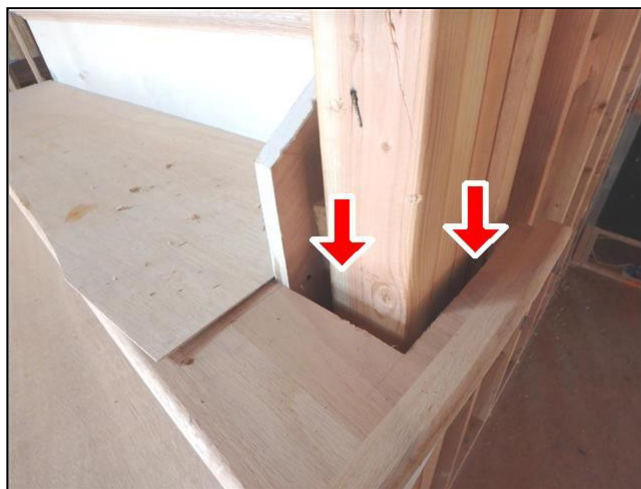
8.3 Item 1(Picture)

1. The stair stringer at the curved foyer stairs improperly cut. Item 1(Picture) As a result gaps are present. Repairs are recommended.

We recommend contacting a licensed contractor regarding these conditions and have repairs made as deemed appropriate.

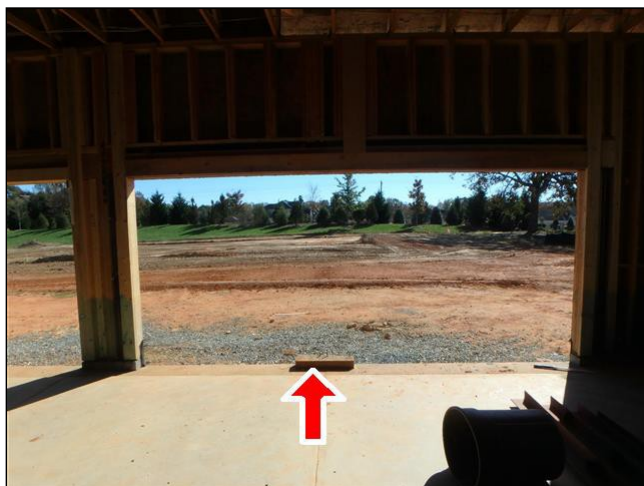
4.1 Item 1(Picture)

- 4.1**
- Evidence suggest garage door placement has changed, the slab has been poured with foundation bolts. Item 1(Picture) Item 2(Picture) As a result there is now an obstruction present in the garage doorway. Repairs are needed.

We recommend contacting a licensed contractor regarding these conditions and have repairs made as deemed appropriate.

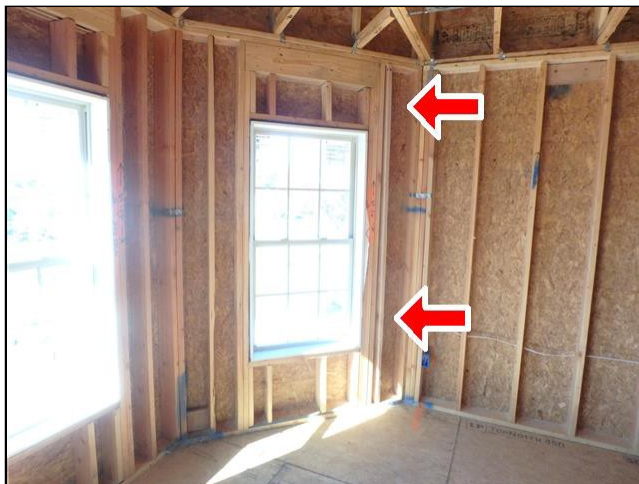
4.3 Item 1(Picture)

1. One 2x6 exterior stud at the 2nd floor guest bedroom is not secured to structure to the right of window. Item 1(Picture) Repairs are needed.

We recommend contacting a licensed contractor regarding these conditions and have repairs made as deemed appropriate.

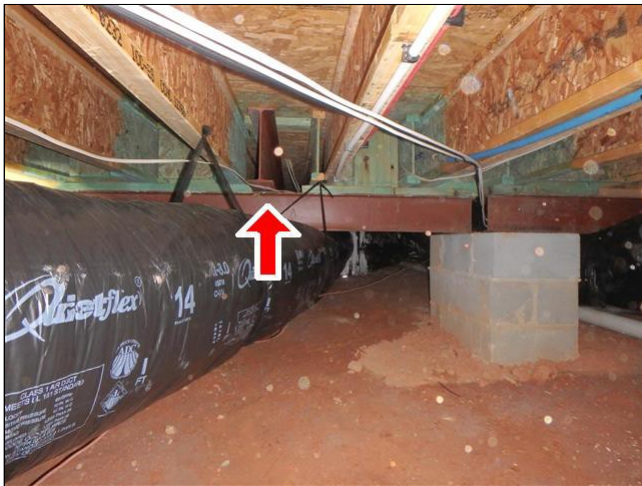
4.4 Item 1(Picture)

1. The Steel "I" Beam end in the crawl space under the kitchen / living room rest between two piers sitting on top of another smaller steel "I" beam. Item 1(Picture) Item 2(Picture) There is no block pier directly under this load point. Engineered Floor system layout was not provided to us or used by us (this inspector) to determine if the layout of pier locations and installations are correct. Improper end bearing of the "I" beam could allow floor system movement and or failure to occur if the floor system. Further evaluation is needed.

A licensed general contractor should be consulted to determine the necessary repairs. If the repair is beyond the scope of the NC Building code, the contractor should consult a professional structural engineer.

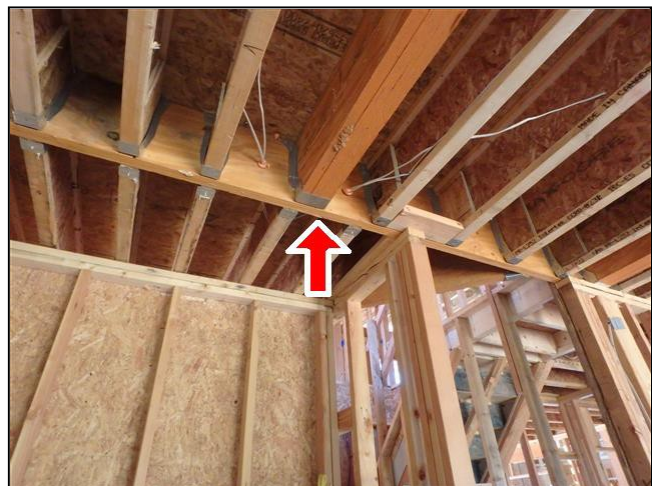
4.4 Item 4(Picture)

2. The LVL beam for second floor at the kitchen not sitting on an interior bearing wall / or support. Item 3(Picture) Item 4(Picture) Engineered Floor system layout was not provided to us or used by us (this inspector) to determine if the layout locations and installations are correct. Improper end bearing of beams could allow movement or failure to occur if the floor system. Further evaluation is needed.

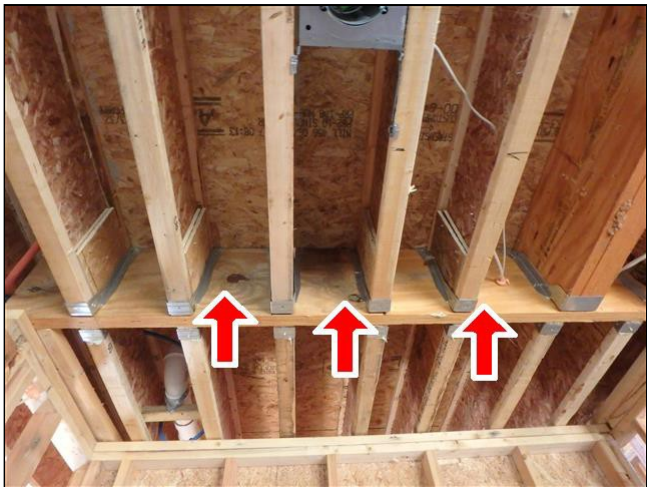
4.4 Item 5(Picture)

3. The Simpson Strong-tie hangers for "I" joists for living room "I" Joists are not nailed properly, as missing nails present. Item 5(Picture) Item 6(Picture) Item 7(Picture) See Video [http://youtu.be/gIK\\_dgXUWQU](http://youtu.be/gIK_dgXUWQU) per the manufacture incorrect installation can cause failure. "I" Joist should not be nailed they are required to have hangers. Repairs are needed. Repairs are needed.

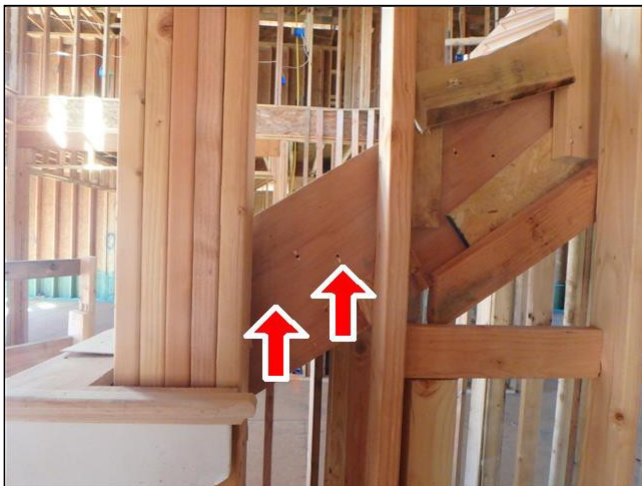
4.5 Item 1(Picture)

1. The fire blocking is incomplete and or missing at stairs. Item 1(Picture) Item 2(Picture) Item 3(Picture) Item 4(Picture) Item 5(Picture) Stairways are another space that fire blocking is required. The main reason for fire blocking at stairways is to protect the strength of the stairway so it will remain strong as long as possible during a fire so people can get out of the basement or down from up stairs. Install wood blocking in the cells between studs along the side of the stair stringer. Repair are needed.

We recommend contacting a licensed contractor regarding these conditions and have repairs made as deemed appropriate.

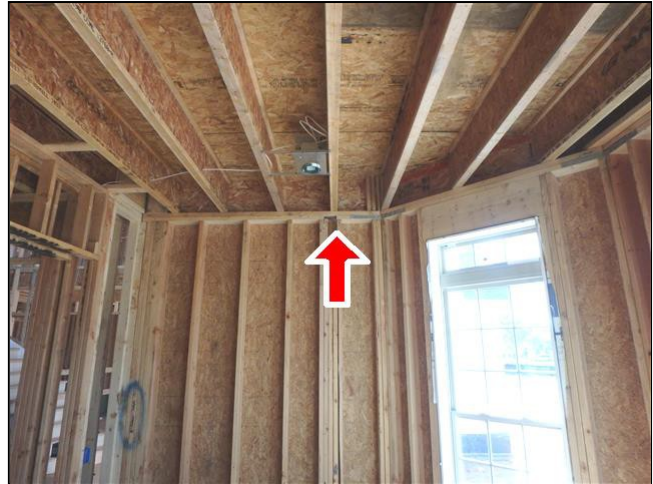
4.5 Item 6(Picture)

2. The top plate for 2x4 wall is damaged / missing between 1st floor front study/office and covered porch. Item 6(Picture) This is a load point for the front covered porch roof. Floor movement could occur in not addressed. Repairs are needed.

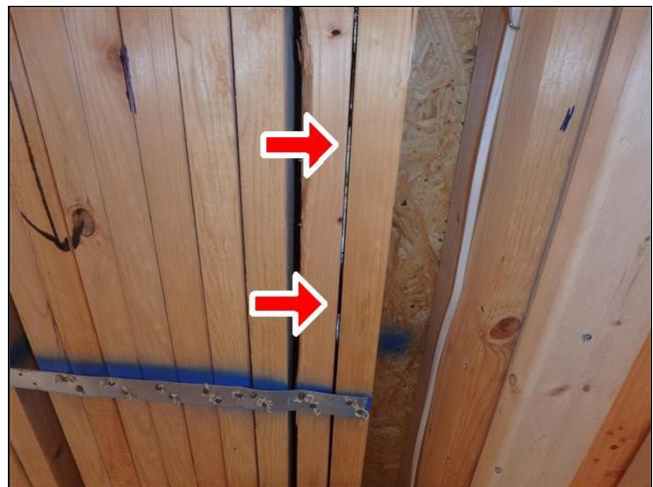
4.5 Item 8(Picture)

3. Visible daylight present in numerous areas due to lack of sealant / spray foam. Item 7(Picture) Item 8(Picture) Item 9(Picture) This should be addressed prior to installing installation. Current conditions will allow air infiltration to occur. Repairs are needed.

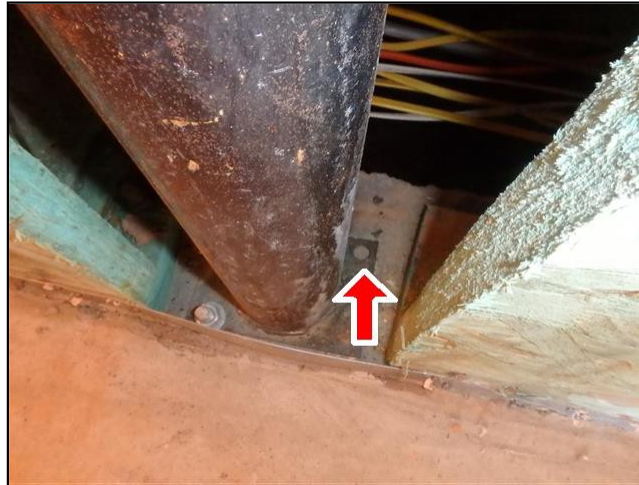
4.6 Item 1(Picture)

1. One steel column at the garage is not properly bolted to the slab in garage between dinning room and garage, as bolt and nut is missing. Item 1(Picture) Repairs are needed.

A licensed general contractor should be consulted to determine the necessary repairs. If the repair is beyond the scope of the NC Building code, the contractor should consult a professional structural engineer.

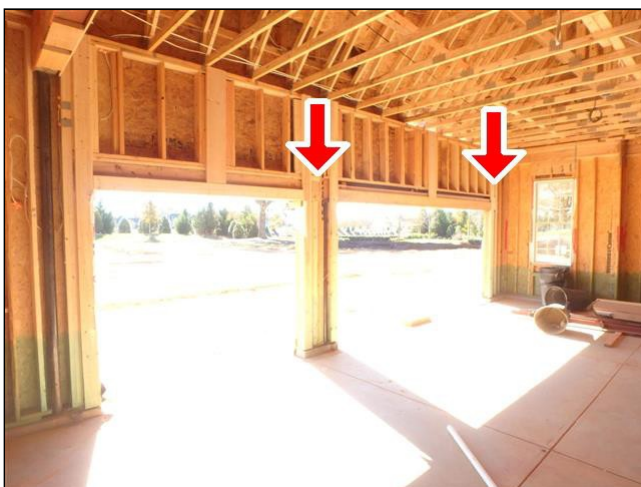
4.8 Item 1(Picture)

1. The steel posts for steel header at garage door opening doesn't appear to be welded. Item 1(Picture) Item 2(Picture) This could allow movement to occur once a load is applied by the brick. Further investigation and repairs are needed.
2. The 2x6 framing above garage door has been installed undersized, shims have been added to try and correct framing detail. Item 3(Picture) This is not best practice. Repairs are recommended.

We recommend contacting a licensed contractor regarding these conditions and have repairs made as deemed appropriate.

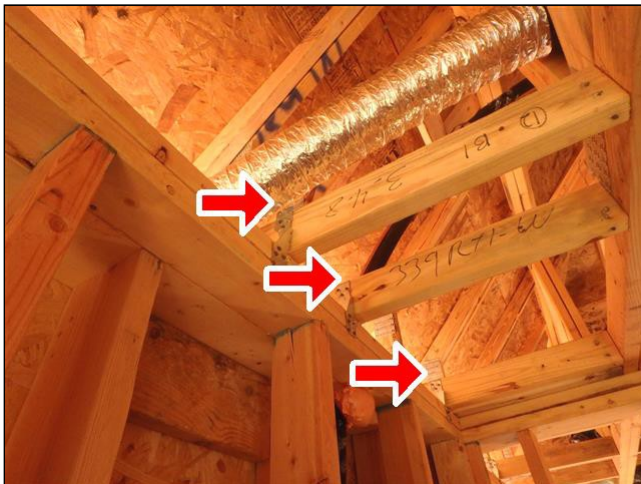
4.10 Item 1(Picture)

1. Several hurricane clips at second floor right side master bathroom for the roof trusses has missing nails that secure the truss to the exterior wall. Item 1(Picture) These clips secure the roof framing to the structure to resist uplift from high winds. Hurricane clips are required for roof truss systems. Repairs are needed.
2. The hip roof truss system has been nailed at the study. Item 2(Picture) Item 3(Picture) Item 4(Picture) Item 5(Picture) This is not best practice. Nailing is not as strong or reliable as nailing. See Web Link: <http://seblog.strongtie.com/2016/11/new-hanger-strengthens-jack-rafter-connections/> Repairs are recommended.

We recommend contacting a licensed contractor regarding these conditions and have repairs made as deemed appropriate.

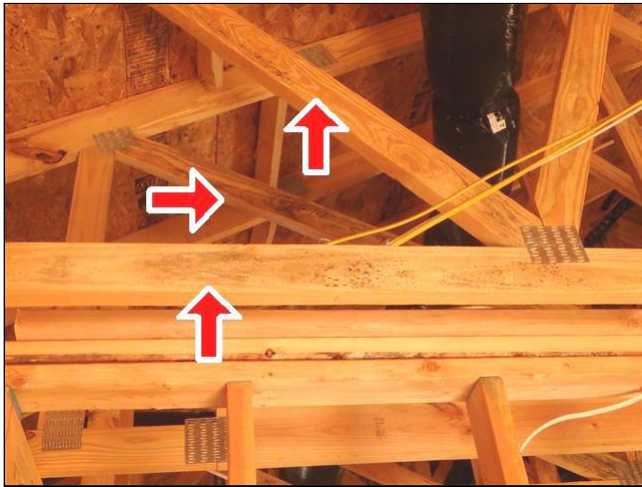
4.10 Item 6(Picture)

1. Discoloration and some type of light growth of a Simple Mold (Microbial) is present on attic trusses. Item 6(Picture) Item 7(Picture) Item 8(Picture) Item 9(Picture) Item 10(Picture)  
Evidence suggest that this condition is from past or present elevated moisture conditions. We did not inspect, test or determine if this type of substance is or is not a health hazard. Further investigation is needed.

We recommend you contact a properly licensed expert for testing, investigation and or correction as deemed appropriate.

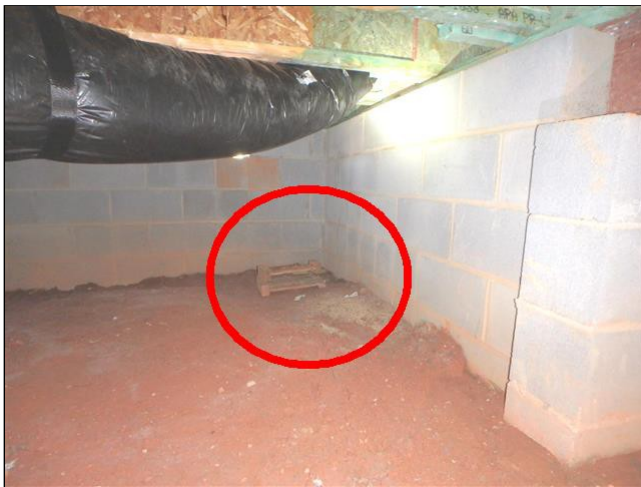
4.12 Item 1(Picture)

1. Wood debris is in contact with the crawl space dirt floor in numerous areas throughout the crawl space. Item 1(Picture) Item 2(Picture) This can attract wood destroying organism. Removal is needed.

We recommend contacting a properly licensed contractor regarding these conditions and have repairs made as deemed appropriate

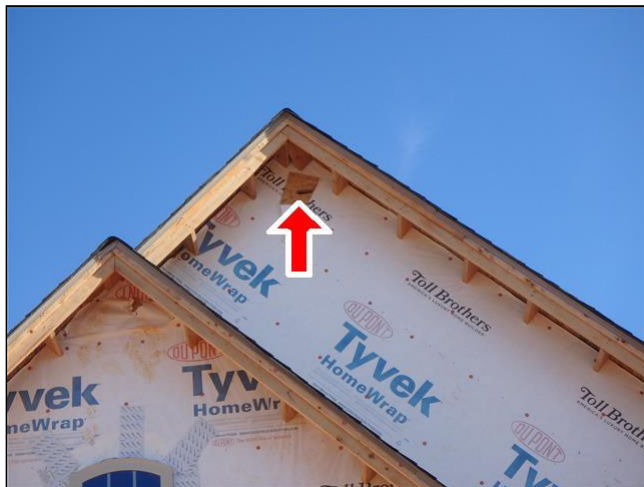
6.0 Item 1(Picture)

1. The House wrap is not installed per manufactures recommendation at the front, sides and rear of home as damage is present. As exposed osb sheathing and damage areas are present. Item 1(Picture) Item 2(Picture) Item 3(Picture) Item 4(Picture) Item 5(Picture) Item 6(Picture) It is recommended that all house wrap issues be addressed prior to the installation of the siding. (See Web-link below for more information) Repairs are needed prior to the installation of siding.
2. The exterior sheathing below master bedroom windows is damaged. Item 4(Picture) Item 5(Picture) Improper installation of plywood and flashing could allow water intrusion to occur. Repairs are needed.

We recommend contacting a licensed contractor regarding these conditions and have repairs made as deemed appropriate.

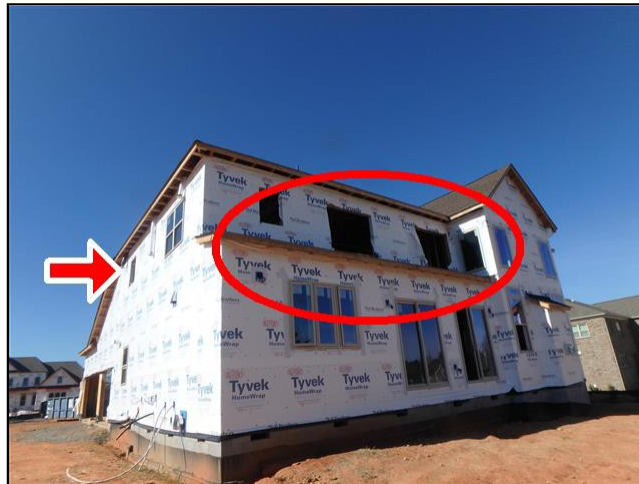
6.2 Item 1(Picture)

1. Four windows were not installed at time of pre-drywall inspection. Item 1(Picture) Damage to the exterior sheathing present. Please insure windows are properly flashed and installed. Improperly installed windows will allow water intrusion to occur. Repairs are needed.

We recommend contacting licensed contractor regarding these conditions and have repairs made as deemed appropriate.

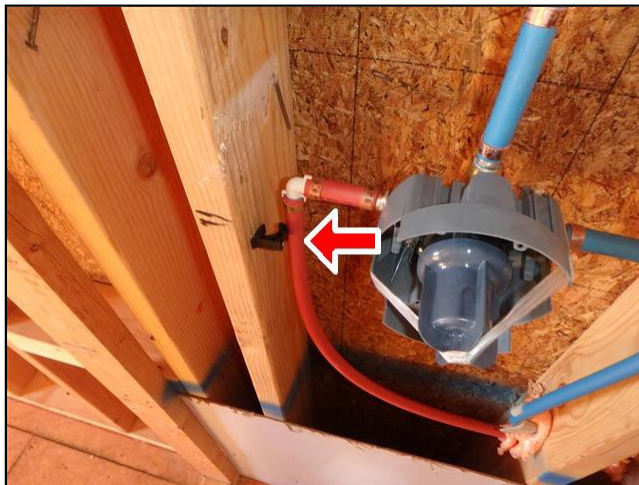
7.1 Item 1(Picture)

1. The pex supply lines for 2nd floor front guest bathroom shower improperly supported. Item 1(Picture) This can cause undue stress on supply line. Repairs are needed.

We recommend contacting a licensed plumber regarding these conditions and have repairs made as deemed appropriate.

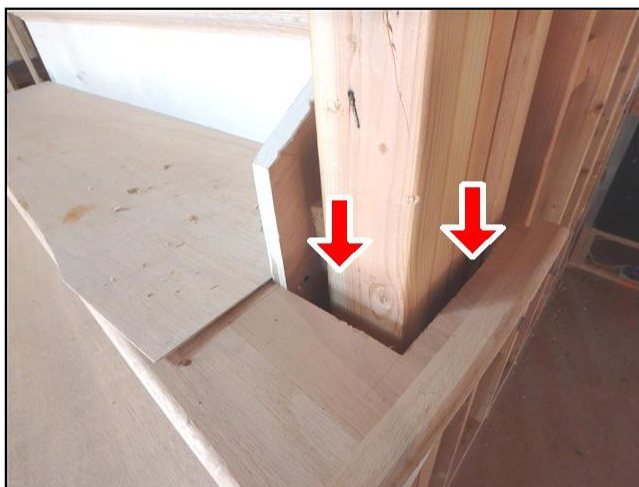
8.3 Item 1(Picture)

1. The stair stringer at the curved foyer stairs improperly cut.Item 1(Picture) As a result gaps are present. Repairs are recommended.

We recommend contacting a licensed contractor regarding these conditions and have repairs made as deemed appropriate.
