INSPECTION REPORT  
Sample  
NC

INSPECTED BY  
Hunter Griggs  
AHI Residential &  
Commercial  
Inspections  
NC 5086 SC 49764

INSPECTION DATE  
2/1/2026  
09:30 AM

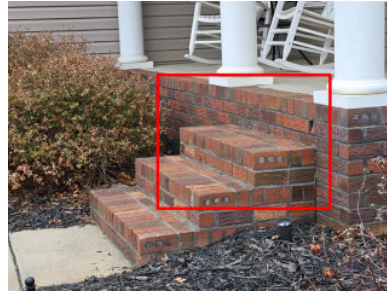
Item 1 – Item 1(Picture)

1. (1)
  1. The brick steps at the front of the home have a significant riser difference between the top step and the second step. This is a safety hazard as it can allow a fall or injury to occur. Repairs are needed.

We recommend contacting a properly licensed contractor regarding these conditions and have repairs made as needed.

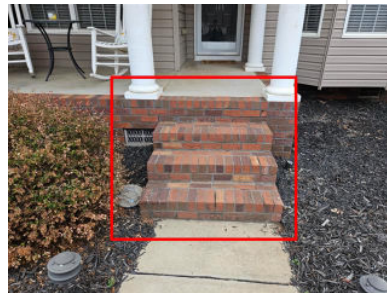
Item 2 – Item 1(Picture)

1. The handrails on the steps at the front of home are missing, steps that have 4 or more risers should have handrails.. A fall or injury could occur if not corrected. Repairs are needed.

We recommend contacting a licensed contractor regarding these conditions and have repairs made as deemed appropriate..

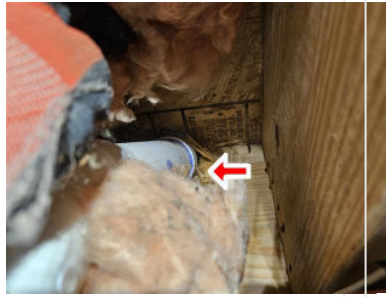
Item 3 - Item 1(Picture)

1. One of the center supports at the left side of the crawlspace has been cut by a tradesmen to make room for plumbing. Center support should be free of damage or modifications to prevent sagging or cracking. Further evaluations and repairs are needed.

We recommend contacting a properly licensed contractor regarding these conditions and have repairs made as needed.

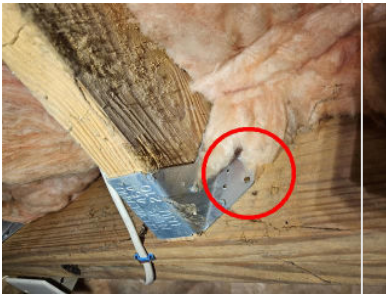
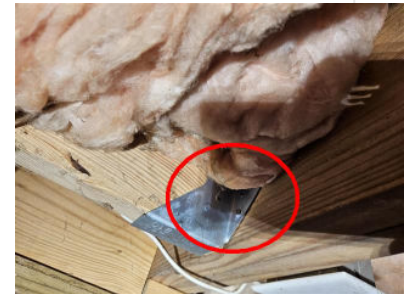
Item 4 - Item 1(Picture)

1. The joist hangers overhead at the crawlspace entrance are not correctly installed. All round holes on hangers should be filled to ensure proper support. Further evaluations and repairs are needed.

We recommend contacting a properly licensed contractor regarding these conditions and have repairs made as needed.

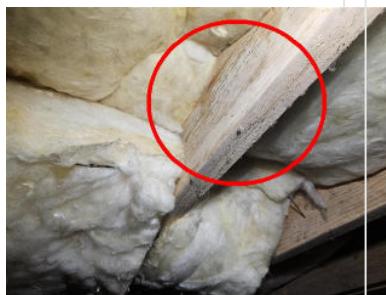
Item 5 - Item 1(Picture)

5. 1. Discoloration and some type of microbial growth is present on the structure in several areas throughout the crawl space/foundation. This type of substance commonly results in the building components becoming weakened and or compromised. Evidence suggests that this condition is from past and or present elevated moisture and humidity conditions. We did not inspect, test or determine if this type of substance is or is not a health hazard.

We recommend contacting a properly licensed water and humidity proofing/control contractor as well a certified mold testing and remediation company regarding these conditions. Repairs deemed appropriate by these specialist should be completed prior to closing.

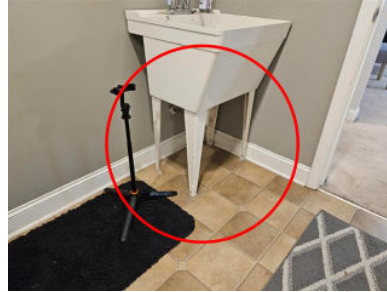
Item 6 – Item 1(Picture)

6. (1)
1. The utility sink is loose and not secured at the washer/dryer room. This can allow undue stress to occur on supply lines allowing leaks to occur. Repairs are needed.  
We recommend contacting a qualified licensed plumber regarding these conditions and have repairs made as deemed appropriate..

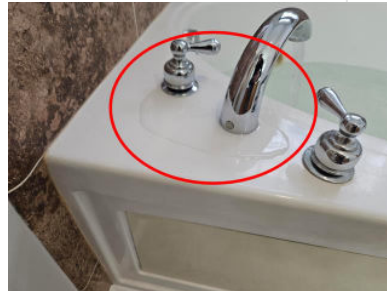
Item 7 – Item 1(Picture)

7. (2)
1. The cold control knob leaks at the master bathroom when on. This is not considered up to today's standard and may allow water to pond onto the floor. Repairs are needed.  
We recommend contacting a qualified licensed plumber regarding these conditions and have repairs made as deemed appropriate..

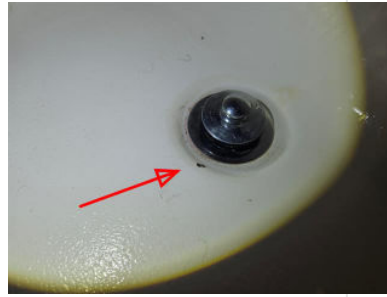
Item 8 - Item 1(Picture)

- 8.
1. The hall bathroom fiberglass tub has chips and damage present. Damaged fiberglass tubs have been known to leak. This can cause water damage to the home. Further investigation and repairs are needed.

We recommend contacting a licensed plumbing contractor regarding these conditions and have repairs made as deemed appropriate.

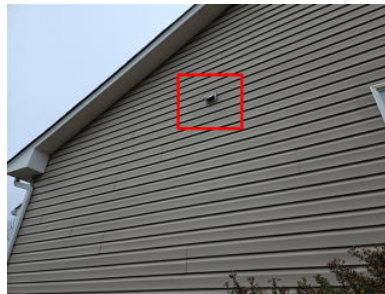
Item 9 - Item 1(Picture)  
Right

1. The exhaust fan hood is damaged at the rear exterior of home. This may allow insects or critters to enter home. Repairs are needed.

We recommend contacting a properly licensed contractor regarding these conditions and have repairs made as deemed appropriate.

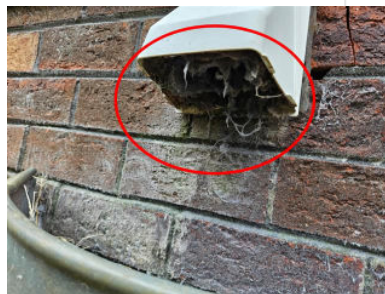
Item 10 - Item 1(Picture)

1. The dryer vent piping is clogged. Vent pipes should be cleaned regularly to prevent fire hazards.. Repairs are needed.

We recommend contacting a licensed HVAC contractor regarding these conditions and have repairs made as deemed appropriate.

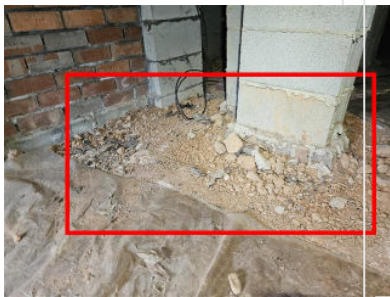
Item 11 – Item 1(Picture)

11. 1. The vapor barrier / diffusion retarder on the crawlspace ground is deteriorated in areas. Visible signs of current elevated moisture levels in the crawl space floor system was present at time of inspection. Moisture barriers keep under ground moisture from entering the crawl space area. This condition is conducive to high moisture content in wood structures, which in turn is conducive to wood destroying insects / mold growth / fungi growth and other potential concerns. We recommend a 6 mil thick plastic be properly spread throughout to cover 100 percent of the crawl space dirt floor.

We recommend contacting a properly licensed contractor regarding these conditions and have repairs made as deemed appropriate

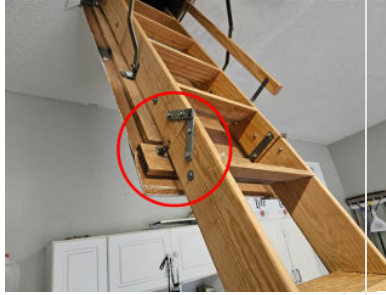
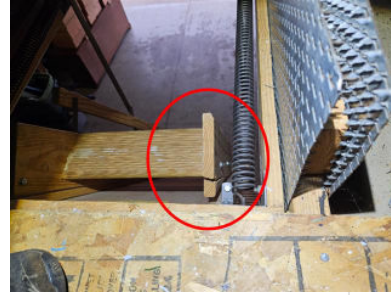
Item 12 – Item 1(Picture)

12. 1. The pull down stairs has a damage panel and stairs. These steps move heavily when used, this is a safety concern. Repairs are needed.

We recommend contacting a properly licensed contractor regarding these conditions and have repairs made as deemed appropriate.

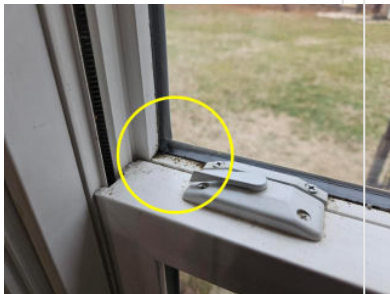
**1.0 Item 1(Picture)**  
Living Room

1. Discoloration and some type of Mold (Microbial) growth is present in the structure at the windows. Evidence suggests that this condition is from past or present elevated moisture conditions. We did not inspect, test or determine if this type of substance is or is not a health hazard. Further investigation is recommended.

We recommend you contact a properly licensed expert for testing, investigation and or correction as deemed appropriate.

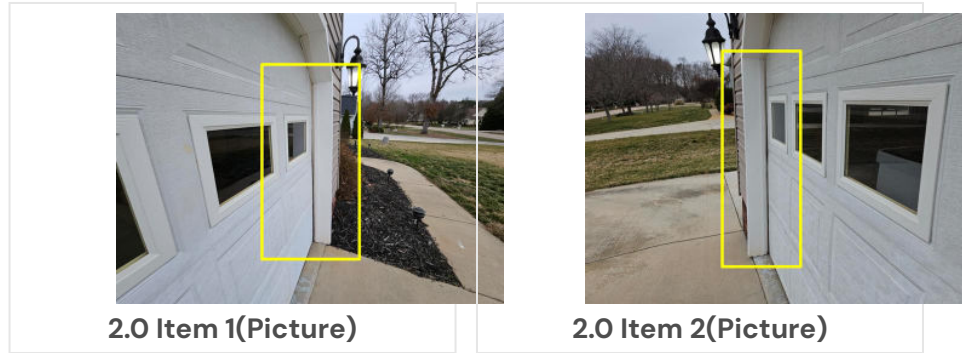
1. The composite trim at the front of home at the garage is loose and deteriorated. This can allow for pest and/or moisture intrusion to occur if not corrected.. Repairs are recommended.

We recommend contacting a qualified individual regarding these conditions and have repairs made as deemed appropriate..

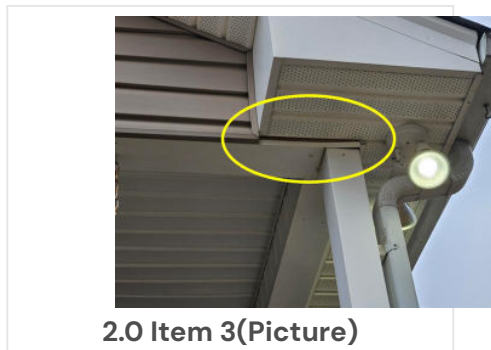
1. The metal trim at the right side (facing front) is missing/overcut. This can allow for moisture intrusion to occur if not corrected.. Repairs are recommended.

We recommend contacting a properly licensed contractor regarding these conditions and have repairs made as deemed appropriate.

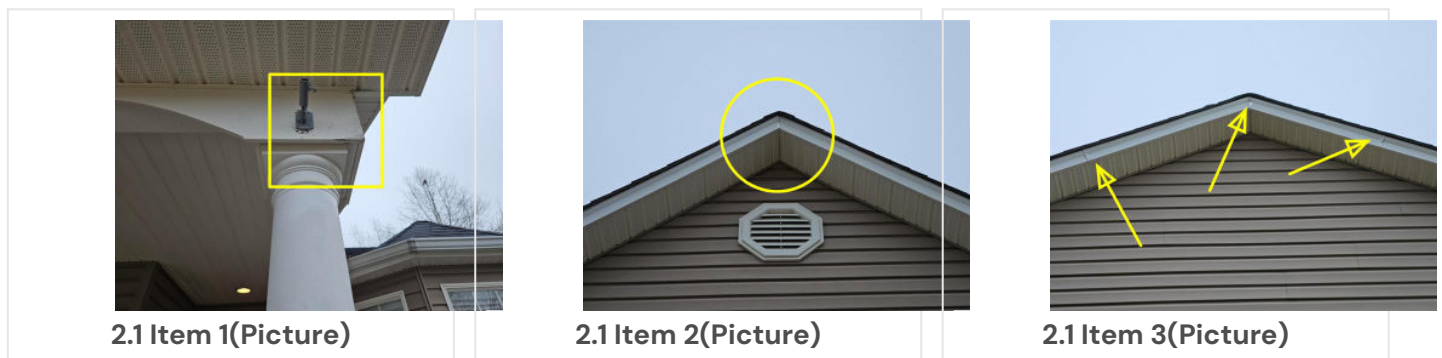
1. The trim and fascia at the exterior in areas is weathered and damaged. Further deterioration will occur if not repaired. Repairs are recommended.

We recommend contacting a properly licensed contractor regarding these conditions and have repairs made as deemed appropriate.

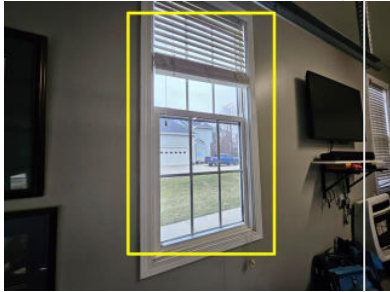
**2.2 Item 1(Picture)**  
Garage

1. Several window(s) has/have failed/compromised thermal seals/fogged window panes. This is indicated by visible moisture, discoloration, calcium deposits and or crystallization visible between the glass window panes. A certified window technician should recheck all windows throughout the dwelling. Due to weather conditions many times compromised/failed windows can not be identified at the time of inspection.

We recommend contacting a properly licensed window technician/contractor regarding these conditions and have repairs made deemed appropriate.

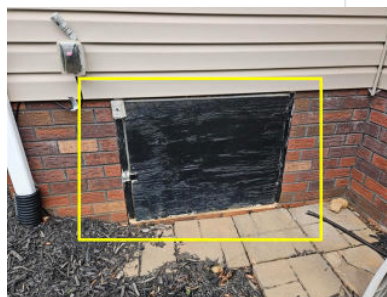
**2.3 Item 1(Picture)**

1. The access door to the crawlspace is deteriorated and beginning to peel paint. The latch does not appear to latch correctly, a block of wood has been added instead. Repairs are recommended.

We recommend contacting a licensed contractor regarding these conditions and have repairs made as deemed appropriate.

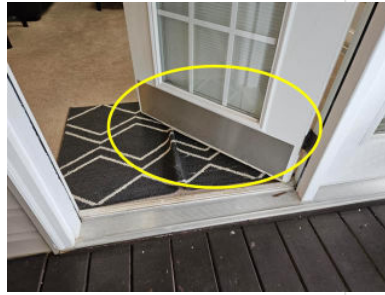
2.3 Item 2(Picture)

1. The rear entry door has damaged weather stripping. This can cause some heat loss in winter and

loss of cool air in summer if not corrected. Repairs are recommended.

We recommend contacting a qualified individual regarding these conditions and have repairs made as deemed appropriate..

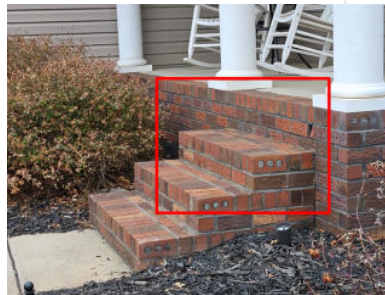
2.4 Item 1(Picture)

1. The brick steps at the front of the home have a significant riser difference between the top step and the second step. This is a safety hazard as it can allow a fall or injury to occur. Repairs are needed.

We recommend contacting a properly licensed contractor regarding these conditions and have repairs made as needed.

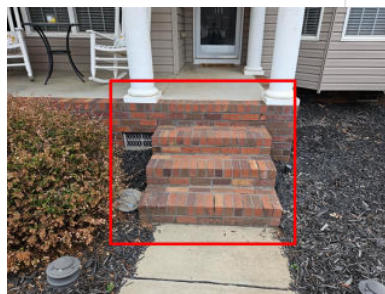
2.4 Item 2(Picture)

1. The handrails on the steps at the front of home are missing, steps that have 4 or more risers should have handrails.. A fall or injury could occur if not corrected. Repairs are needed.

We recommend contacting a licensed contractor regarding these conditions and have repairs made as deemed appropriate..

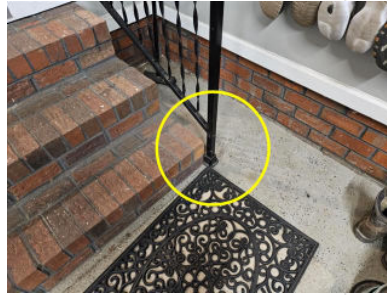
2.4 Item 3(Picture)

1. The handrails on steps at the garage loose at the base of the railing. A fall or injury could occur if not corrected. Repairs are recommended.

We recommend contacting a licensed contractor regarding these conditions and have repairs made as deemed appropriate..

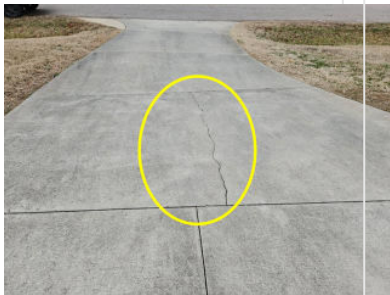
2.5 Item 1(Picture)

1. The concrete drive at the front of home deteriorated in areas and beginning to crack. Further deterioration can occur if not repaired. Further evaluations and repairs are recommended.

We recommend contacting a properly licensed contractor regarding these conditions and have repairs made as deemed appropriate.

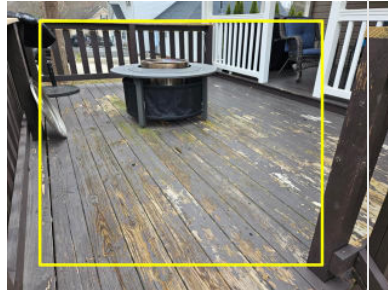
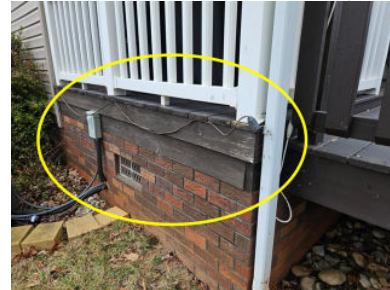
2.6 Item 1(Picture)

1. The stain for deck boards and railing is peeling. As a result of this condition it can allow UV deterioration and water absorption to occur to deck. Changes in moisture content of decking may result in checking, splitting, warping, cupping, or corrosion of fasteners. These defects can be

minimized or eliminated by "treating" the exposed surfaces of treated decking with periodic topical applications (e.g. brush or spray) of a preservative formulation containing a water repellent, also available at building supply stores. We recommend that these topical "treatments" be applied as soon as the deck is finished, after the first year, and thereafter at 3 or 5 year intervals. (This is a maintenance item and is for your information) Repairs are recommended.

We recommend contacting a properly licensed contractor regarding these conditions and have repairs made as deemed appropriate

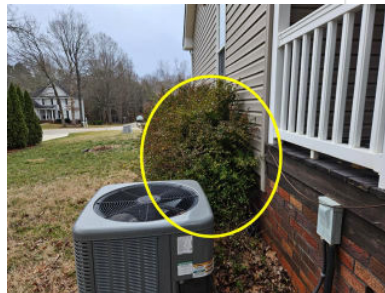
2.7 Item 1(Picture)

1. Trim all trees and shrubs to a minimum of 12 inches away from structure. This will help prevent premature deterioration of the building components. Repairs are recommended.

We recommend contacting a qualified individual regarding these conditions and have repairs made as needed.

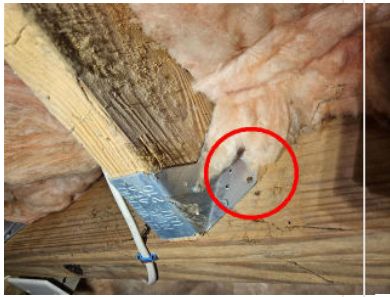
4.1 Item 3(Picture)

- The joist hangers overhead at the crawlspace entrance are not correctly installed. All round holes on hangers should be filled to ensure proper support. Further evaluations and repairs are needed. We recommend contacting a properly licensed contractor regarding these conditions and have repairs made as needed.

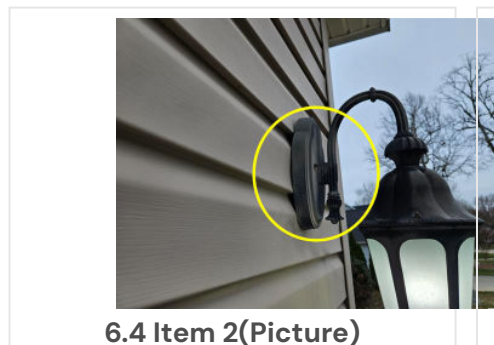
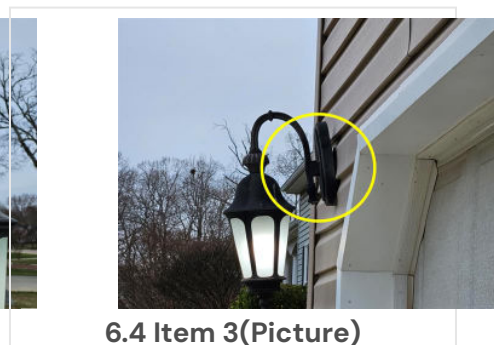
1. The front of home light fixtures are loose at the wall and is missing the flat trim that these fixtures are typically installed on. This can allow water intrusion to occur.. Repairs are recommended.

We recommend contacting a licensed electrician regarding these conditions and have repairs made as deemed appropriate.

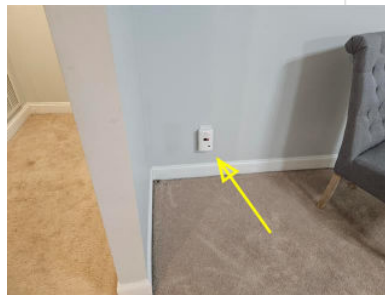
6.7 Item 1(Picture)

1. As part of the our standard of practice, the inspector must report the absence or presence of a permanently installed carbon monoxide detector in all homes with garages or fueled appliances. Please note that your report reflects the absence of a permanently installed carbon monoxide detector, however a plug in type detector was present. All homes with gas appliances, garages, or fireplace should have a carbon monoxide detector as protection to prevent possible carbon monoxide poisoning. It is recommended that you ask for disclosure from seller to determine if the plug in type carbon monoxide detector will remain with the home or that you consider purchasing and installing a carbon monoxide detector prior to moving into the home.

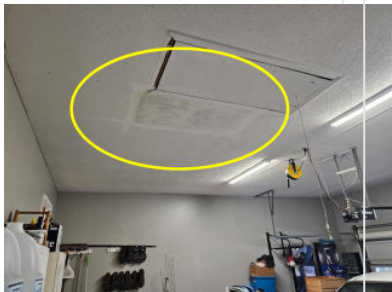
9.1 Item 1(Picture)

1. The home had numerous cosmetic defects present at the time of inspection. These items include but are not limited to; the walls, ceilings, floors, trim, doors, and/or cabinets. This is for your information.
