# Inspection Report

SAMPLE INSPECTION - ACTUAL REPORT 100,000.00 in Damage  
Contractors wanted Open Checkbook  
Sample Nc 28201

**AHI Residential & Commercial Inspections, Inc**

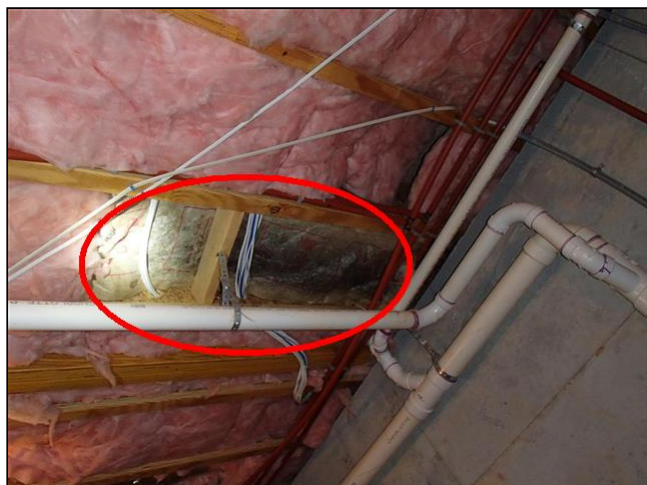
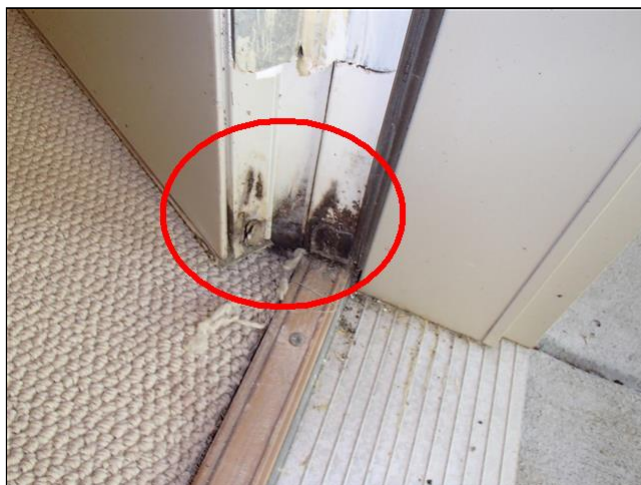
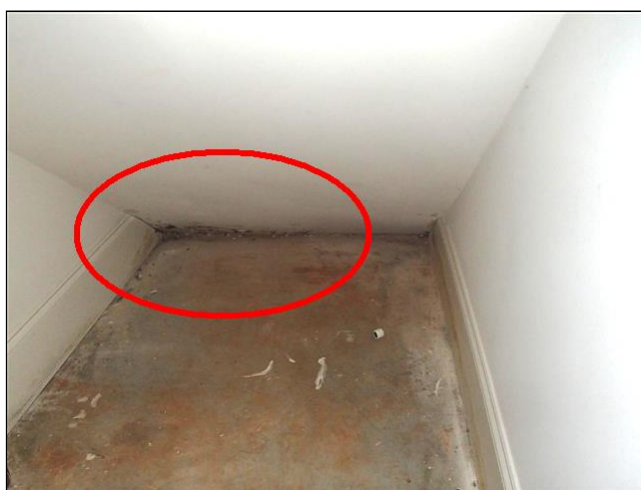
1. Discoloration and some type of microbial growth is present in the structure at several areas including but not limited to the basement and or interior spaces. Item 1(Picture) Item 2(Picture) Item 3(Picture) Item 4(Picture) This type of substance commonly results in the building and finish type materials becoming weakened and or compromised. Evidence suggest that this condition is from past or present elevated moisture conditions.

From Shower Pan Leak

We did not inspect, test or determine if this type of substance is or is not a health hazard. We recommend you contact a properly licensed expert for testing, investigation and or correction as deemed appropriate.

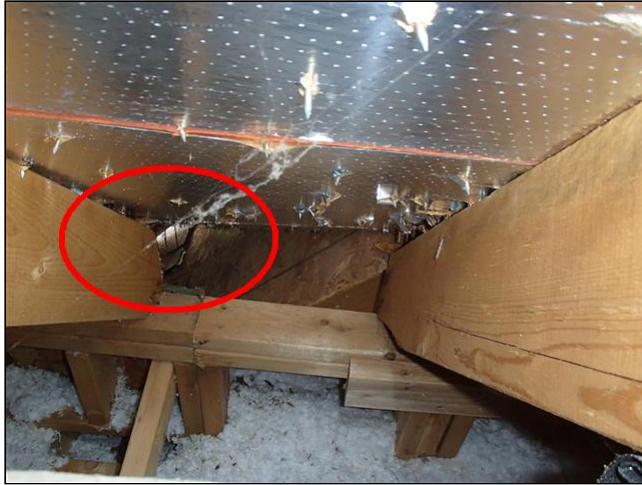
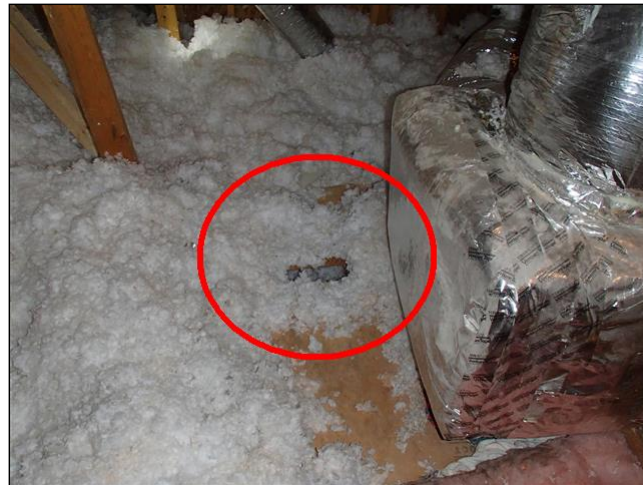
1. Evidence of rodent activity present in the attic, evidence suggest that they are entering the attic at rear soffits. Item 5(Picture) Item 6(Picture) Item 7(Picture) Repairs are needed to prevent damage from occurring. Further investigation and repairs are needed.

We recommend contacting a licensed pest control company regarding these conditions and have repairs made as deemed appropriate.

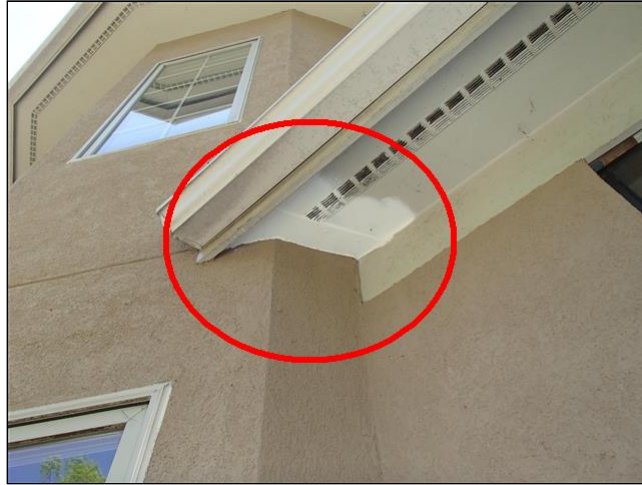
1. The soffit panel at eave on the rear of home covered porch show signs of repair. Item 1(Picture)  
Unable to determine the cause of the damage. Further investigation is needed.

We recommend contacting a properly licensed contractor regarding these conditions and have repairs made as deemed appropriate.

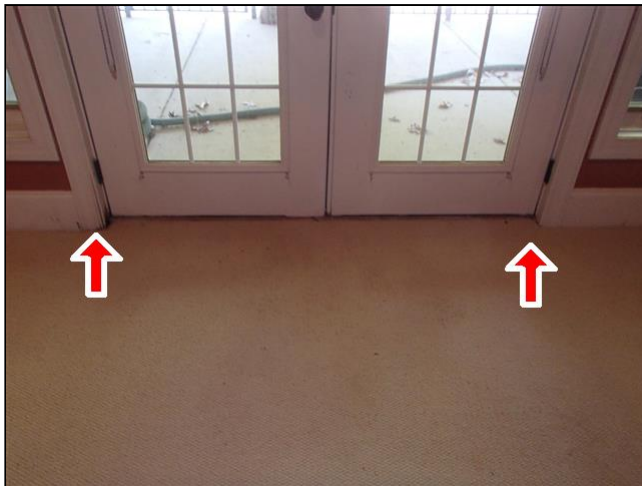
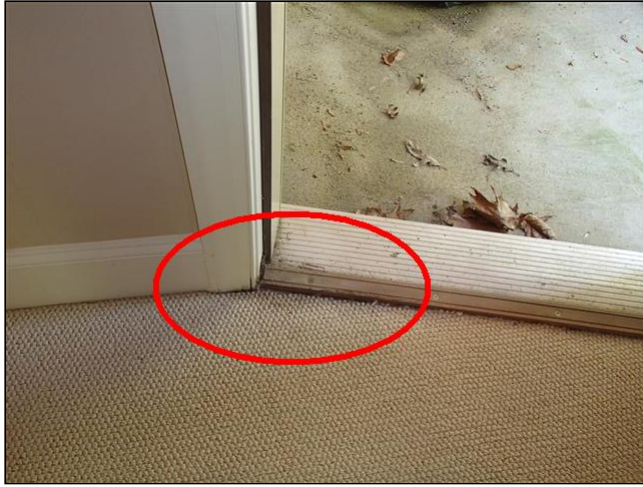
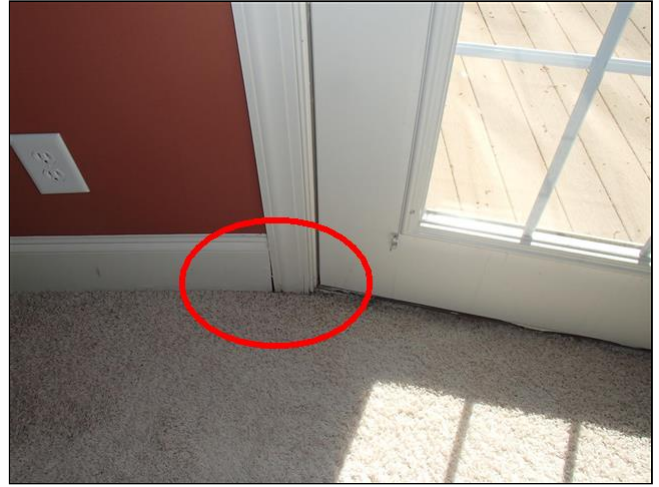
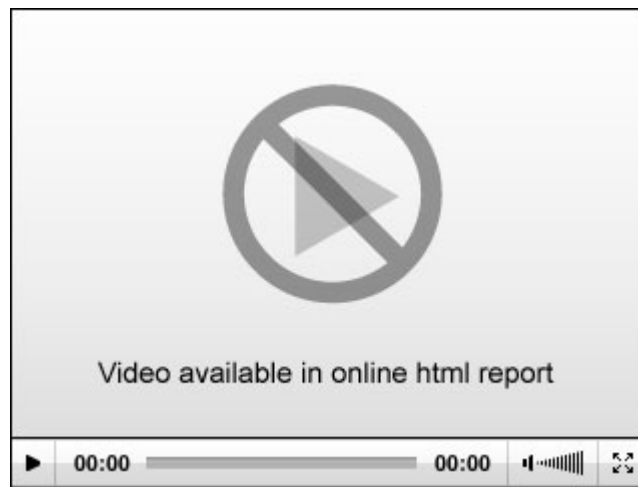
1. The rear entry doors at all of the basement doors shows signs of active water intrusion at threshold. Item 1(Picture) Item 2(Picture) Item 3(Picture) Item 4(Picture) Water intrusion if not corrected can lead to significant repair costs. Further investigation and repairs by a licensed contractor are needed.
2. The dead bolt at the laundry room entrance is damaged. Item 5(Picture) A repair or replacement is needed.

Rear Entry Door (Office)

Rear Entry Door Master Bedroom

We recommend contacting a properly licensed contractor regarding these conditions and have repairs made as deemed appropriate.

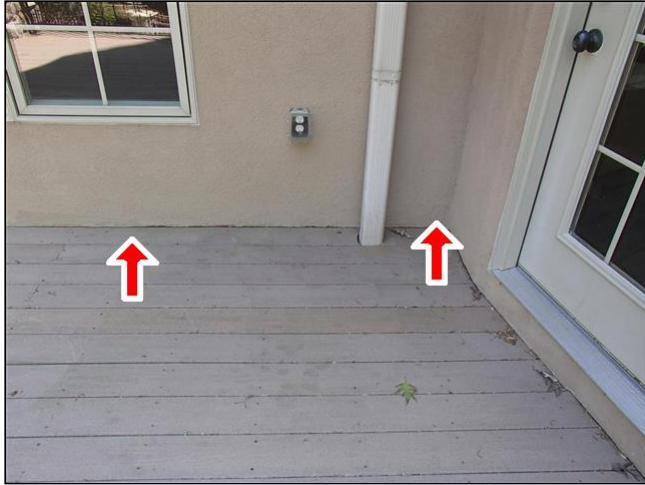
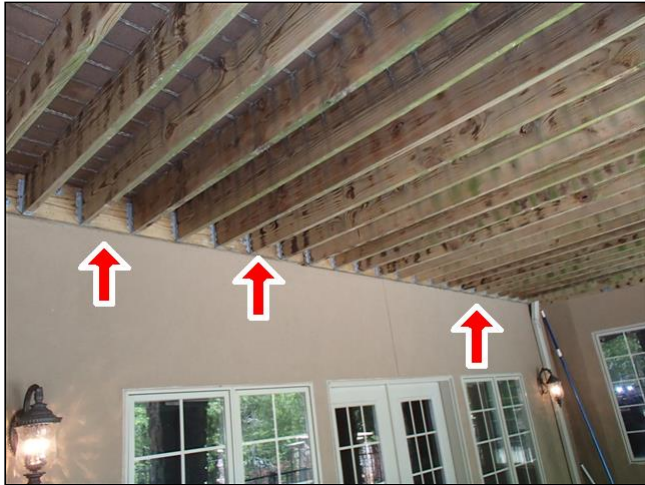
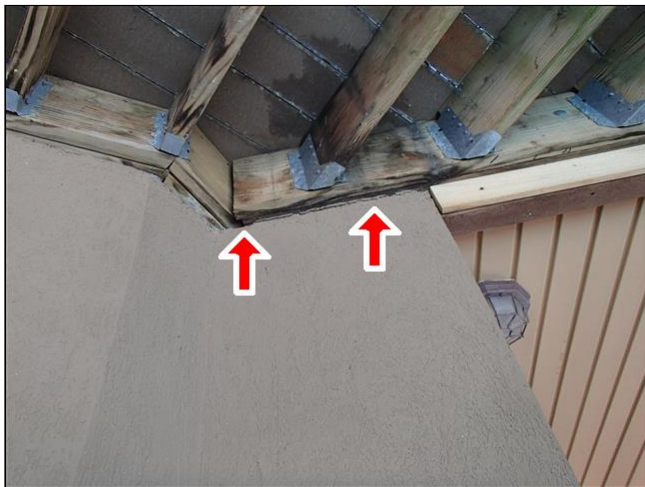
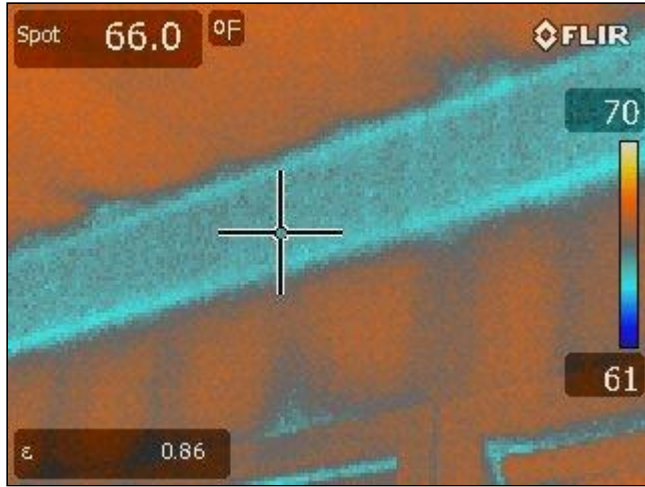
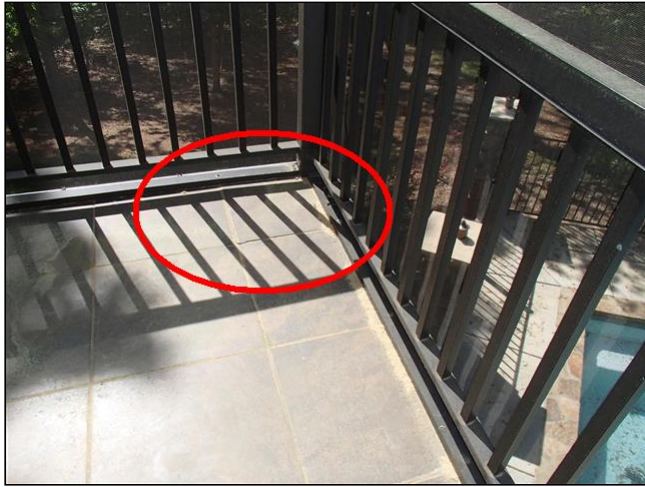
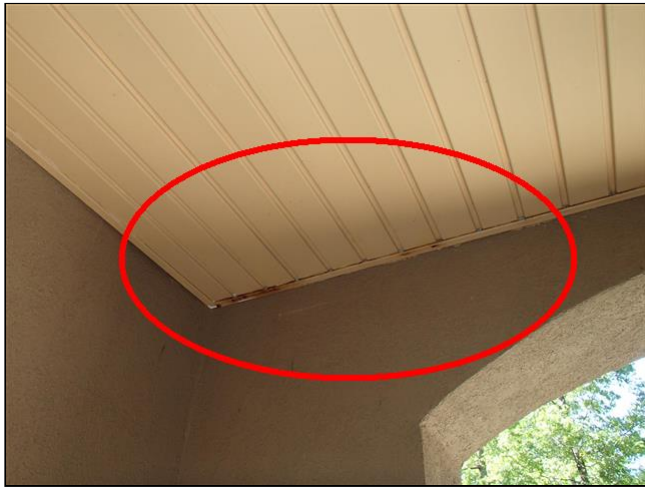
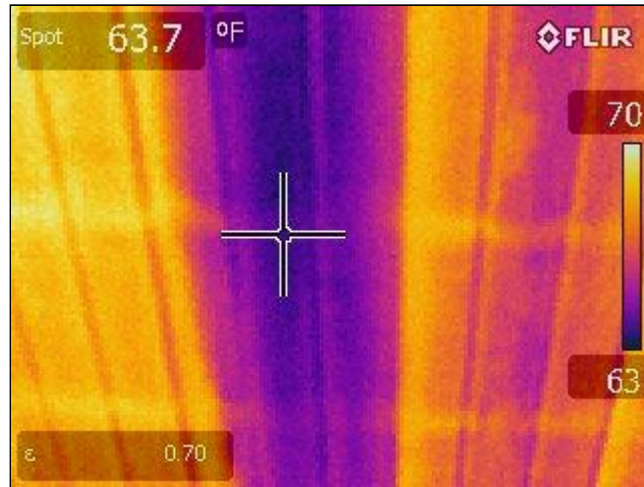
1. The rear deck ledger board has no visible signs of flashing present. Item 1(Picture) Item 2(Picture) Item 3(Picture) Item 4(Picture) Item 5(Picture) This can allow water intrusion to occur. A thermal camera was used on the interior of the home indicating that moisture intrusion is occurring. Item 6(Picture) Item 7(Picture) Item 8(Picture) Further investigation is needed.
2. The rear patio has damaged tiles and show signs of active water intrusion. Item 9(Picture) Item 10(Picture) Item 11(Picture) Item 12(Picture) Item 13(Picture) Item Further investigation and repairs are needed.

We recommend contacting a properly licensed contractor regarding these conditions and have repairs made as deemed appropriate.

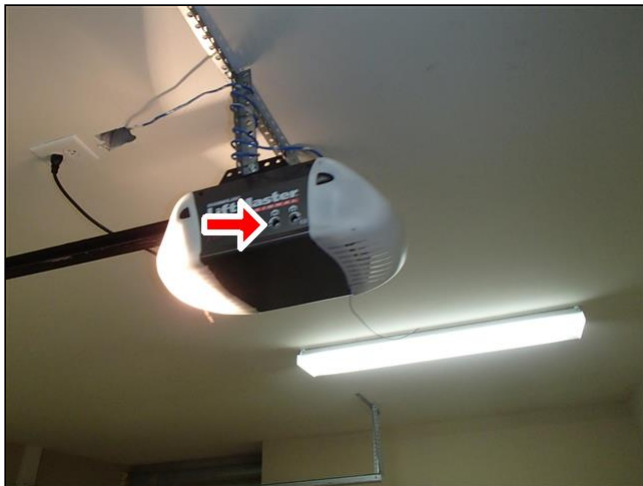
Basement Garage Door Operator

1. The Garage door operator the basement garage door and main level garage door operator(s) safety reverse will not reverse properly when met with resistance. Item 1(Picture)Item 2(Picture) Item 3(Picture) (SAFETY ISSUE) Adjustments needed.
2. The sensors are in place for main level left garage door (Facing Front), however they will not reverse the door when sensors are tested. Item 4(Picture) (SAFETY ISSUE) Repairs are needed.

We recommend contacting a properly licensed garage door company regarding these conditions and have repairs made as deemed appropriate.

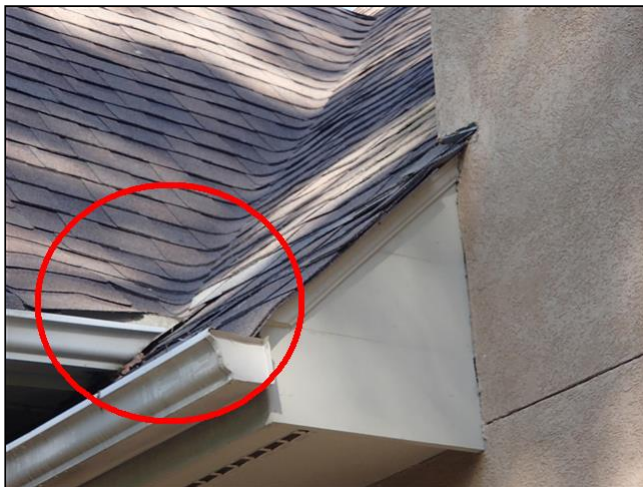
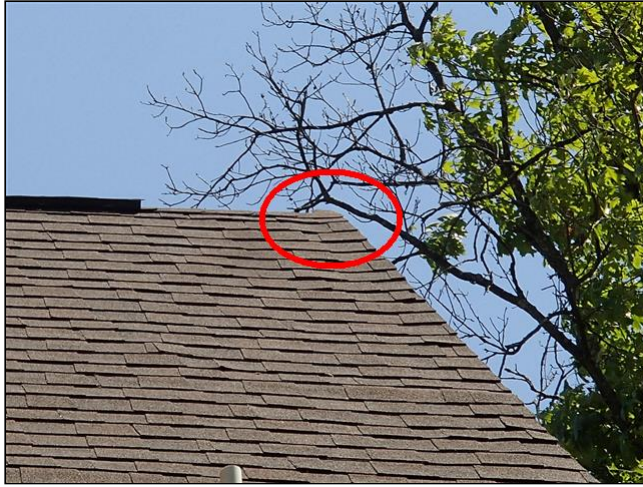
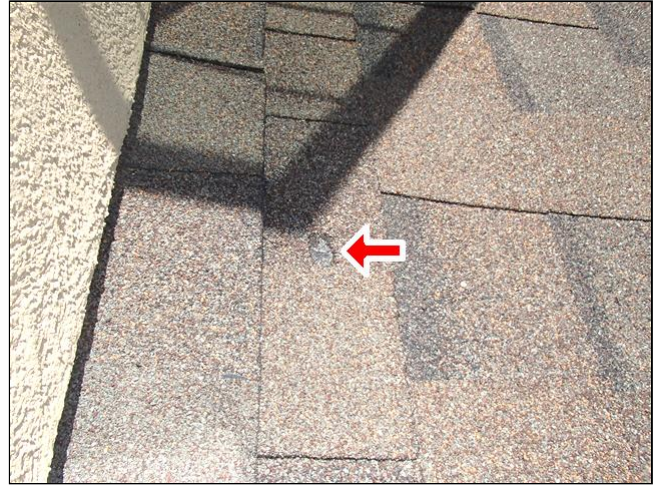
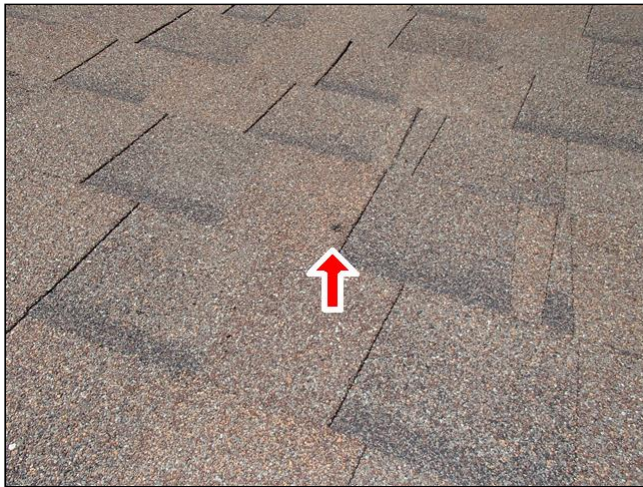
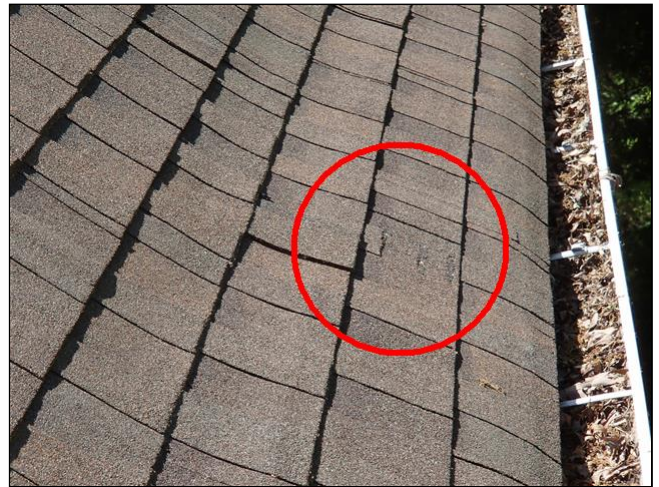
1. Evidence of repairs are present at the rear of the home. Item 1(Picture) A thermal camera indicated that the lower repair is still active. **(See Section 9.0)** Further investigation and repairs by a licensed roofing contractor is needed.
2. Several damaged shingles were observed at the left front side ridge and rear of the home. Item 3(Picture) Item 4(Picture) Item 5(Picture) Item 6(Picture) Item 7(Picture) This can allow water intrusion to occur. Further investigation and repairs are needed.

Ridge Cap Shingles Damaged

We recommend contacting a licensed roofing contractor regarding these conditions and have repairs made as deemed appropriate.

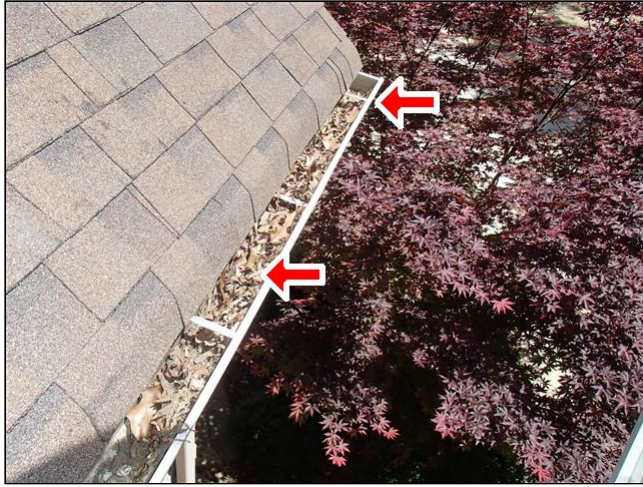
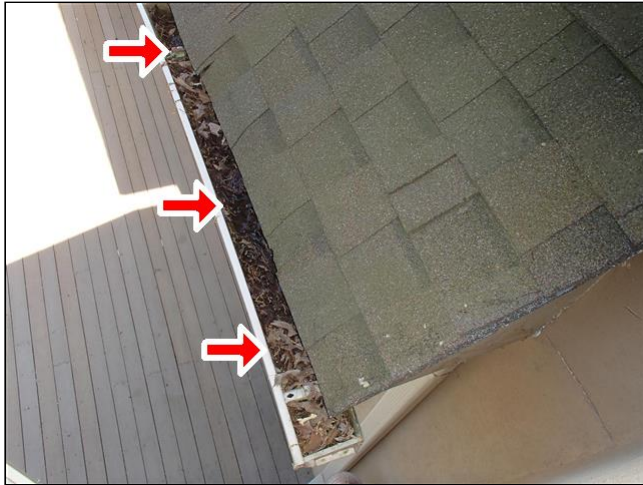
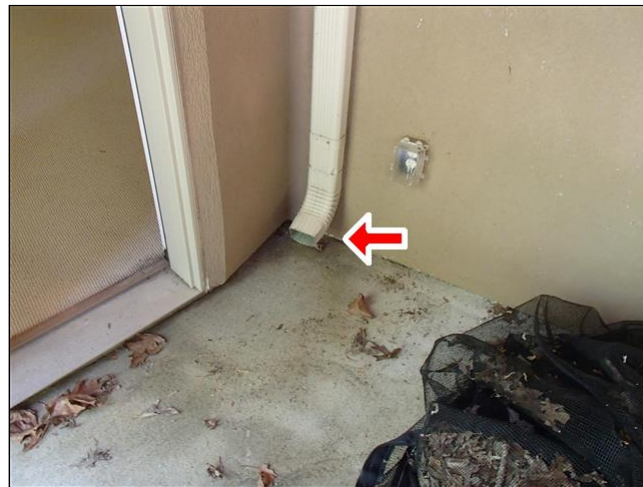
1. The gutter are clogged at the virtually all areas where gutters are installed.Item 1(Picture) Item 2(Picture) Item 3(Picture) Gutters that drain poorly or clogged can lead to many costly problems such as deterioration of fascia, soffit or roof edge. It can also cause gutters to pull loose and lead to possible water intrusion. Repairs are needed.
2. The downspouts are clogged. Item 4(Picture) Repairs are needed.
3. The downspouts at the rear of the home under deck are not extended away from the foundation of the home. Item 5(Picture) This can allow water intrusion to occur. The downspouts should extend away from the foundation of the home. Repairs are needed.

We recommend contacting a properly licensed contractor regarding these conditions and have repairs made as deemed appropriate.

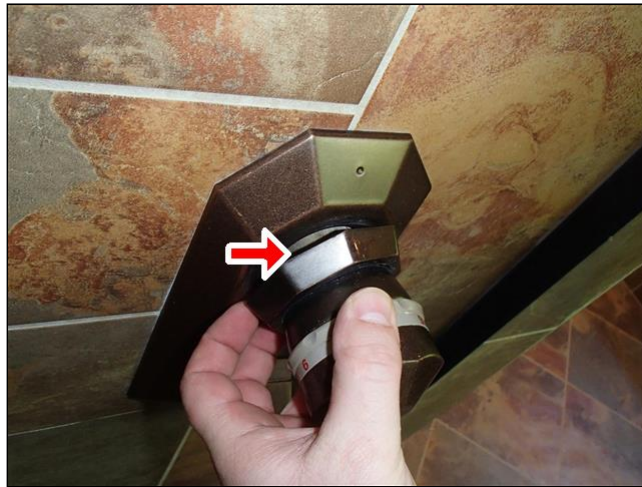
1. The control knob for the master bathroom shower is damaged. Item 1(Picture) Current conditions can allow water behind the tile enclosure. Repairs are needed.

We recommend contacting a qualified licensed plumber regarding these conditions and have repairs made as deemed appropriate..

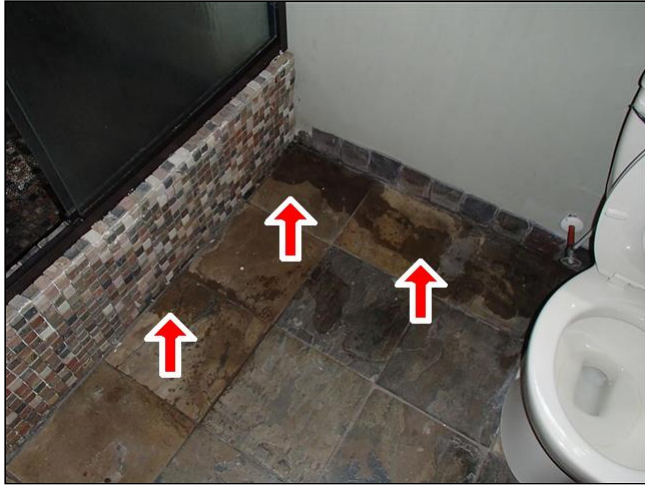
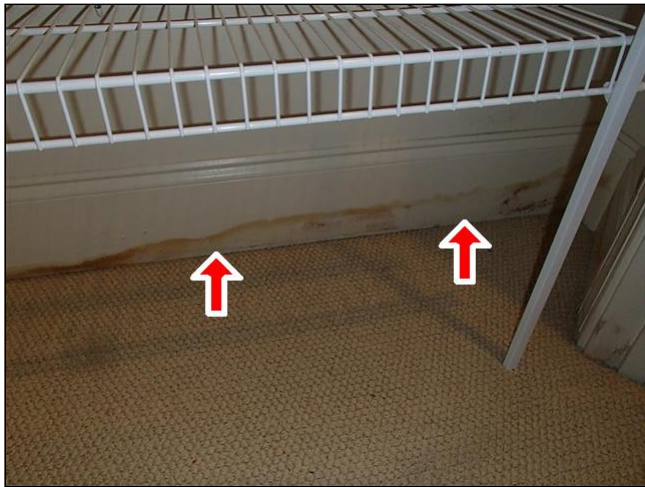
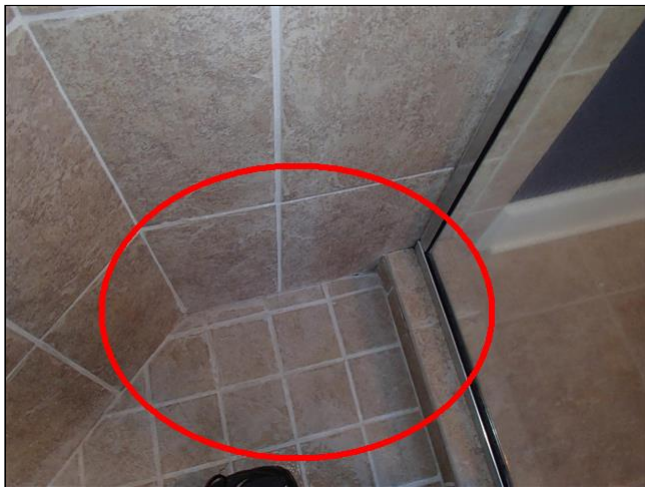
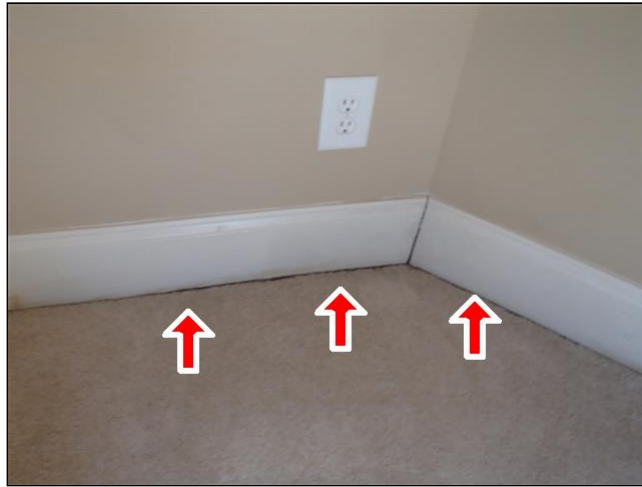
1. The basement guest bathroom shower pan is leaking. Item 1(Picture) Item 2(Picture) Item 3(Picture) Item 4(Picture) Evidence suggest that it was improperly expanded/installed. This pan collects the water from the bottom of the shower and directs it into the drain line piping. Typically the only way to repair this properly is to replace the pan which requires tearing out the floor of the shower and the lower portions of the walls. Based on the extent of the damage we suspect that there is framing damage behind the walls. Repairs are needed.

2. The 2nd floor front guest bathroom shower pan is leaking. Item 5(Picture) Item 6(Picture) Item 7(Picture) This pan collects the water from the bottom of the shower and directs it into the drain line piping. Typically the only way to repair this properly is to replace the pan which requires tearing out the floor of the shower and the lower portions of the walls. Repairs are needed.

We recommend contacting a licensed contractor regarding the conditions and have repairs made as deemed appropriate.

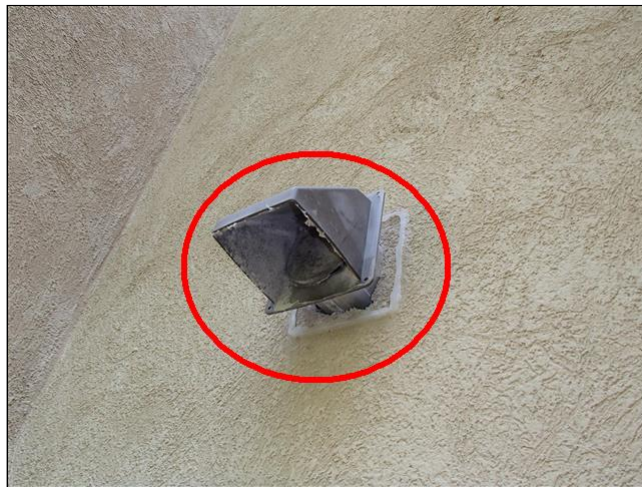
1. The dryer vent hood outside is loose/not secured to the structure. Item 1(Picture) Repairs are needed.

We recommend contacting a licensed HVAC contractor regarding these conditions and have repairs made as deemed appropriate.

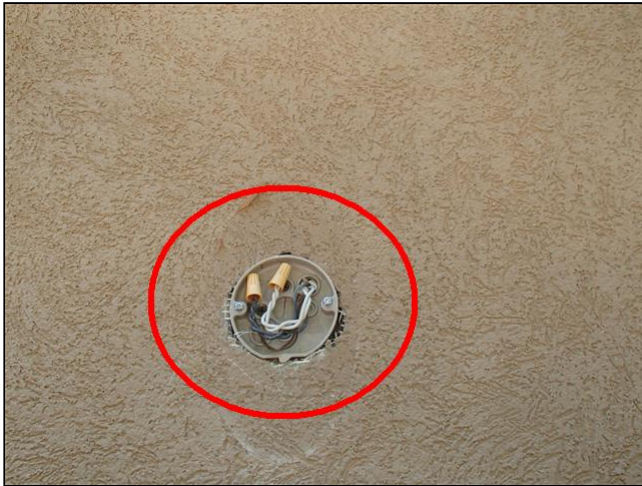
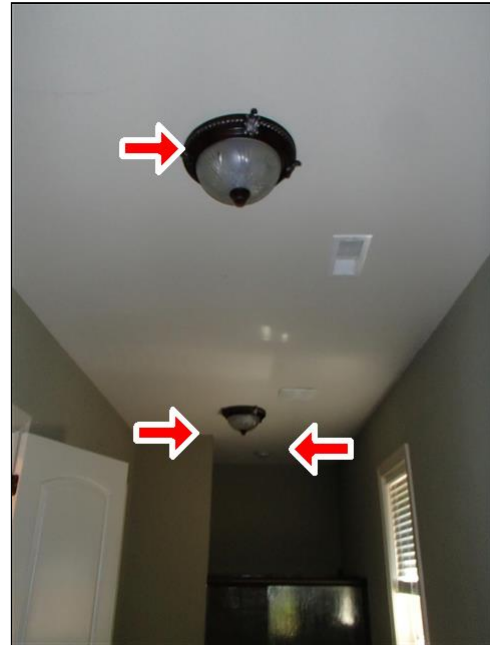
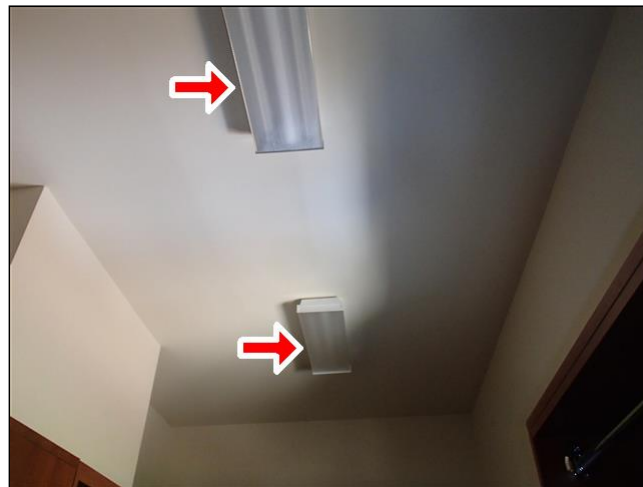
1. The exterior basement garage light fixture is missing. Item 1(Picture) This can allow water intrusion to occur. A replacement is needed.
2. The light fixtures at the basement guest bathroom did not work when tested. Item 2(Picture) Further investigation is needed. (Try Bulbs First)

3. The fluorescent light fixtures at the master bedroom closets did not work when tested. Item 3(Picture) Further investigation is needed. (Try Bulbs First)

We recommend contacting a licensed electrician regarding these conditions and have repairs made as deemed appropriate.

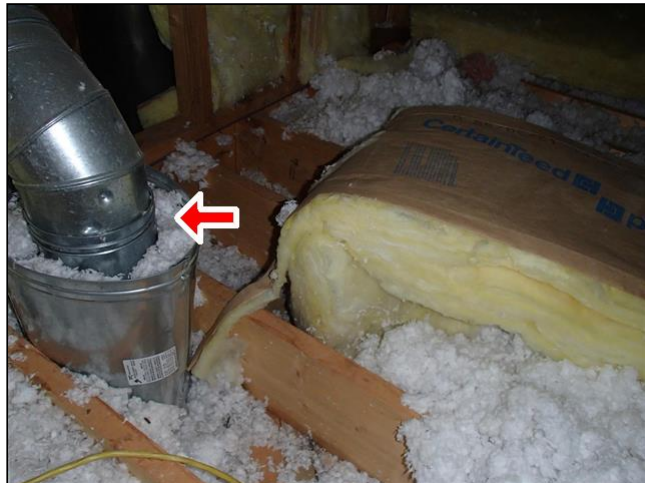
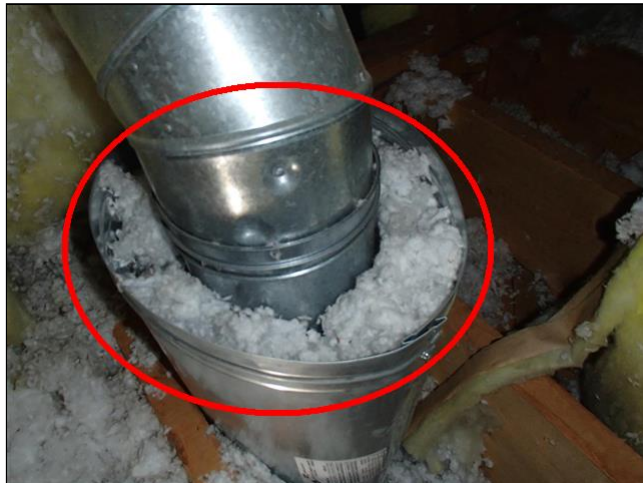
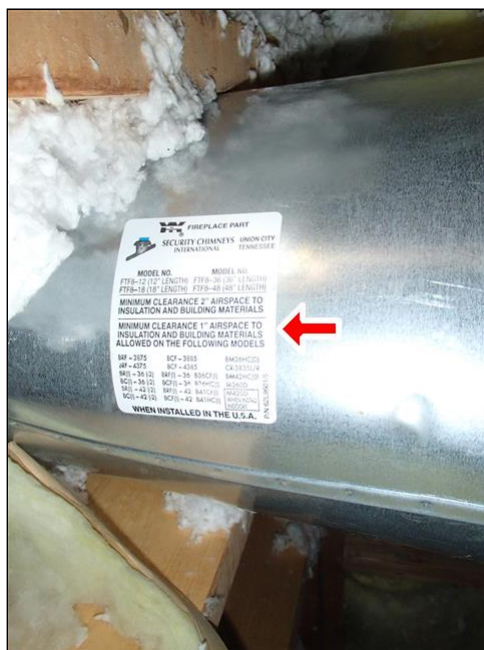
1. The metal liner in chimney for vented fireplace at the master bedroom has combustible (insulation) material in contact with the flue. Item 1(Picture) Item 2(Picture) Per the manufactures label it requires 1" clearance from combustible. Item 3(Picture) Removal of combustible material is needed.

We recommend contacting a properly licensed contractor regarding these conditions and have repairs made as deemed appropriate.

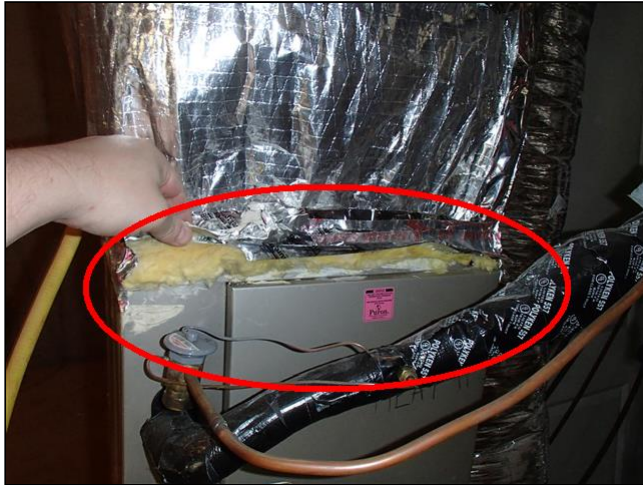
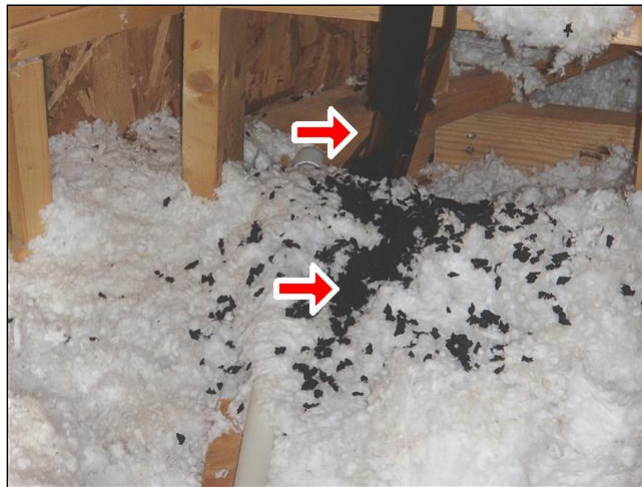
1. The evaporator coil has air leaks present at supply plenum. Item 1(Picture) Condensation and energy loss can occur as a result. Repairs are needed to prevent condensation.
2. The foam sleeve insulation on suction line has damaged insulation in the attic. Item 2(Picture) Item 3(Picture) Evidence suggest rodent/squirrel activity. The Missing foam insulation on suction line can cause energy loss and condensation. Repairs are needed to prevent condensation.

We recommend contacting a licensed HVAC contractor regarding these conditions and have repairs made as deemed appropriate.

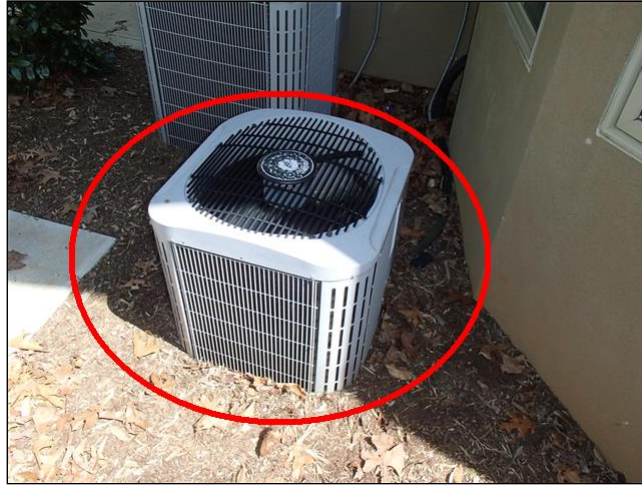
1. The cooling temperature split (temperature differential) across the air handler for the basement unit was below the normal operating range of 14-22 degrees. Item 1(Picture) The unit is not functioning as intended. If the cause of the problem is found to be low refrigerant, a written statement from a licensed A/C contractor should be obtained stating that the entire system has been leak tested and that no leaks are present. Further investigation by a licensed HVAC contractor is needed.

We recommend contacting a licensed heating/cooling contractor regarding these conditions and have repairs made as deemed appropriate.

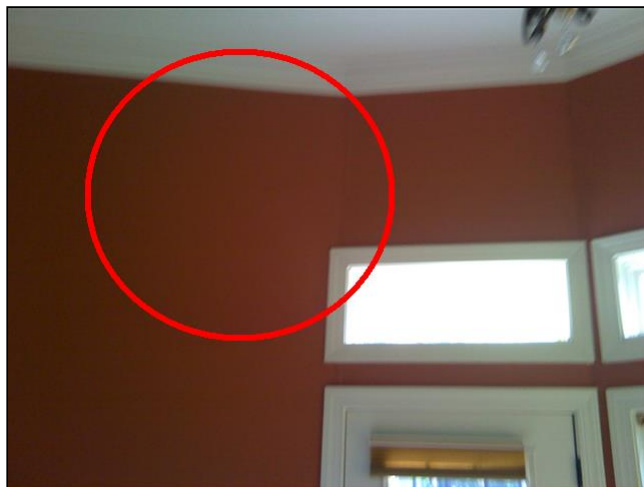
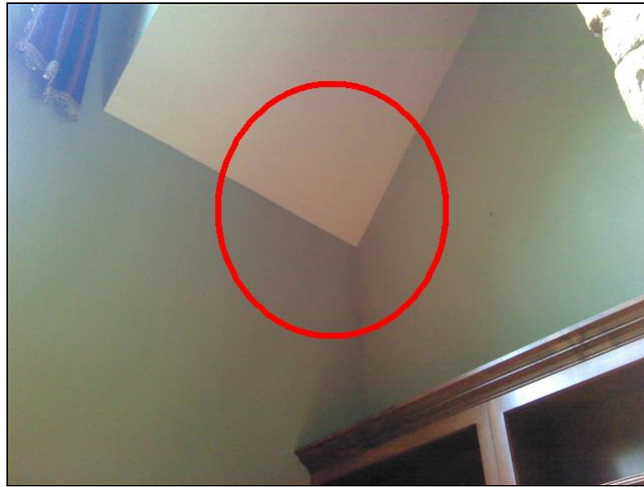
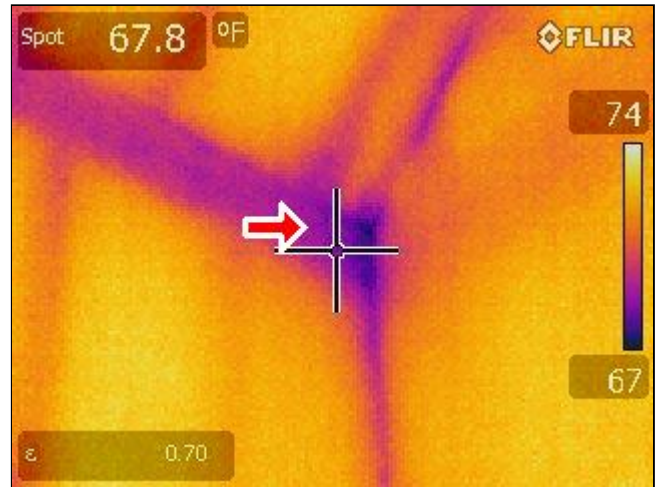
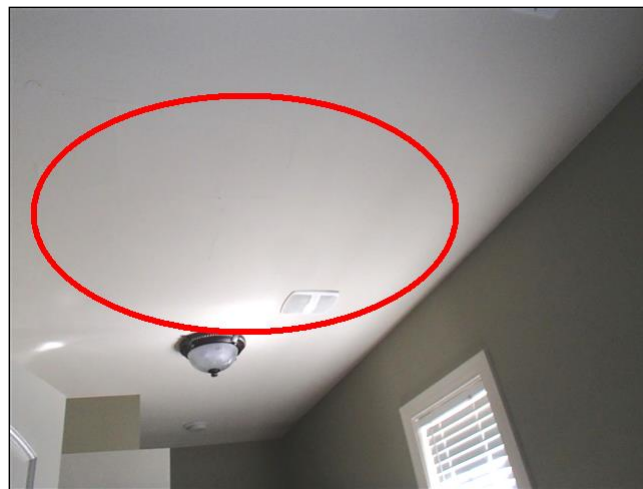
1. The Sheetrock on the ceiling reveals a water stain indicating a leak still exists at the Living Room and master Bedroom. Item 1(Picture) Item 2(Picture) Item 3(Picture) Item 4(Picture) A thermal camera was used and it indicated that the leak has not been corrected. Further investigation and repairs are needed. Due to the extent of the damage it is likely that framing damage has occurred. Coverings will likely need to be removed to uncover the extent of the damage. Further investigation and repairs are needed.
2. The sheetrock on the ceiling in the basement guest bathroom shows signs of repair. Item 5(Picture) We were unable to determine the cause of the damage.

We recommend contacting a properly licensed contractor regarding these conditions and have repairs made as deemed appropriate.

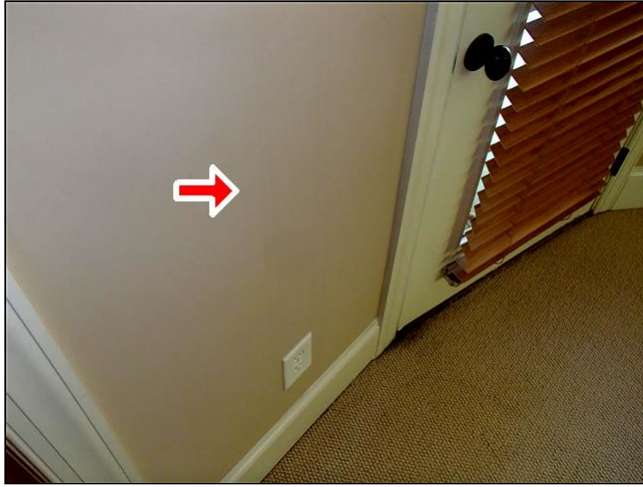
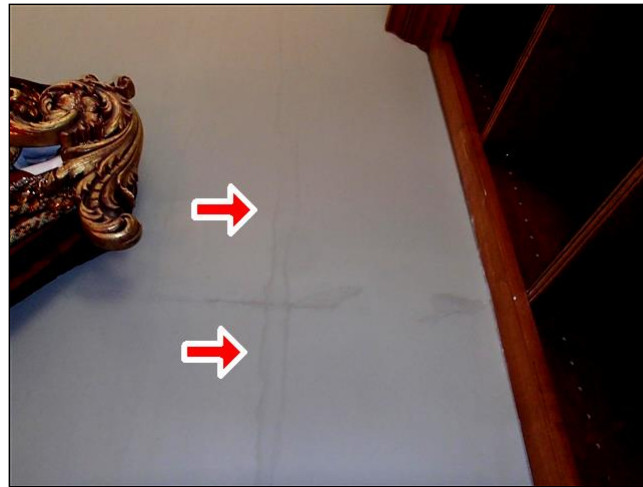
1. The Sheetrock on the ceiling reveals a water stain indicating a leak still exists at the basement office, Living Room and master Bedroom. Item 1(Picture) Item 2(Picture) Item 3(Picture) Further investigation and repairs are needed. Due to the extent of the damage it is likely that framing damage has occurred. Coverings will likely need to be removed to uncover the extent of the damage. Further investigation and repairs are needed.

We recommend contacting a properly licensed contractor regarding these conditions and have repairs made as deemed appropriate.

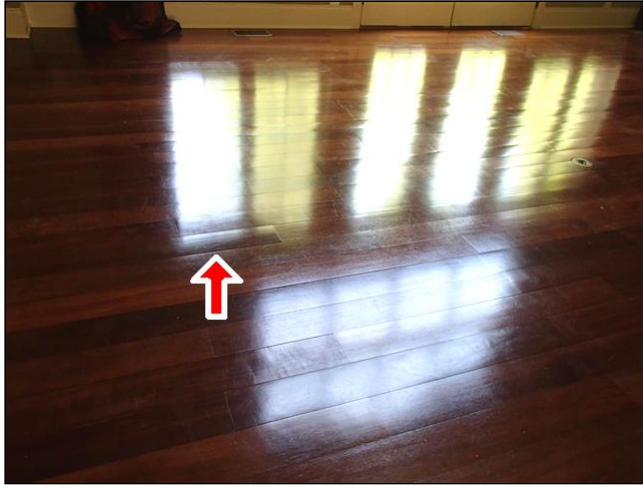
1. The hardwood floor in the living room shows signs of cupping. Item 1(Picture) Item 2(Picture) This is an indication of moisture. Cupping and crowning are common complaints that develop with high humidity. Both problems occur across the width of the flooring material. Cupping is when the edges of a board are higher than the center. It can occur after water spills onto the floor and is absorbed by the wood, but high humidity is more often the cause. If the wood expands significantly, compression can result as the boards are crushed together, deforming the boards at the edges. Cupping is caused by a moisture imbalance throughout the thickness of the wood: the wood is wetter on the bottom of the board than on the top. Further investigation by a licensed contractor is needed.

We recommend contacting a licensed contractor regarding these conditions and have repairs made as deemed appropriate.

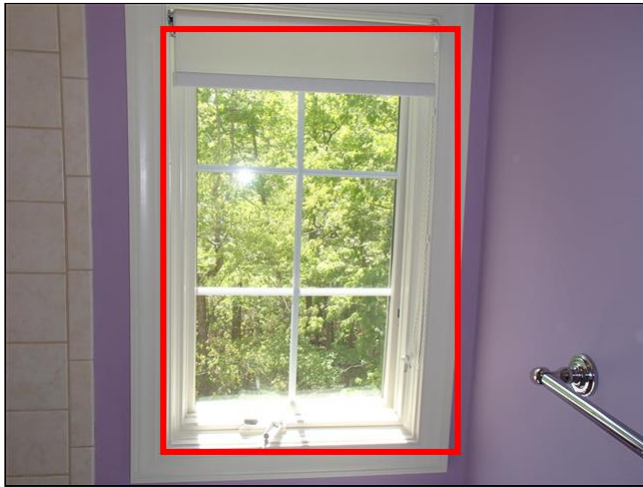
1. One window stuck shut at the 2nd floor rear guest bathroom. Item 1(Picture) Item 2(Picture)  
Repairs are needed.

We recommend contacting a licensed window technician regarding these conditions and have repairs made as deemed appropriate..

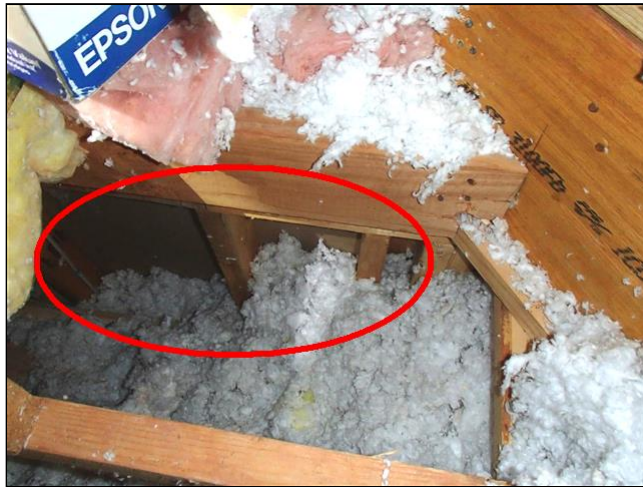
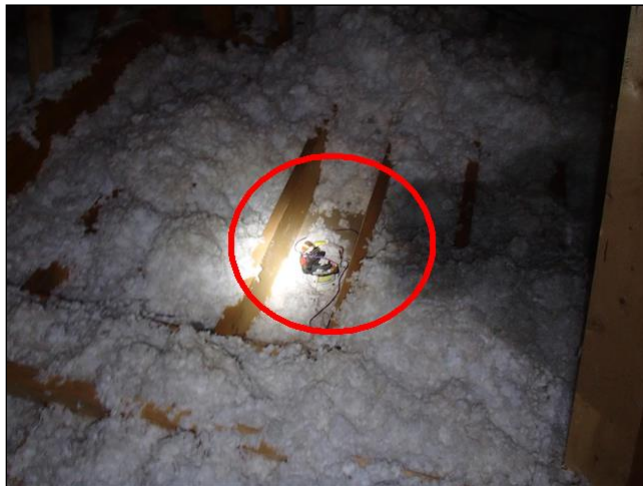
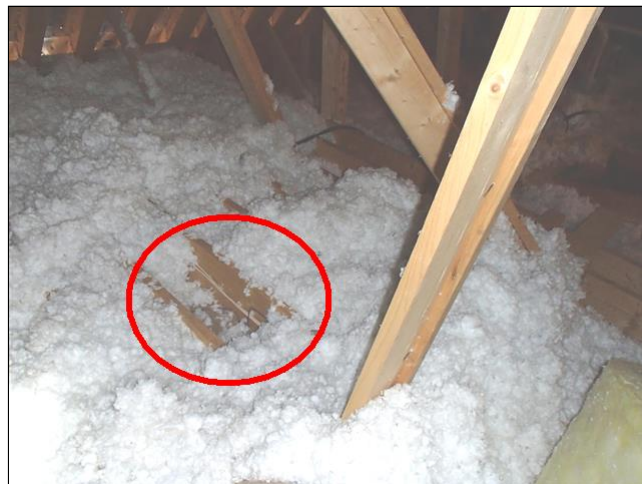
1. Fiberglass (loose-fill) insulation is compressed and missing in areas of the attic, exposed sheet rock visible in several areas. Item 1(Picture) Item 2(Picture) Item 3(Picture) Item 4(Picture) Item 5(Picture) Heat loss can occur more on this home than one that is properly insulated. Repairs are needed.

We recommend contacting a properly licensed contractor regarding these conditions and have repairs

made as deemed appropriate.

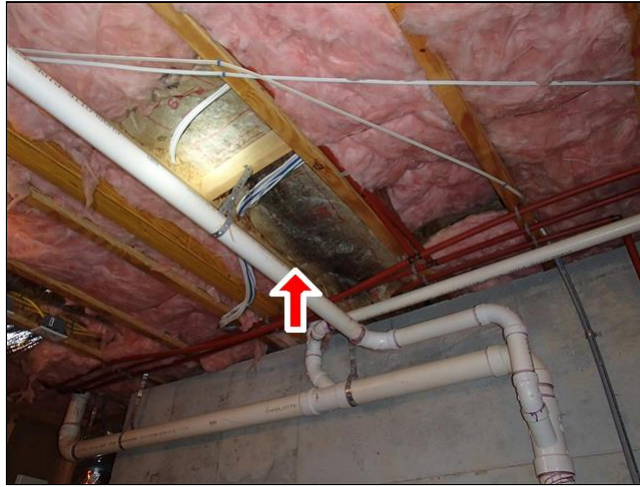
1. The insulation has been installed wrong side up underneath the floor system in the crawl space (Vapor Barrier Warm side up is the correct installation), this may cause adverse moisture conditions that can lead to the premature deterioration of the building components. Item

1(Picture) Repairs are needed.

We recommend contacting a licensed contractor regarding these conditions and have repairs made as deemed appropriate.

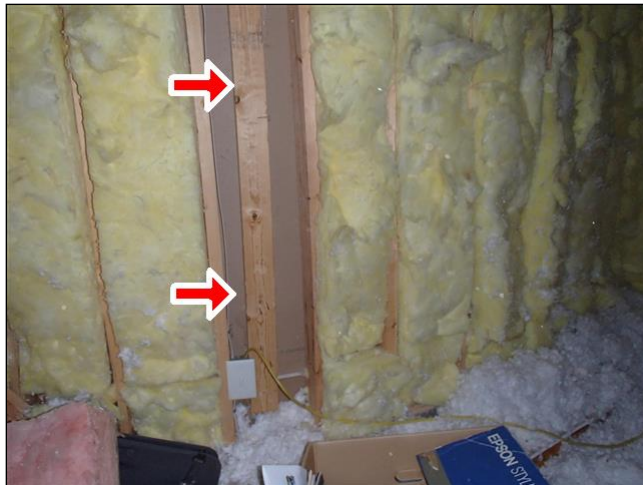
1. The wall insulation has fallen in areas. Item 1(Picture) Item 2(Picture) This can allow heat loss to occur. Repairs are needed.

We recommend contacting a properly licensed contractor regarding these conditions and have repairs made as deemed appropriate

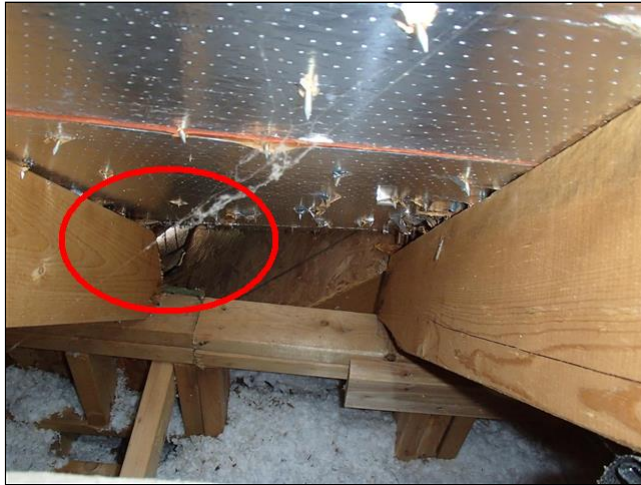
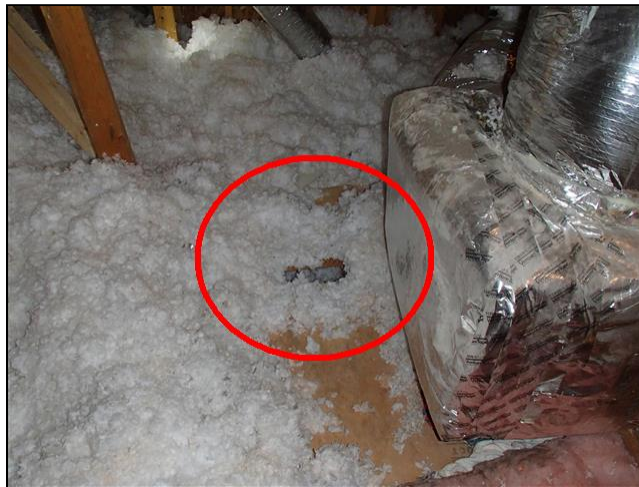
1. Evidence of rodent activity present in the attic, evidence suggest that they are entering the attic at rear soffits. Item 5(Picture) Item 6(Picture) Item 7(Picture) Repairs are needed to prevent damage from occurring. Further investigation and repairs are needed.

We recommend contacting a licensed pest control company regarding these conditions and have repairs made as deemed appropriate.

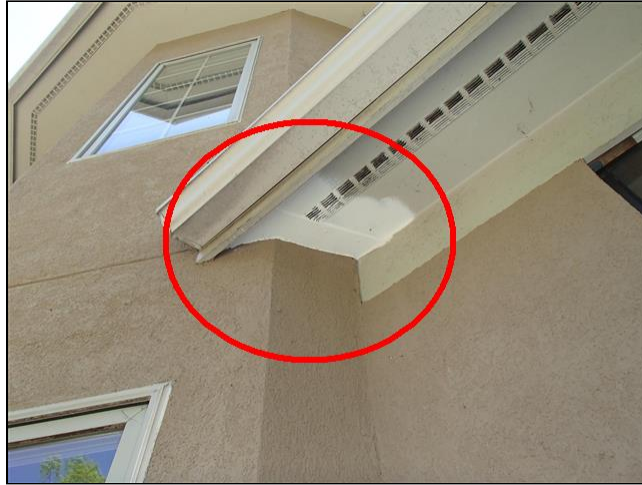
1. The soffit panel at eave on the rear of home covered porch show signs of repair. Item 1(Picture)  
Unable to determine the cause of the damage. Further investigation is needed.

We recommend contacting a properly licensed contractor regarding these conditions and have repairs made as deemed appropriate.

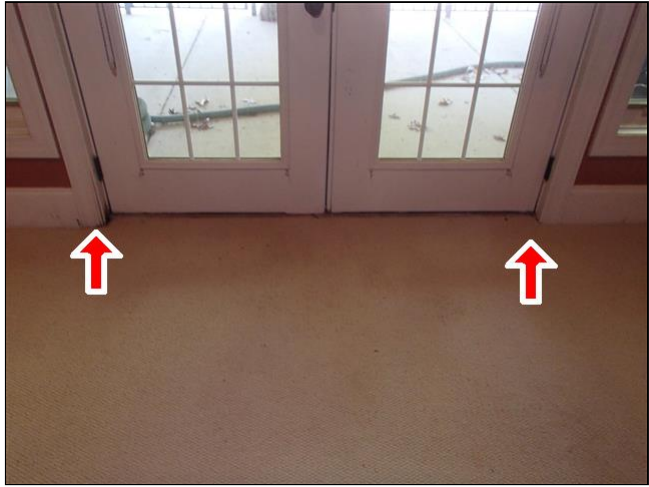
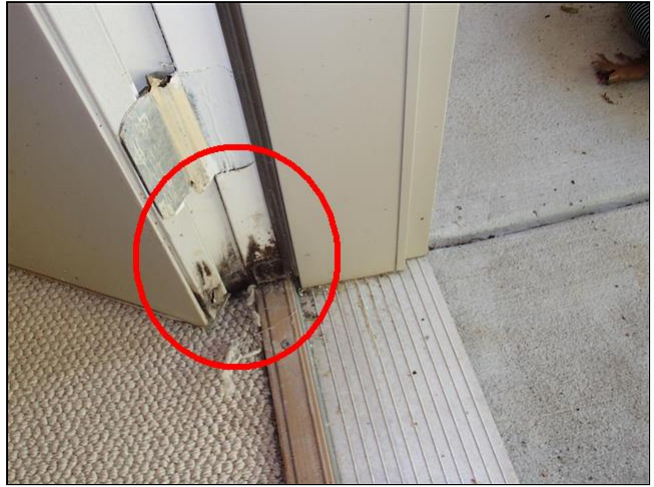
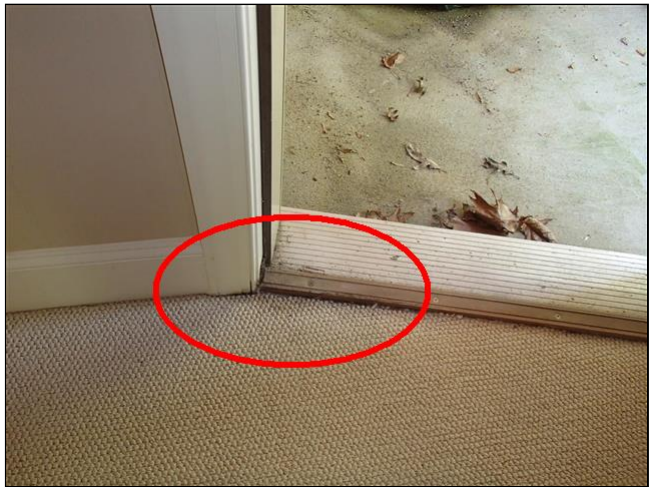
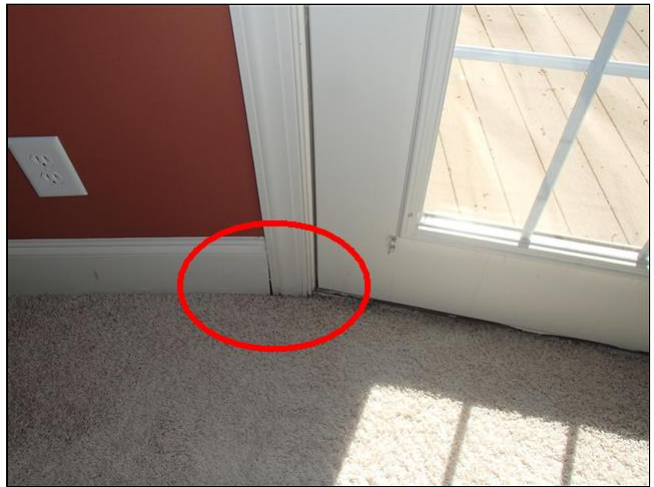
1. The rear entry doors at all of the basement doors shows signs of active water intrusion at threshold. Item 1(Picture) Item 2(Picture) Item 3(Picture) Item 4(Picture) Water intrusion if not corrected can lead to significant repair costs. Further investigation and repairs by a licensed contractor are needed.
2. The dead bolt at the laundry room entrance is damaged. Item 5(Picture) A repair or replacement is needed.

We recommend contacting a properly licensed contractor regarding these conditions and have repairs made as deemed appropriate.
