# Inspection Report

SAMPLE INSPECTION - ACTUAL REPORT 100,000.00 in Damage  
Contractors wanted Open Checkbook  
Sample Nc 28201

**AHI Residential & Commercial Inspections, Inc**

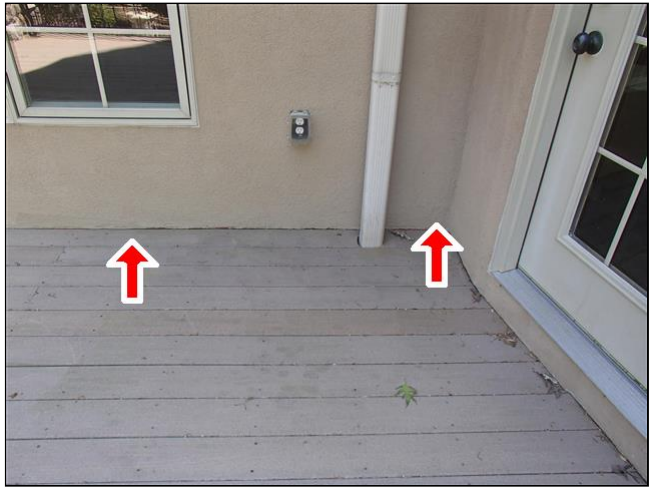
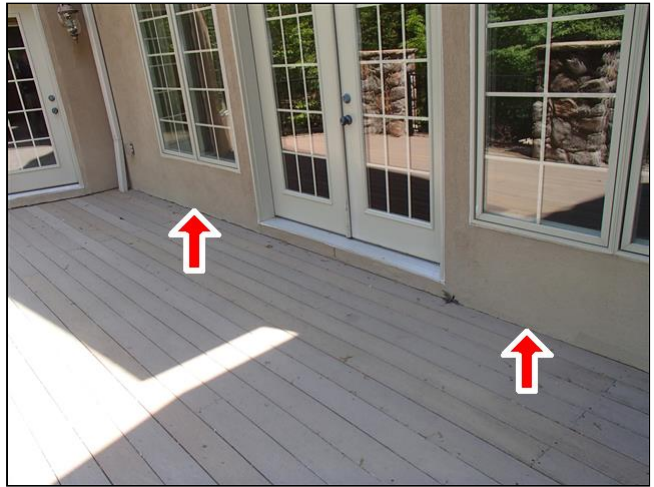
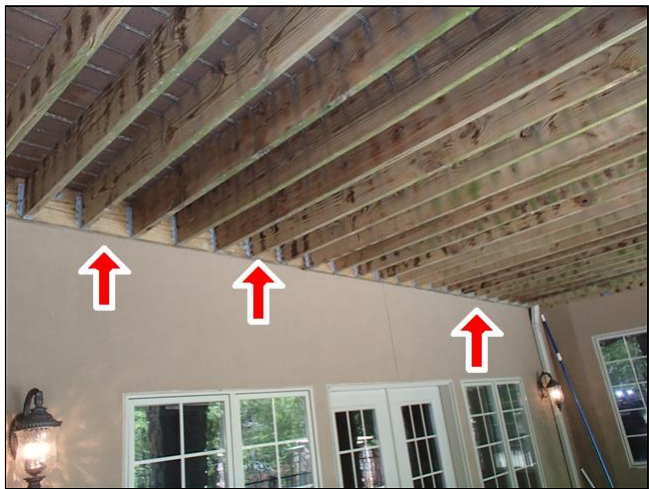
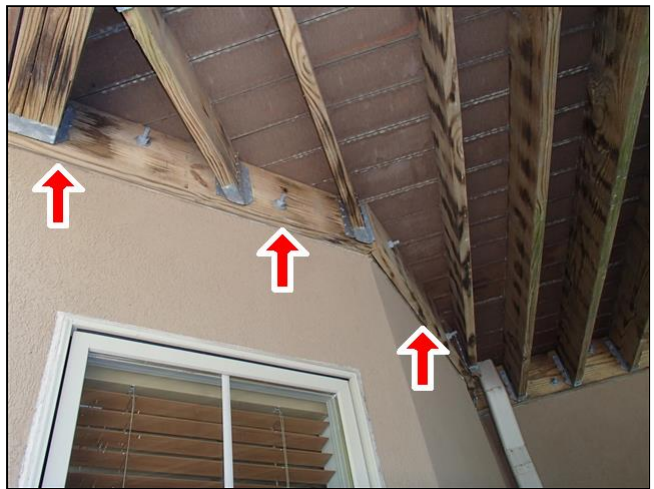
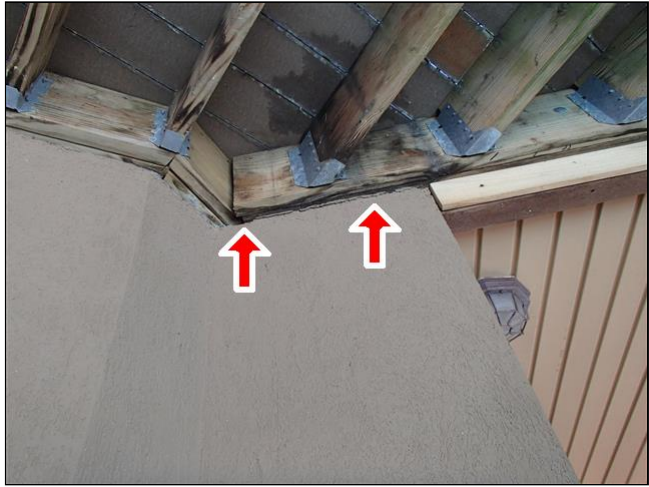
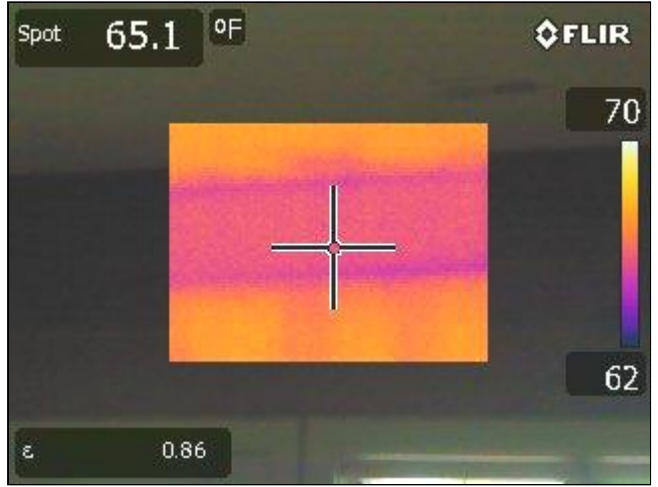
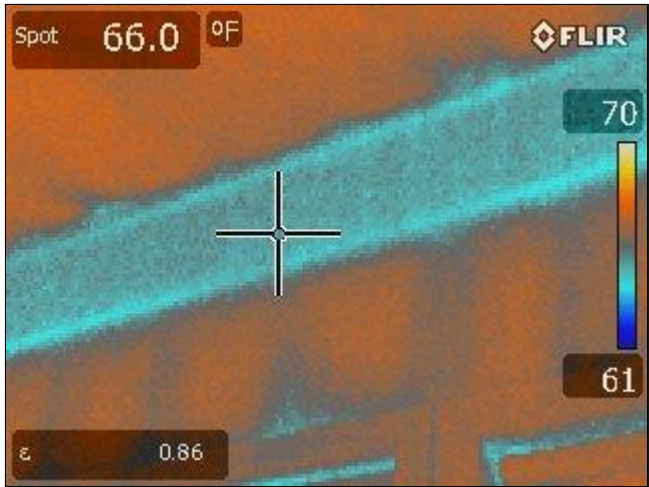
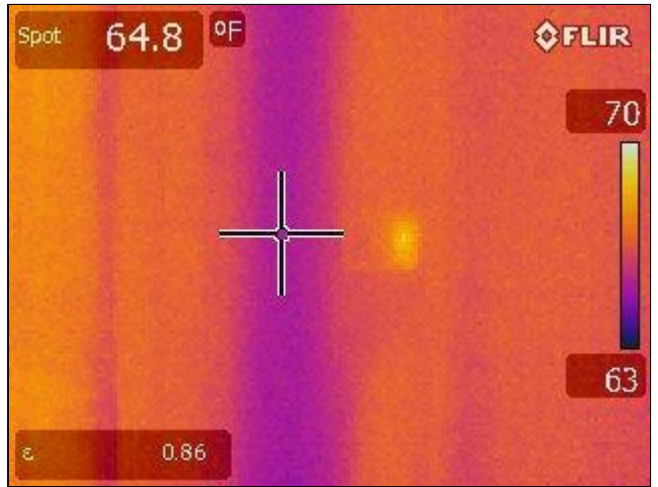
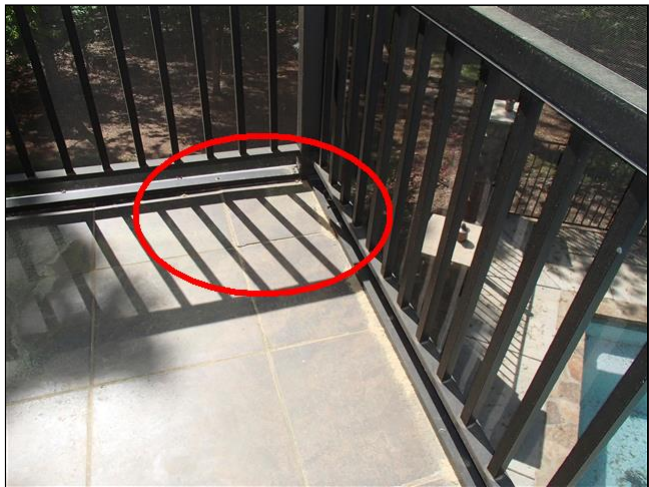
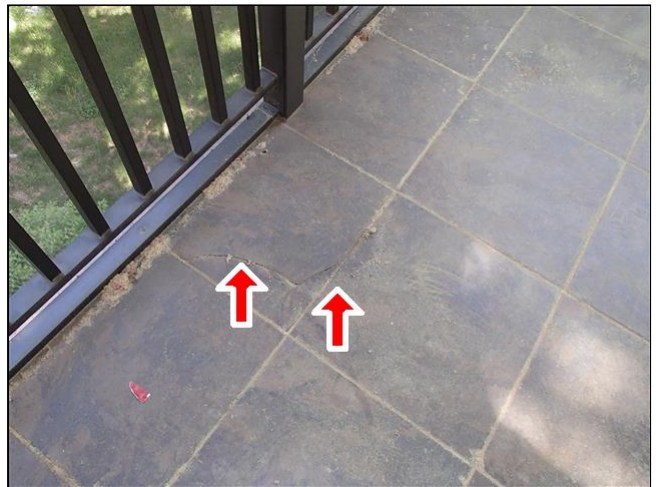
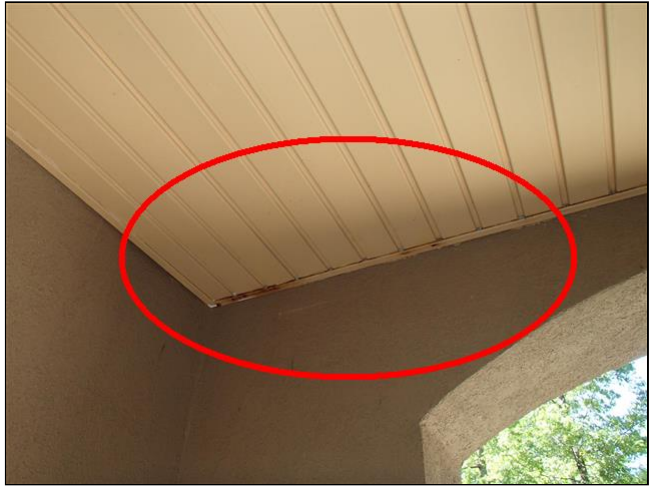
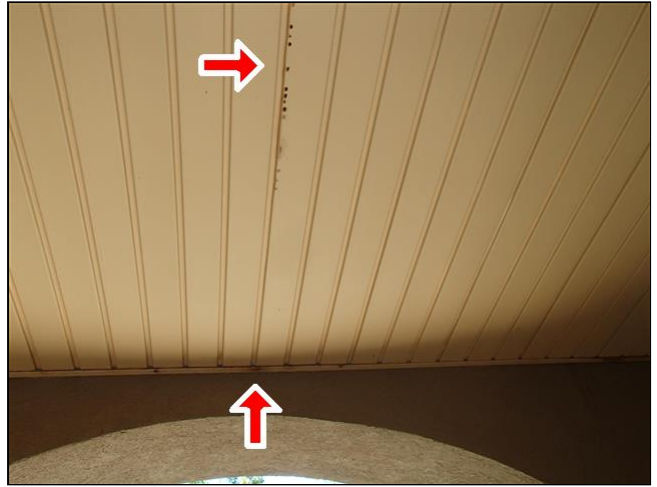
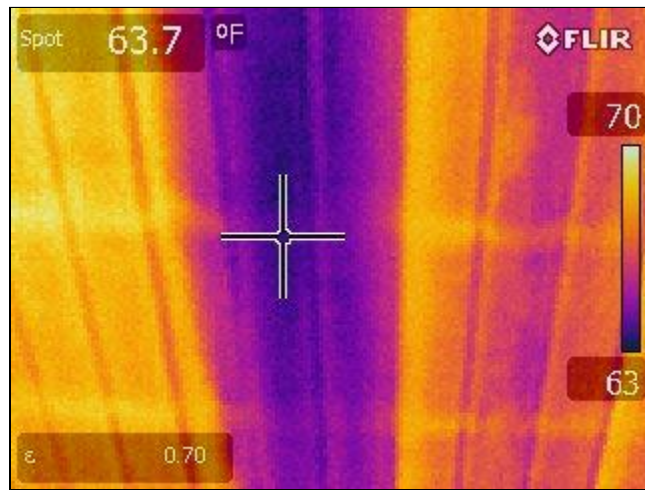
1. The rear deck ledger board has no visible signs of flashing present. Item 1(Picture) Item 2(Picture) Item 3(Picture) Item 4(Picture) Item 5(Picture) This can allow water intrusion to occur. A thermal camera was used on the interior of the home indicating that moisture intrusion is occurring. Item 6(Picture) Item 7(Picture) Item 8(Picture) Further investigation is needed.
2. The rear patio has damaged tiles and show signs of active water intrusion. Item 9(Picture)Item 10(Picture) Item 11(Picture) Item 12(Picture) Item 13(Picture) Item Further investigation and repairs are needed.

We recommend contacting a properly licensed contractor regarding these conditions and have repairs made as deemed appropriate.

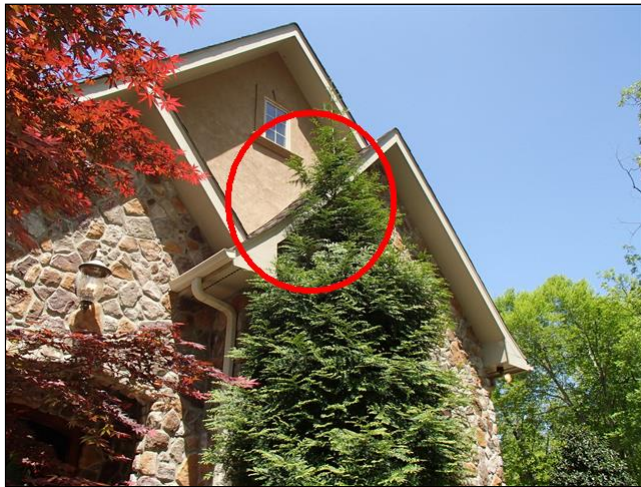
### 3.7

1. Tree in contact with home. Item 1(Picture) Trim all trees and shrubs to a minimum of 12 inches away from structure. This will help prevent premature deterioration of the building components. (This is a preventive maintenance item and is for your information)
2. Dead tree present at the front of the home. Item 2(Picture) Removal recommended.

We recommend contacting a licensed landscaper regarding these conditions and have repairs made as deemed appropriate.

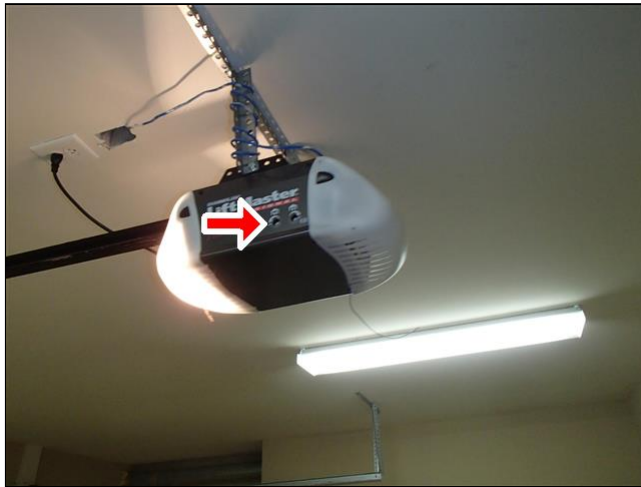
Basement Garage Door Operator

1. The Garage door operator the basement garage door and main level garage door operator(s) safety reverse will not reverse properly when met with resistance. Item 1(Picture)Item 2(Picture) Item 3(Picture) (SAFETY ISSUE) Adjustments needed.
2. The sensors are in place for main level left garage door (Facing Front), however they will not reverse the door when sensors are tested. Item 4(Picture) (SAFETY ISSUE) Repairs are needed.

We recommend contacting a properly licensed garage door company regarding these conditions and have repairs made as deemed appropriate.

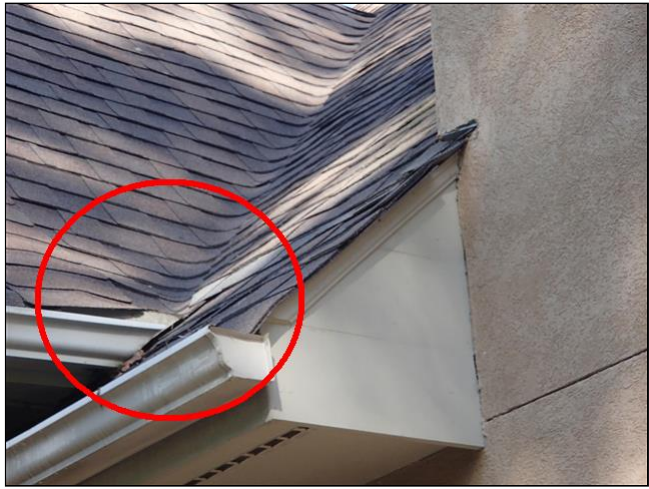
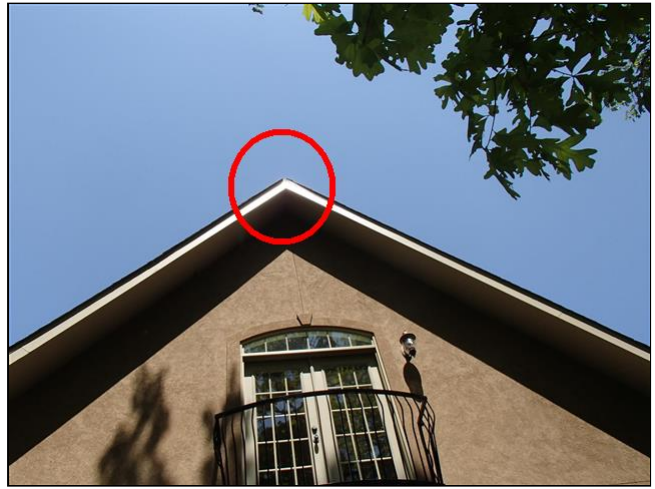
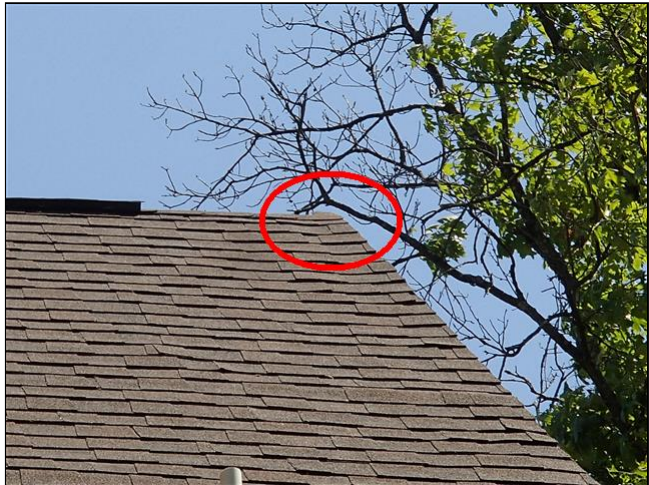
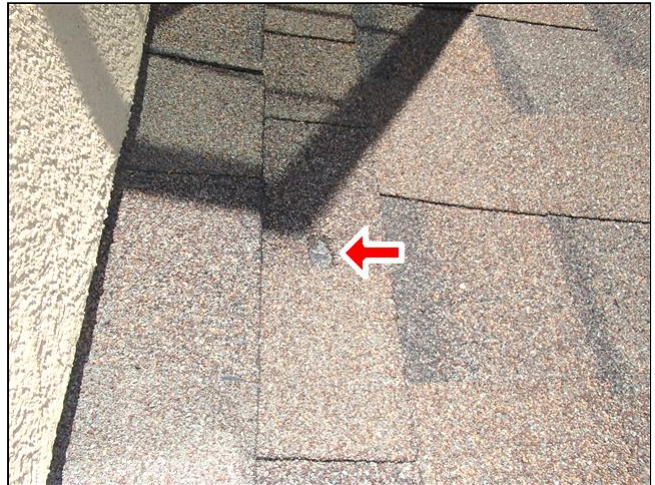
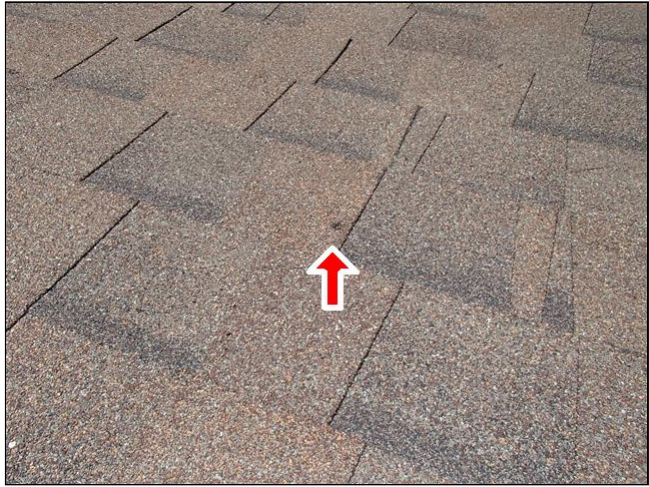
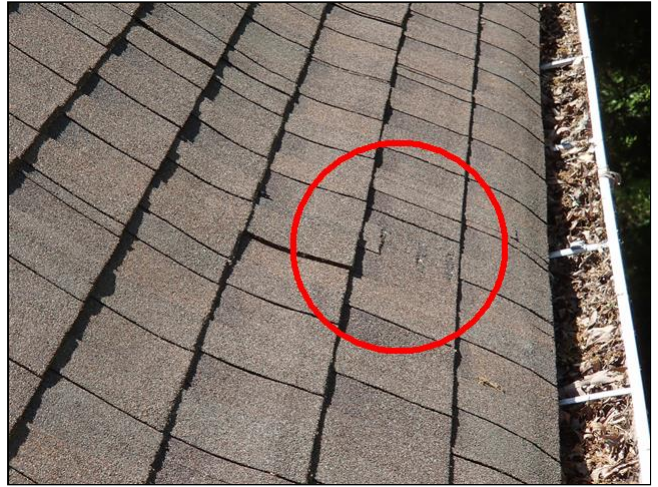
Ridge Cap Shingles Damaged

1. Evidence of repairs are present at the rear of the home. Item 1(Picture) A thermal camera indicated that the lower repair is still active. **(See Section 9.0)** Further investigation and repairs by a licensed roofing contractor is needed.
2. Several damaged shingles were observed at the left front side ridge and rear of the home. Item 3(Picture) Item 4(Picture) Item 5(Picture) Item 6(Picture) Item 7(Picture) This can allow water intrusion to occur. Further investigation and repairs are needed.

We recommend contacting a licensed roofing contractor regarding these conditions and have repairs made as deemed appropriate.

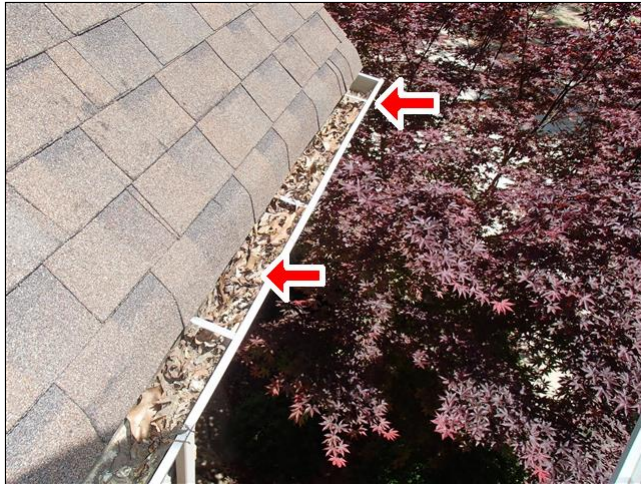
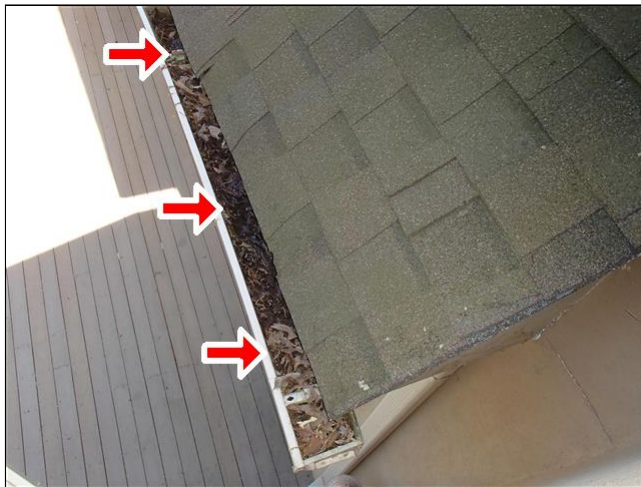
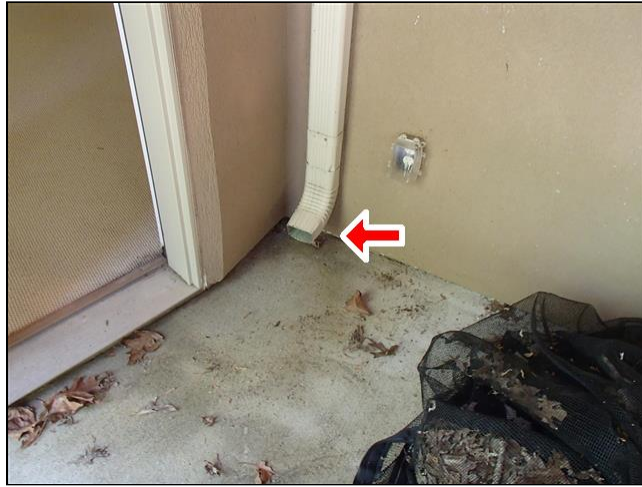
#### 4.1

1. The gutter are clogged at the virtually all areas where gutters are installed. Item 1(Picture) Item 2(Picture) Item 3(Picture) Gutters that drain poorly or clogged can lead to many costly problems such as deterioration of fascia, soffit or roof edge. It can also cause gutters to pull loose and lead to possible water intrusion. Repairs are needed.
2. The downspouts are clogged. Item 4(Picture) Repairs are needed.
3. The downspouts at the rear of the home under deck are not extended away from the foundation of the home. Item 5(Picture) This can allow water intrusion to occur. The downspouts should extend away from the foundation of the home. Repairs are needed.

We recommend contacting a properly licensed contractor regarding these conditions and have repairs made as deemed appropriate.

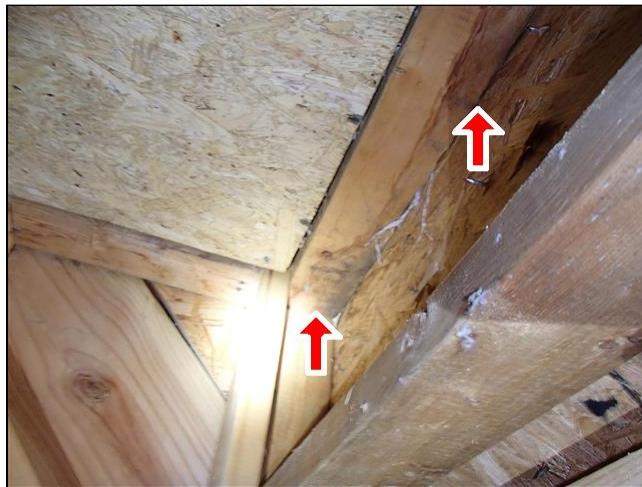
#### 4.3

1. Evidence of past water intrusion was visible in the attic below chimney. Item 1(Picture) Moisture meter was used and it indicated that the leak has been corrected. (This is for your information)

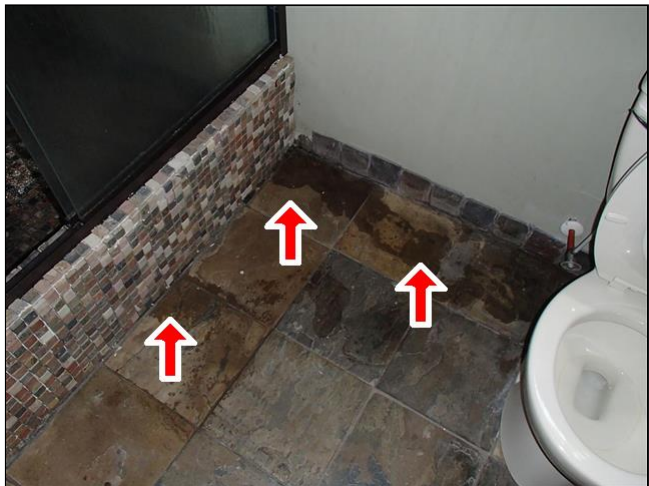
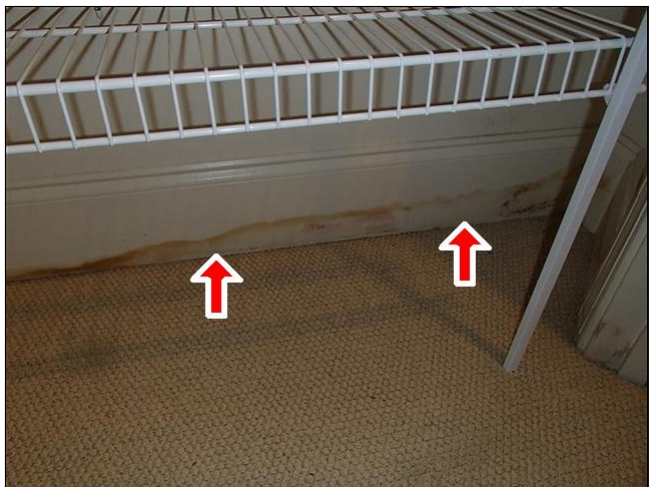
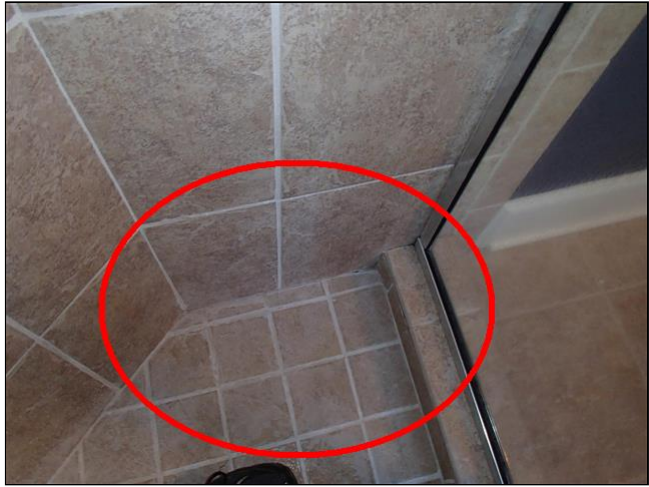
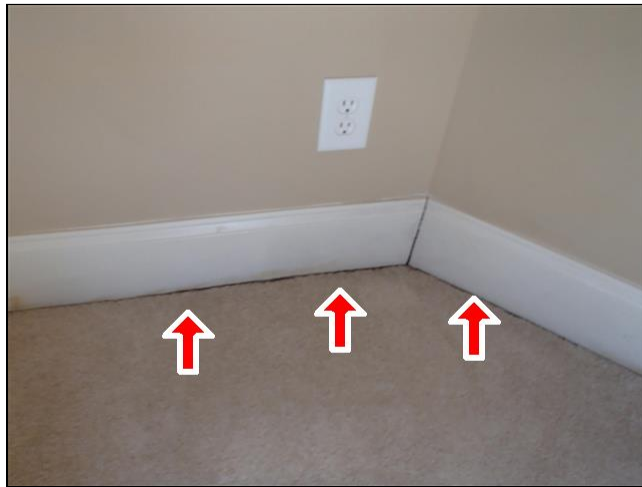
## 5.5 (1)

1. The basement guest bathroom shower pan is leaking. Item 1(Picture) Item 2(Picture) Item 3(Picture) Item 4(Picture) Evidence suggest that it was improperly expanded/installed. This pan collects the water from the bottom of the shower and directs it into the drain line piping. Typically the only way to repair this properly is to replace the pan which requires tearing out the floor of the shower and the lower portions of the walls. Based on the extent of the damage we suspect that there is framing damage behind the walls. Repairs are needed.

2. The 2nd floor front guest bathroom shower pan is leaking. Item 5(Picture) Item 6(Picture) Item 7(Picture) This pan collects the water from the bottom of the shower and directs it into the drain line piping. Typically the only way to repair this properly is to replace the pan which requires tearing out the floor of the shower and the lower portions of the walls. Repairs are needed.

We recommend contacting a licensed contractor regarding the conditions and have repairs made as deemed appropriate.

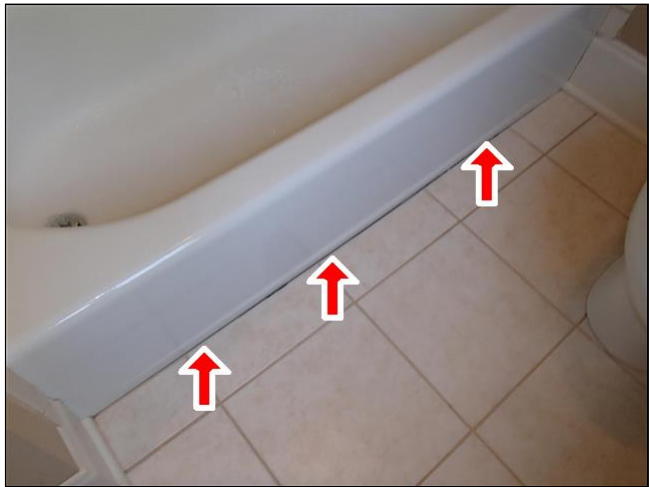
(2)

1. The Caulking is needed at/around the following bathroom tubs and or showers. Item 9(Picture)Item 10(Picture) Gaps between the tile and the tub can allow water damage to occur. Non-Visible moisture damage may be present in and around these areas. (This is a preventive maintenance item and is for your information)

We recommend contacting a qualified individual regarding these conditions and have repair made as deemed appropriate.

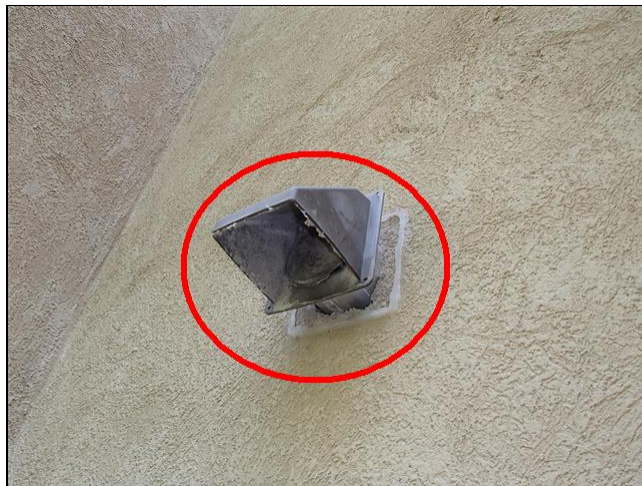
## 5.6

1. The dryer vent hood outside is loose/not secured to the structure. Item 1(Picture) Repairs are needed.

We recommend contacting a licensed HVAC contractor regarding these conditions and have repairs made as deemed appropriate.

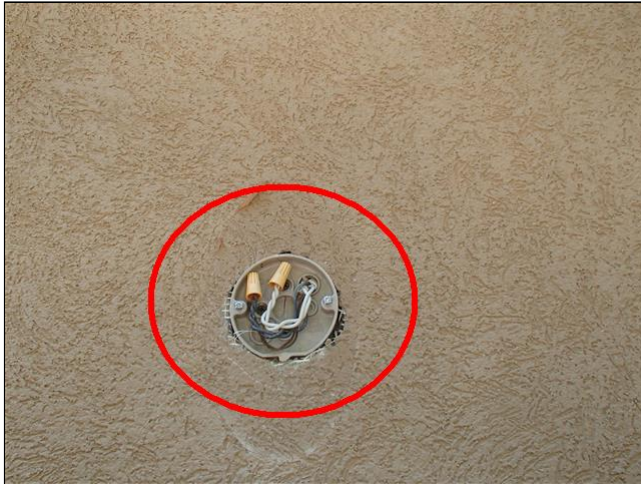
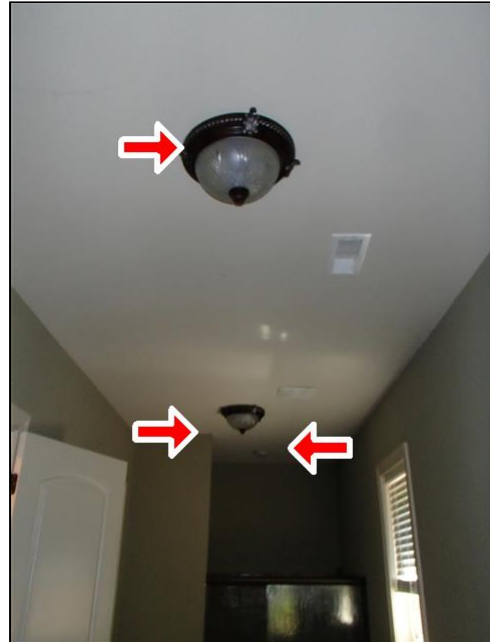
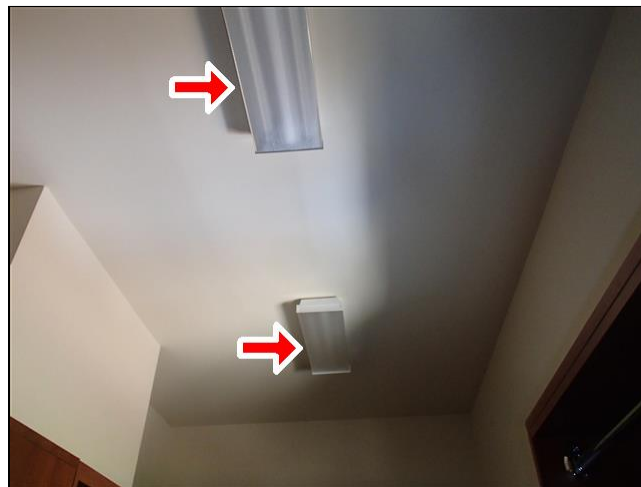
1. The exterior basement garage light fixture is missing. Item 1(Picture) This can allow water intrusion to occur. A replacement is needed.
2. The light fixtures at the basement guest bathroom did not work when tested. Item 2(Picture) Further investigation is needed. (Try Bulbs First)
3. The fluorescent light fixtures at the master bedroom closets did not work when tested. Item 3(Picture) Further investigation is needed. (Try Bulbs First)

We recommend contacting a licensed electrician regarding these conditions and have repairs made as deemed appropriate.

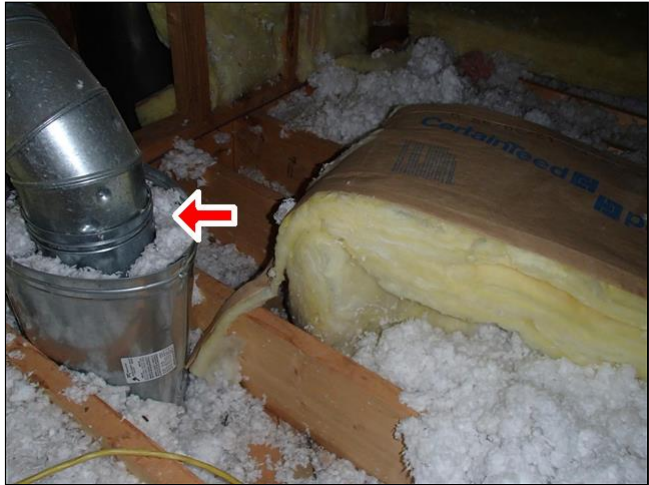
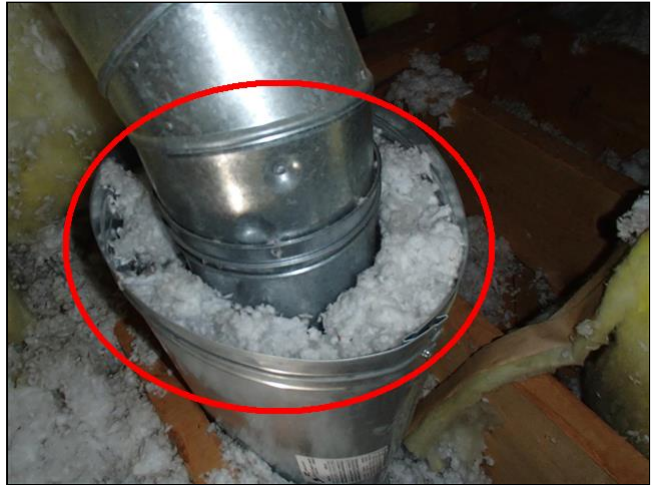
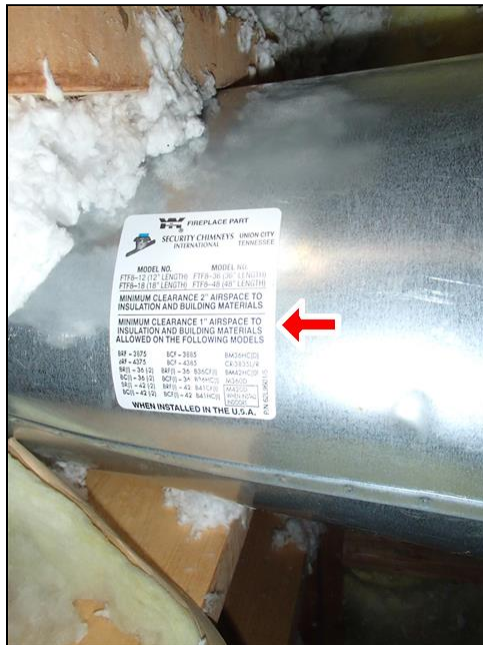
1. The metal liner in chimney for vented fireplace at the master bedroom has combustible (insulation) material in contact with the flue. Item 1(Picture) Item 2(Picture) Per the manufactures label it requires 1" clearance from combustible. Item 3(Picture) Removal of combustible material is needed.

We recommend contacting a properly licensed contractor regarding these conditions and have repairs made as deemed appropriate.

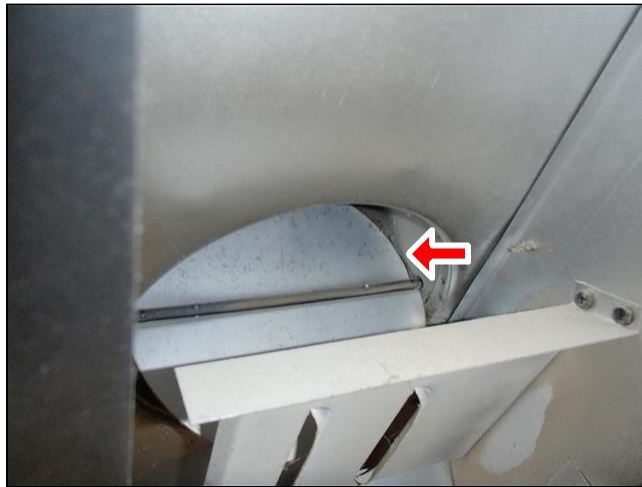
## 7.5

1. The vented fire logs insert in the master bedroom must remain open during use. Item 1(Picture)  
Without a clamp to force open the damper, it could shut and cause unsafe carbon dioxide to enter into living space Non-vented gas logs are not allowed in bedrooms because of the possibility of carbon monoxide leaking into the room.

We recommend contacting a properly licensed HVAC contractor regarding these conditions and have repairs made as deemed appropriate.

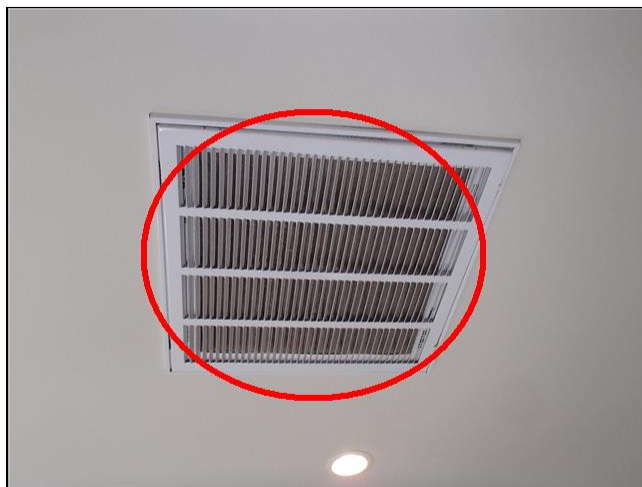
## 7.6

1. The disposable filters are dirty, these conditions restrict air flow. Item 1(Picture) The filters at all locations need replacing. (This is a maintenance item and is for your information)

We recommend contacting a qualified individual regarding these conditions and have repairs made as deemed appropriate

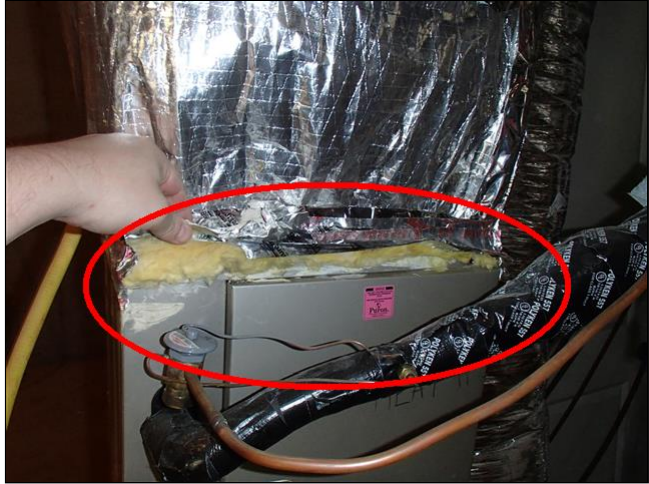
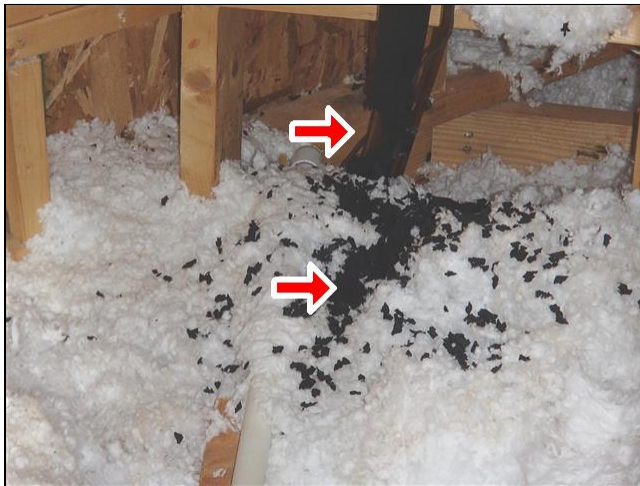
1. The evaporator coil has air leaks present at supply plenum. Item 1(Picture) Condensation and energy loss can occur as a result. Repairs are needed to prevent condensation.
2. The foam sleeve insulation on suction line has damaged insulation in the attic. Item 2(Picture) Item 3(Picture) Evidence suggest rodent/squirrel activity. The Missing foam insulation on suction line can cause energy loss and condensation. Repairs are needed to prevent condensation.

We recommend contacting a licensed HVAC contractor regarding these conditions and have repairs made as deemed appropriate.

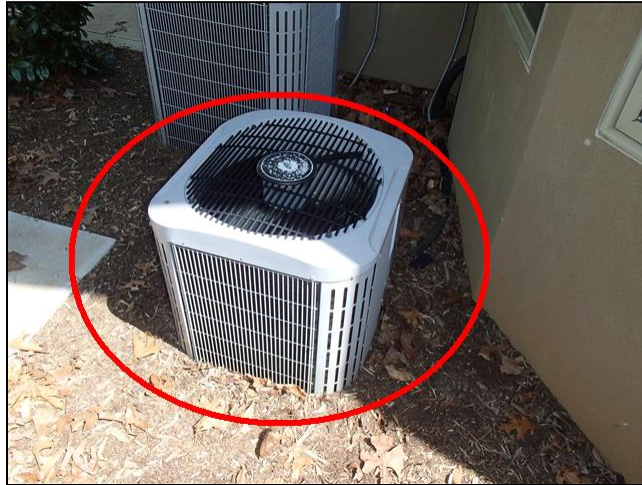
## 8.4

1. The cooling temperature split (temperature differential) across the air handler for the basement unit was below the normal operating range of 14-22 degrees. Item 1(Picture) The unit is not functioning as intended. If the cause of the problem is found to be low refrigerant, a written statement from a licensed A/C contractor should be obtained stating that the entire system has been leak tested and that no leaks are present. Further investigation by a licensed HVAC contractor is needed.

We recommend contacting a licensed heating/cooling contractor regarding these conditions and have repairs made as deemed appropriate.

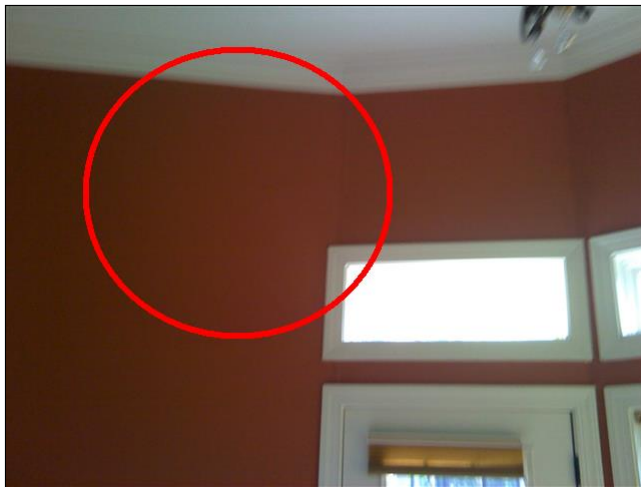
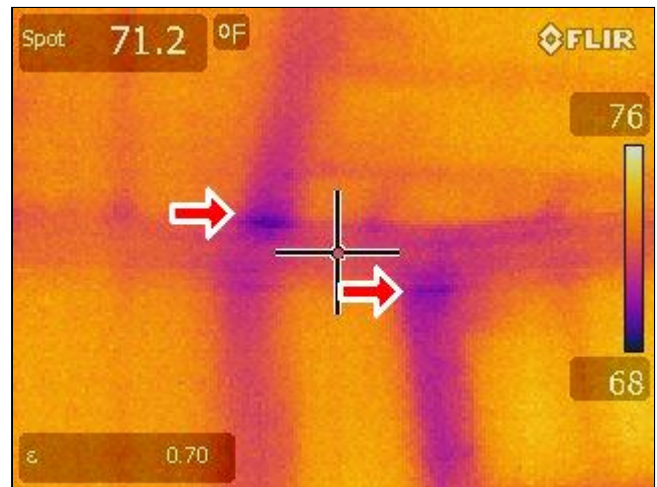
Master Bedroom

1. The Sheetrock on the ceiling reveals a water stain indicating a leak still exists at the Living Room and master Bedroom. Item 1(Picture) Item 2(Picture) Item 3(Picture) Item 4(Picture) A thermal camera was used and it indicated that the leak has not been corrected. Further investigation and repairs are needed. Due to the extent of the damage it is likely that framing damage has occurred. Coverings will likely need to be removed to uncover the extent of the damage. Further investigation and repairs are needed.
2. The sheetrock on the ceiling in the basement guest bathroom shows signs of repair. Item 5(Picture) We were unable to determine the cause of the damage.

We recommend contacting a properly licensed contractor regarding these conditions and have repairs made as deemed appropriate.

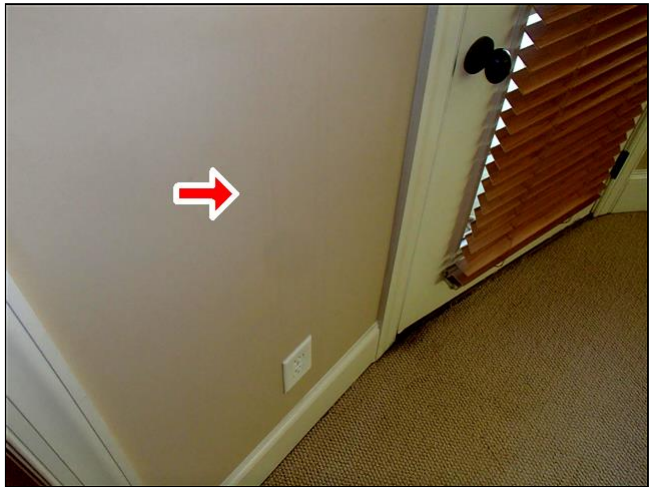
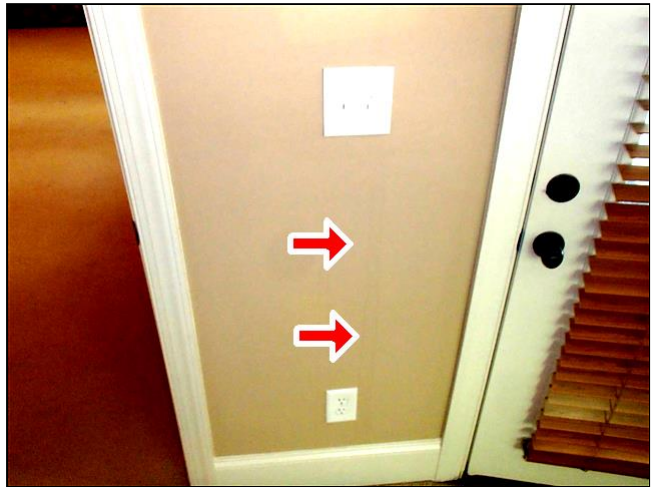
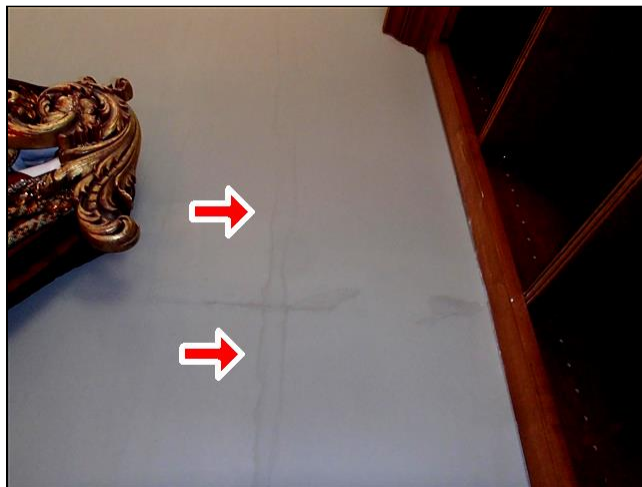
## 9.1

1. The Sheetrock on the ceiling reveals a water stain indicating a leak still exists at the basement office, Living Room and master Bedroom. Item 1(Picture) Item 2(Picture) Item 3(Picture) Further investigation and repairs are needed. Due to the extent of the damage it is likely that framing damage has occurred. Coverings will likely need to be removed to uncover the extent of the damage. Further investigation and repairs are needed.

We recommend contacting a properly licensed contractor regarding these conditions and have repairs made as deemed appropriate.

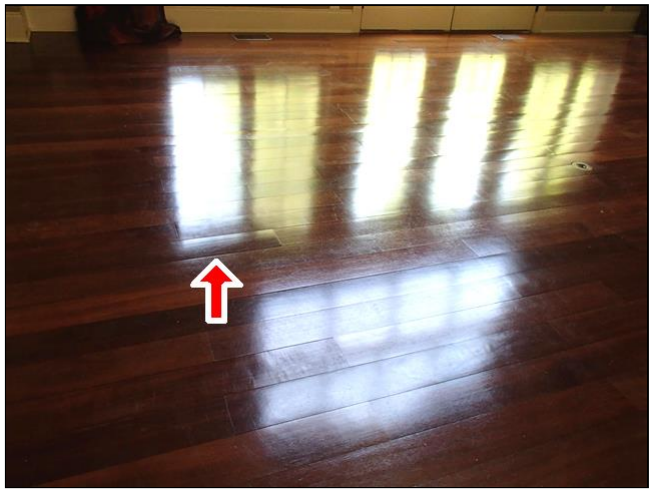
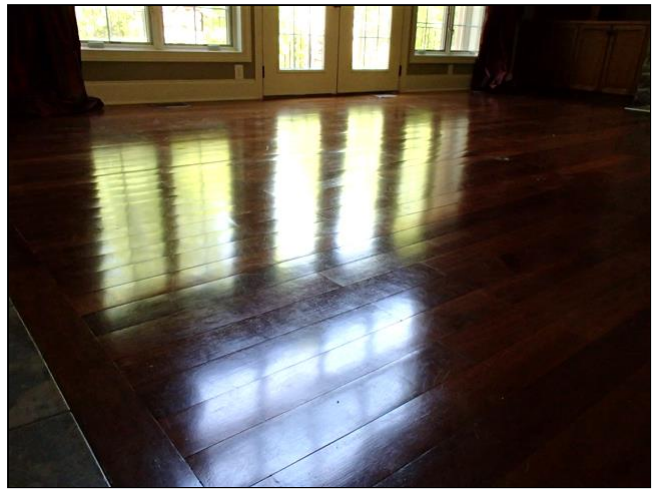
## 9.2

1. The hardwood floor in the living room shows signs of cupping. Item 1(Picture) Item 2(Picture) This is an indication of moisture. Cupping and crowning are common complaints that develop with high humidity. Both problems occur across the width of the flooring material. Cupping is when the edges of a board are higher than the center. It can occur after water spills onto the floor and is absorbed by the wood, but high humidity is more often the cause. If the wood expands significantly, compression can result as the boards are crushed together, deforming the boards at the edges. Cupping is caused by a moisture imbalance throughout the thickness of the wood: the wood is wetter on the bottom of the board than on the top. Further investigation by a licensed contractor is needed.

We recommend contacting a licensed contractor regarding these conditions and have repairs made as deemed appropriate.

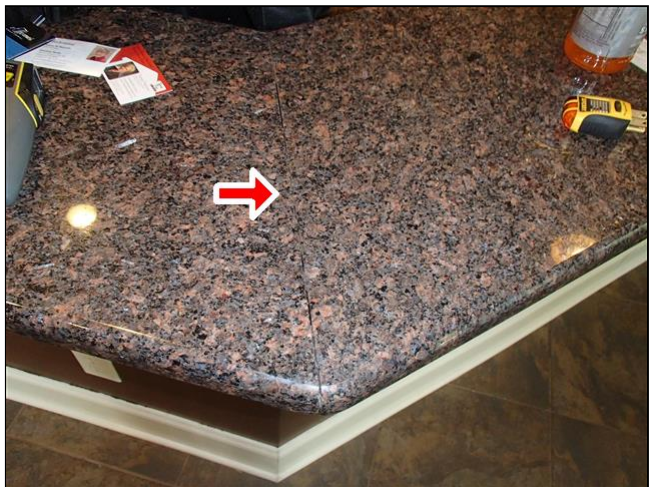
## 9.4

1. The granite countertop at the kitchen seams are coming apart. Item 1(Picture) Item 2(Picture) This is cosmetic and is for your information. Recommend repair or replace as necessary.

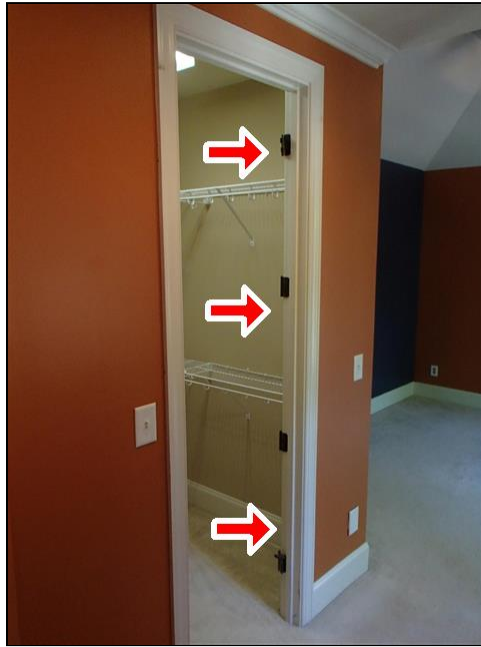
## 9.5

1. The Closet door missing at the 2nd floor front guest bedroom closet. Item 1(Picture) A replacement is needed.

We recommend contacting a properly licensed contractor regarding these conditions and have repairs made as deemed appropriate.

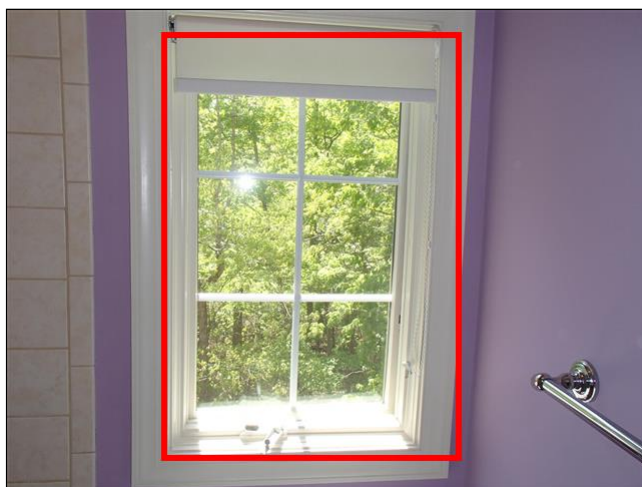
## 9.6

1. One window stuck shut at the 2nd floor rear guest bathroom. Item 1(Picture) Item 2(Picture) Repairs are needed.

We recommend contacting a licensed window technician regarding these conditions and have repairs made as deemed appropriate..

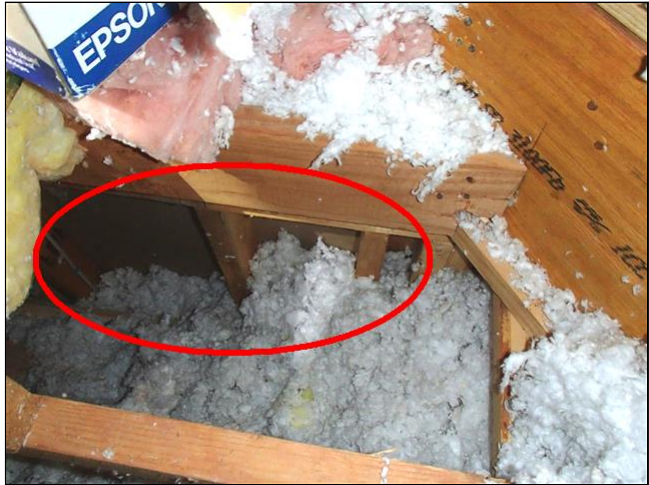
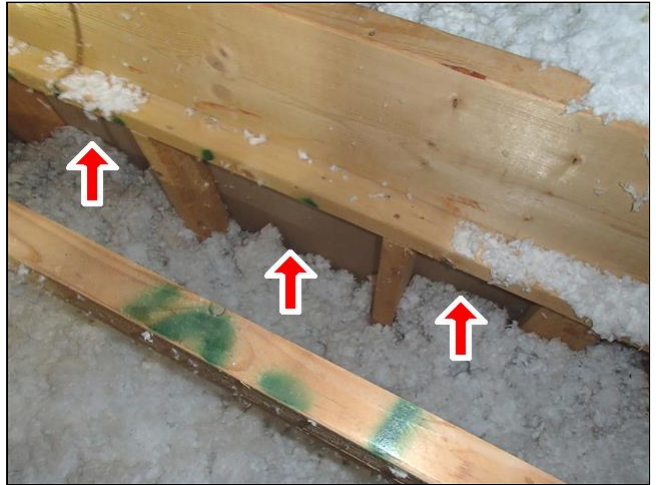
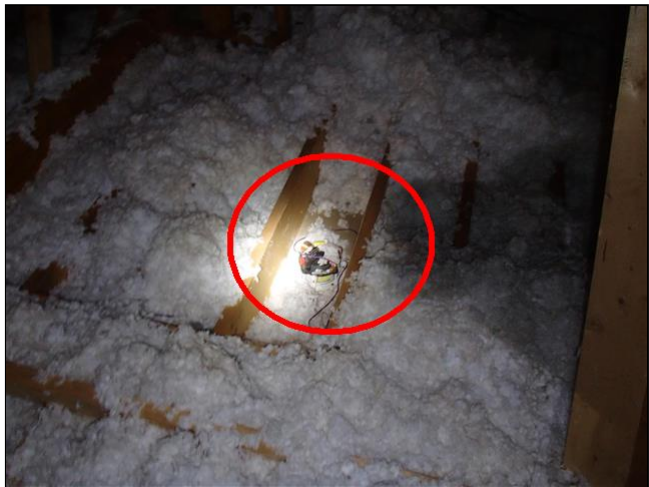
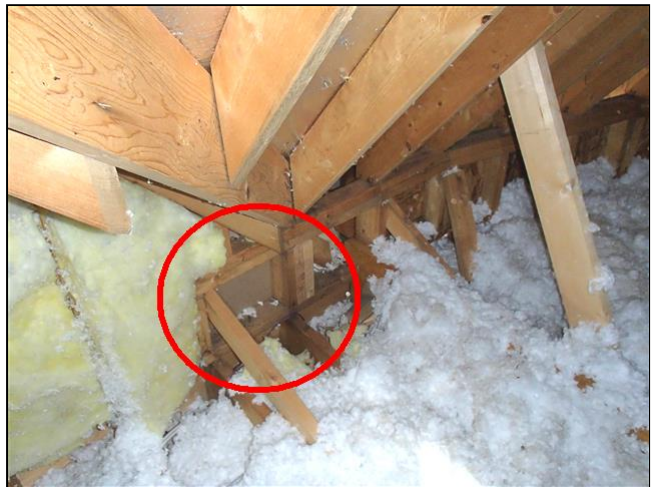
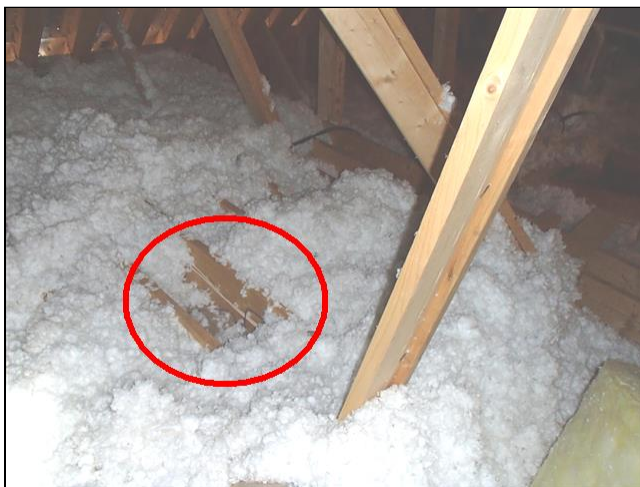
1. Fiberglass (loose-fill) insulation is compressed and missing in areas of the attic, exposed sheet rock visible in several areas. Item 1(Picture) Item 2(Picture) Item 3(Picture) Item 4(Picture) Item 5(Picture)  
Heat loss can occur more on this home than one that is properly insulated. Repairs are needed.

We recommend contacting a properly licensed contractor regarding these conditions and have repairs made as deemed appropriate.

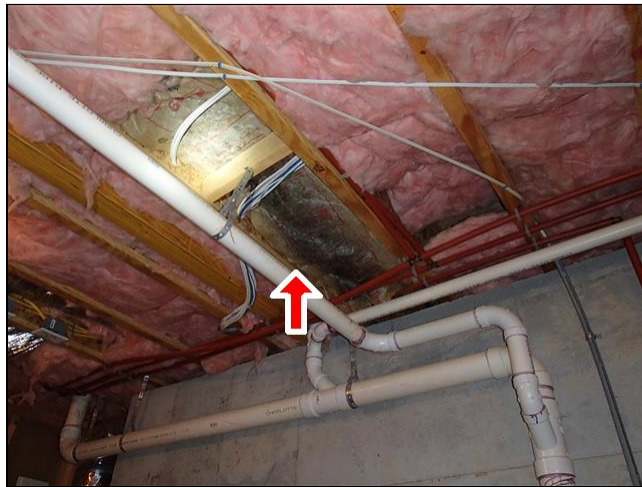
### 10.3

1. The insulation has been installed wrong side up underneath the floor system in the crawl space (Vapor Barrier Warm side up is the correct installation), this may cause adverse moisture conditions that can lead to the premature deterioration of the building components. Item 1(Picture) Repairs are needed.

We recommend contacting a licensed contractor regarding these conditions and have repairs made as deemed appropriate.

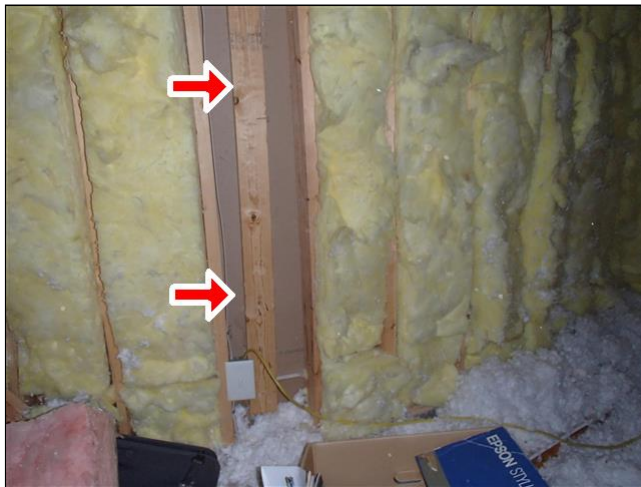
### 10.4

1. The wall insulation has fallen in areas. Item 1(Picture) Item 2(Picture) This can allow heat loss to occur. Repairs are needed.

We recommend contacting a properly licensed contractor regarding these conditions and have repairs made as deemed appropriate
