# Inspection Report

**Prepared For:**  
Sample Commercial Inspection

**Property Address:**  
Sample Inspection  
Charlotte NC

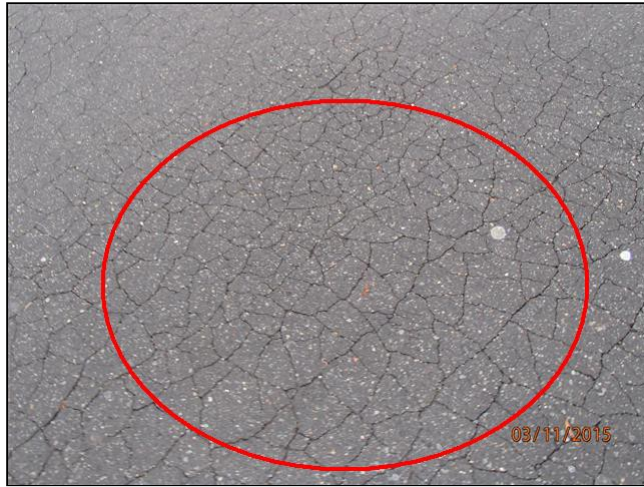
2.5 Item 3(Picture)

1. The asphalt parking surface exhibits signs of wear and aging. Several cracks and pot holes are beginning to form. Item 1(Picture) Item 2(Picture) Item 3(Picture) Item 4(Picture) After long, wet winters potholes can become a huge problem for many asphalt parking lots. they can also cause the damaged asphalt area to become much larger if left untreated and have constant traffic driving over them. Deterioration of asphalt increases more rapidly when cracks develop because more water penetrates the material and vegetation can take root. Repairs are recommended .

We recommend contacting a licensed asphalt company regarding these conditions and have repairs made as deemed appropriate

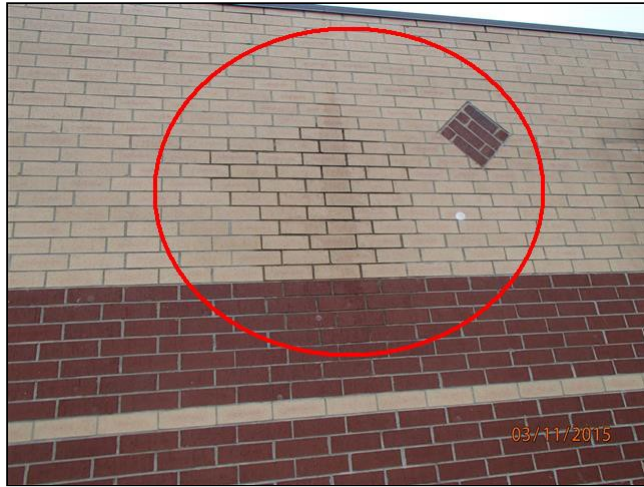
3.0 Item 3(Picture)

1. The masonry show signs of moisture intrusion from roof at front of building in areas. Item 1(Picture) Item 2(Picture) Item 3(Picture) Item 4(Picture) (SEE SECTION 4.0) Further investigation and repairs are needed.

We recommend contacting a licensed commercial roofing contractor regarding these conditions and have repairs made as deemed appropriate.

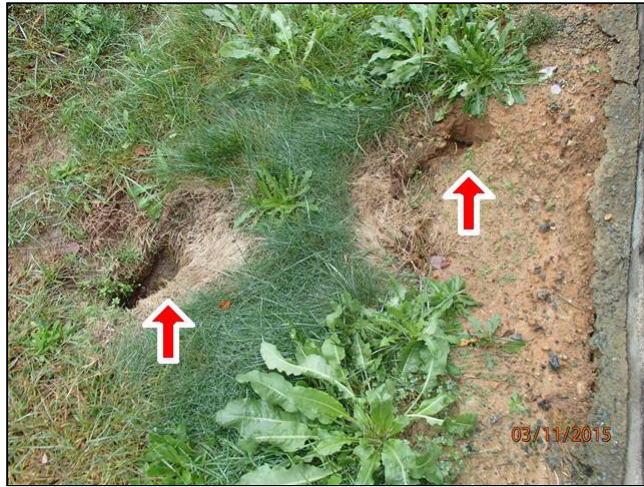
3.6 Item 3(Picture)

1. The grading at the rear of the property (behind goodwill) does not promote positive drainage away from foundation, as a result erosion is occurring. Item 1(Picture) Item 2(Picture) Item 3(Picture) Item 4(Picture) Voids in soil (possible sinkhole) are present as a result. Further deterioration will occur if not corrected. Foundation issues could occur if not corrected. Further investigation and repairs are needed.

We recommend contacting a licensed contractor regarding these conditions and have repair made as deemed appropriate.

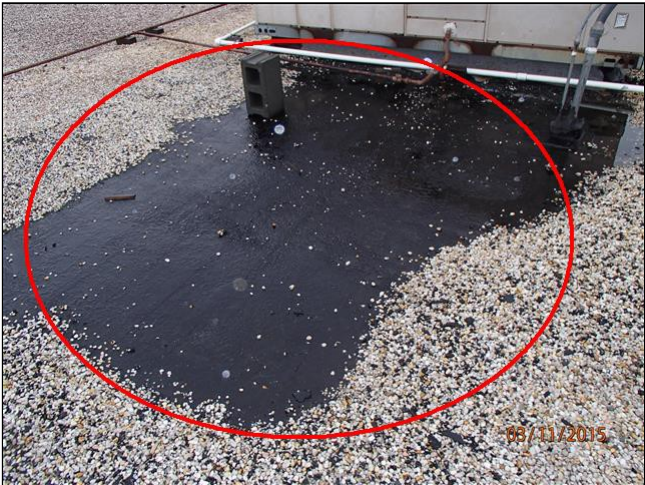
4.0 Item 2(Picture)

1. Active roof leaks are present at Suite 3710 (Goodwill). Item 1(Picture) Item 2(Picture) Item 3(Picture) The gravel on roof is missing in areas. As a result cracking is occurring this is an indication of UV damage. Item 4(Picture) Current conditions will water intrusion to occur. Evidence suggest that the gravel has been removed / pushed away from areas to try and repair roof leaks. Once roof leaks have been repaired gravel should be replaced to protect roof coverings from UV damage. Repairs are needed.

We recommend contacting a licensed commercial roofing contractor regarding these conditions for further evaluation and repair.

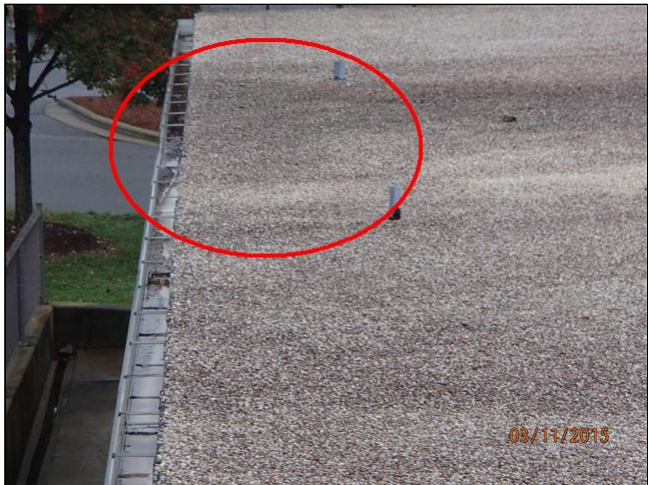
4.0 Item 5(Picture)

2. Active roof leaks are present at Suite 3710-B (Total you by Sonya D.) Item 5(Picture) Item 6(Picture) Roof leaks at rear from appeared to be from improper drainage into gutters at rear. Roof leak at center of building appeared to be from center Heat Pump location. Further investigation and repairs are needed.

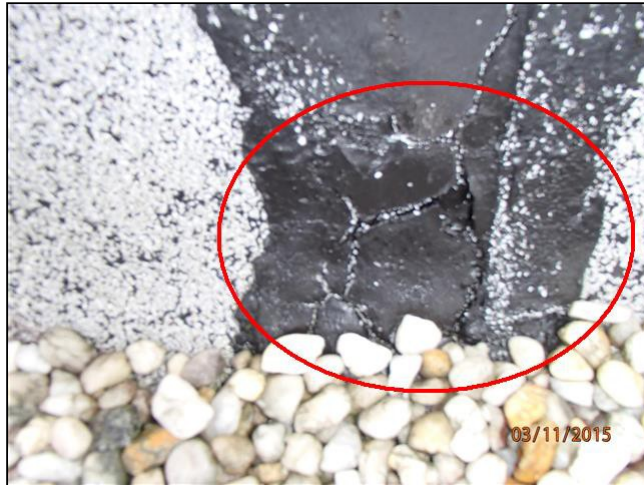
4.0 Item 7(Picture)

3. Cracking is occurring at the seams at Parapets-Where Roofs meet front walls. Item 7(Picture) Item 8(Picture) Item 9(Picture) . Visible signs of water intrusion present due to water staining on masonry side at front of building.Further investigation and repair by a licensed roofing contractor is needed.

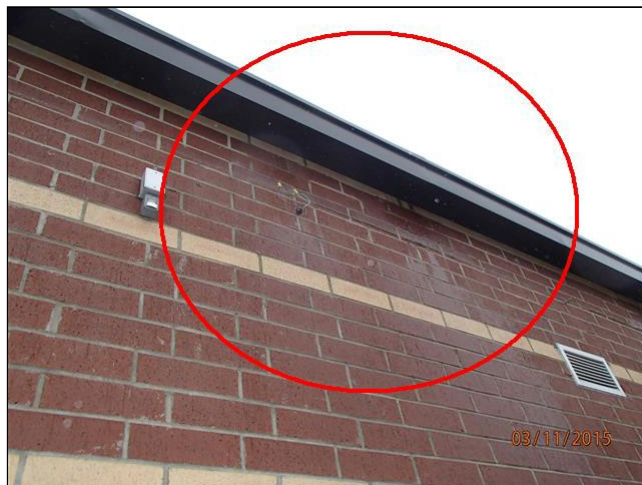
4.4 Item 2(Picture)

1. The gutter at rear of unit 3710-B not draining properly and over flowing. Item 1(Picture) Item 2(Picture) This can lead to water intrusion. Evidence of water intrusion is present. Repairs are needed.

We recommend contacting a licensed contractor regarding these conditions and have repairs made as deemed appropriate..

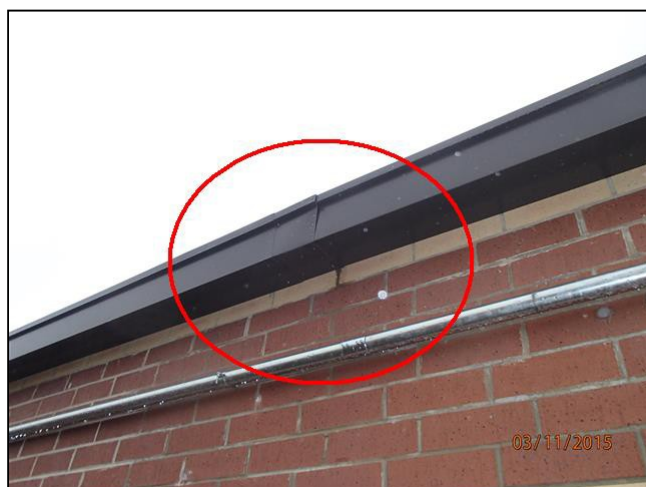
4.4 Item 3(Picture)

2. The gutter is damaged at the rear of structure leaking at seams.Item 3(Picture) Loose or leaking gutters can cause deterioration of fascia, soffit or roof edge. It can also cause gutters to pull loose and lead to possible water intrusion. Visible signs of water intrusion present at unit 3710-B. Repairs are needed.

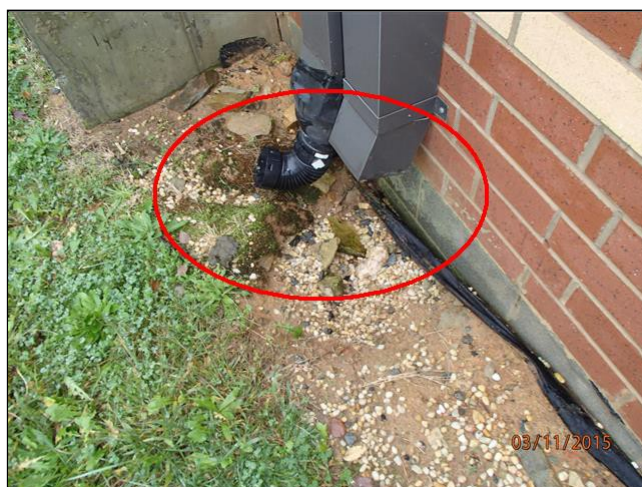
4.4 Item 4(Picture)

3. The downspout at rear of Unit 3710 (Goodwill) shows signs of erosion below downspout as extension is missing. Item 4(Picture) Erosion will continue if not corrected. This can lead to water intrusion and or foundation issues if not corrected. Repairs are needed.

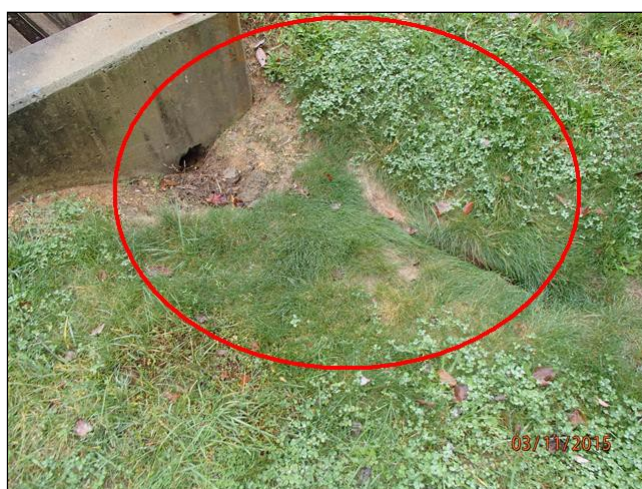
4.4 Item 6(Picture)

4. The concrete drainage trench at rear of structure appears clogged. Item 5(Picture) Item 6(Picture) Repairs are recommended.

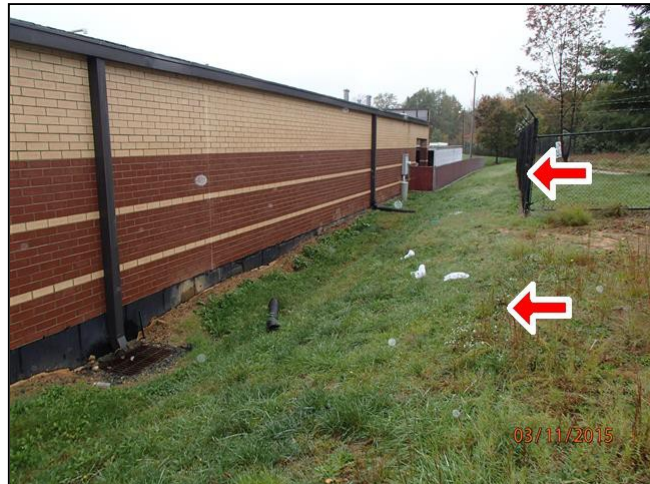
2.2 Item 2(Picture)

1. The grading at the rear of the property (behind goodwill) does not promote positive drainage away from foundation, as a result erosion is occurring. Item 1(Picture) Item 2(Picture) (SEE SECTION 3.6) Repairs are needed.

We recommend contacting a licensed contractor regarding these conditions and have repair made as deemed appropriate.

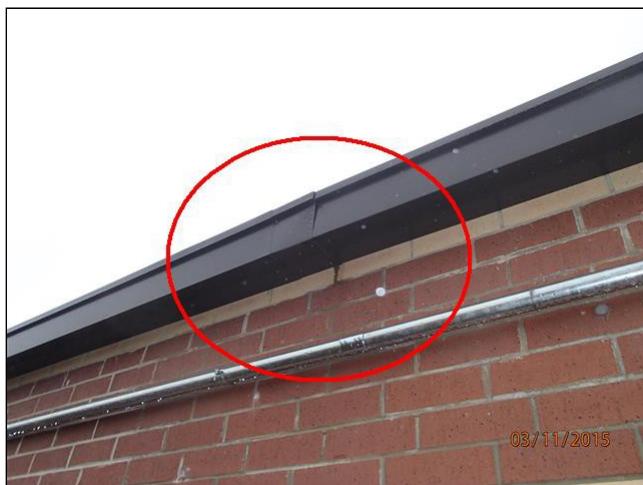
4.4 Item 3(Picture)

2. The gutter is damaged at the rear of structure leaking at seams.Item 3(Picture) Loose or leaking gutters can cause deterioration of fascia, soffit or roof edge. It can also cause gutters to pull loose and lead to possible water intrusion. Visible signs of water intrusion present at unit 3710-B. Repairs are needed.

We recommend contacting a licensed contractor regarding these conditions and have repairs made as deemed appropriate..

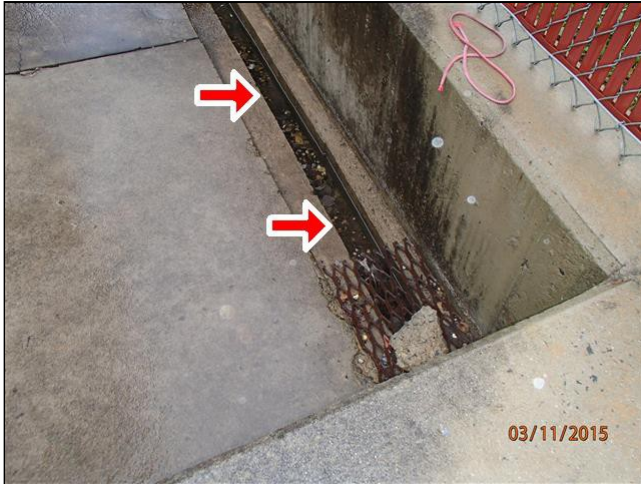
4.4 Item 5(Picture)

4. The concrete drainage trench at rear of structure appears clogged. Item 5(Picture) Item 6(Picture) Repairs are recommended.

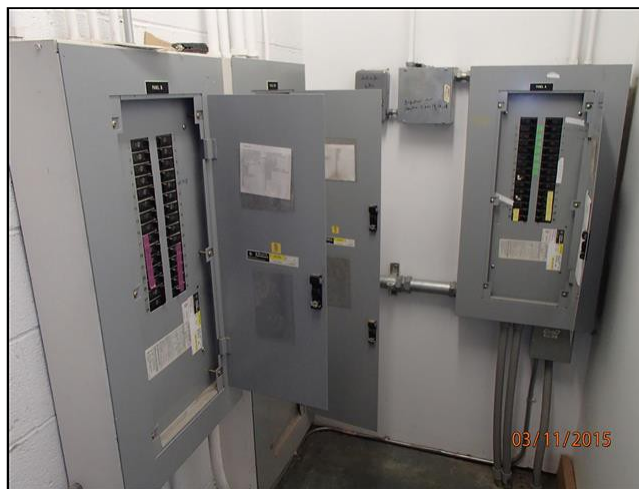
6.0 Item 3(Picture) Electrical Panels (Unit 3710 Goodwill)

1. The main panel box is located at the rear of each unit. However, the main disconnect (shut-off) is outside at meter base panel (for your information). Item 3(Picture)

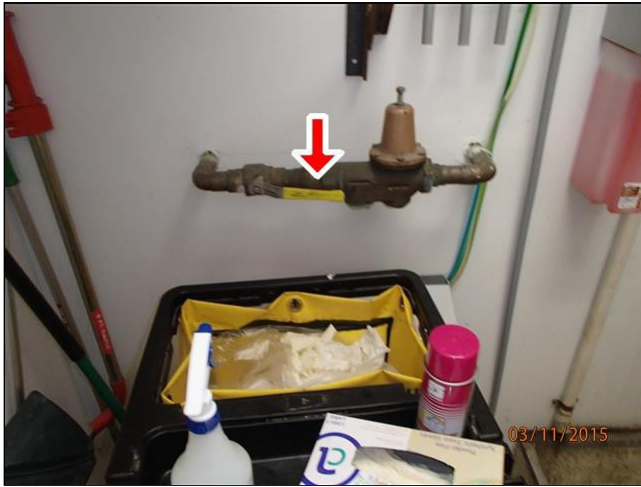
7.0 Item 1(Picture)

1. The main shut off for unit 3710 is the yellow lever located at utility / cleaning closet. Item 1(Picture) This is for your information.
2. The main shut off for unit 3710-A is the yellow lever located in ceiling above water heater. Item 2(Picture) This is for your information.
3. The main shut off for unit 3710-B is the yellow lever at rear of unit. Item 3(Picture) This is for your information.

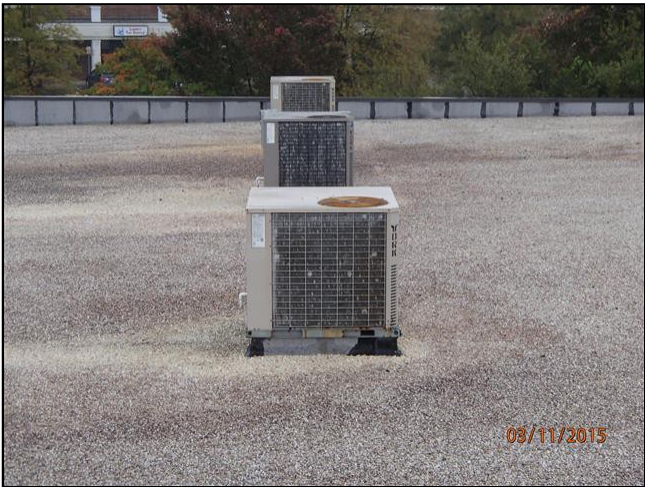
Heat Pumps (Unit 3710-B) NOT INSPECTED

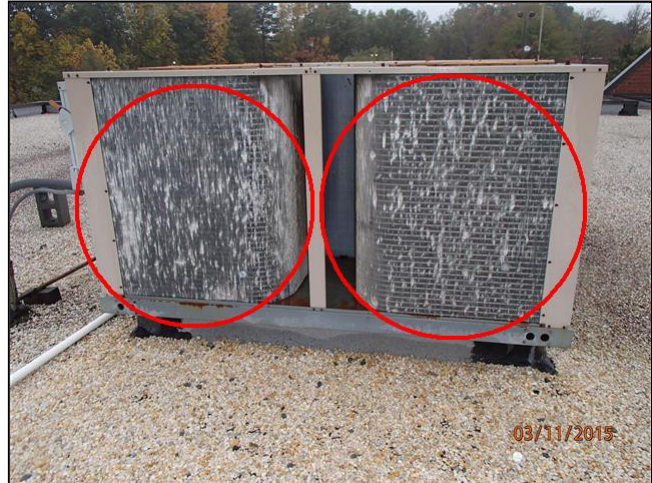
8.0 Item 2(Picture) Package Units

1. Three heat pumps and all package units show signs of hail damage to coils/fins. Item 1(Picture)  
Item 2(Picture) Further investigation is recommended.

Due to the nature of commercial HVAC systems, we recommend that an annual service contractor the a licensed commercial hvac contractor is maintained.

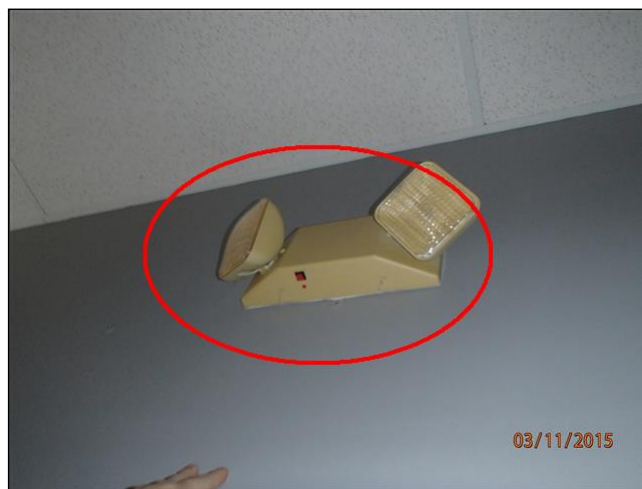
9.5 Item 2(Picture)

1. The emergency lighting throughout the units were damaged and would not operate when tested. Item 1(Picture) Item 2(Picture) (Safety Issue) Repairs are needed.

We recommend contacting a licensed contractor regarding these conditions and have repairs made as deemed appropriate.

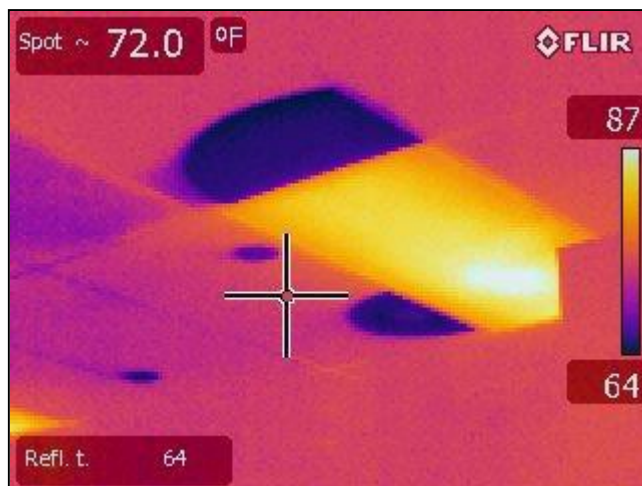
10.0 Item 2(Picture)

- Active water intrusion is occurring at unit 3710 (Goodwill). Item 1(Picture) Item 2(Picture) A thermal camera indicated that active leaks are present. Further investigation and repairs are needed.

We recommend contacting a licensed commercial roofing contractor and or licensed commercial HVAC regarding these conditions and have repairs made as deemed appropriate.

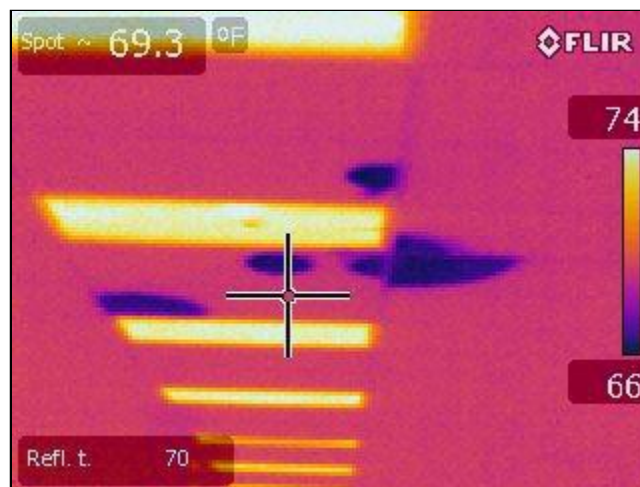
12.0 Item 3(Picture)

1. Active roof leaks present at center and rear of unit 3710-B. Item 1(Picture) Item 2(Picture) Item 3(Picture) (See Section 4.0) A thermal camera indicated that active leaks are present. Further investigation and repairs are needed.

We recommend contacting a licensed commercial roofing contractor and or licensed commercial HVAC regarding these conditions and have repairs made as deemed appropriate.

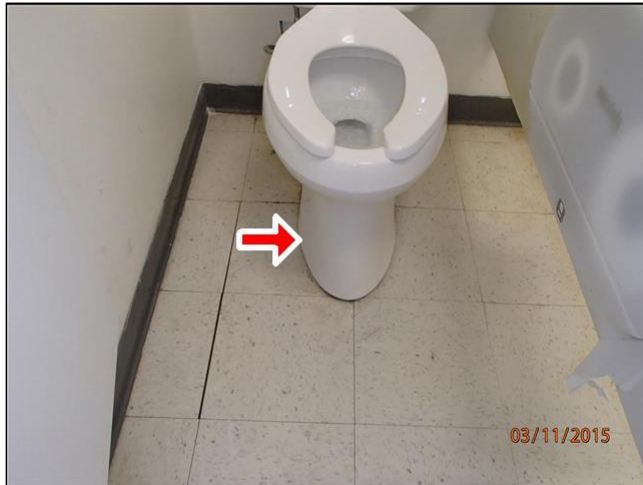
13.6 Item 1(Picture)

1. The Men's bathroom for toilet's for unit 3710 (Goodwill) not flush with floor and are loose. Item 1(Picture) Item 2(Picture) Excessive gaps due to shims present. This can damage the toilet. Repairs may involve re-setting the toilet on a new wax seal.

We recommend contacting
