Table of Contents

**AHI Residential & Commercial Inspections, Inc**

Sample Commercial

123 Sample Inspection Rd  
Sample City NC

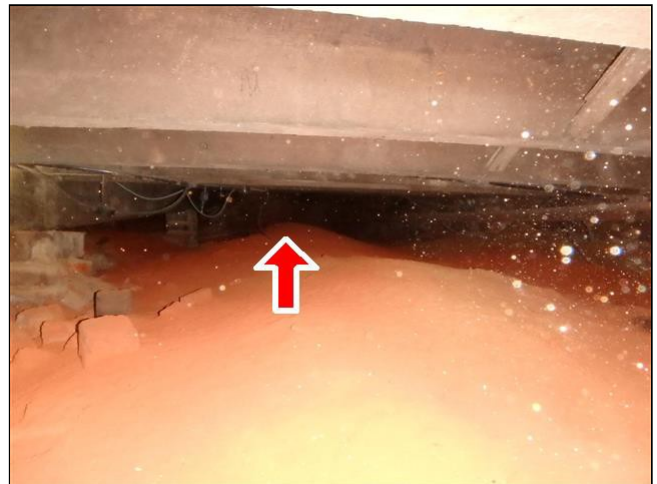
1.5 Item 2(Picture)

1. The clearance is limited at the front of building and left side due to low clearance issues. Item 1(Picture) Item 2(Picture) Item 3(Picture) Item 4(Picture) As a result we could not crawl this location. These areas were not inspected as a result. Hidden damage may be present. Further investigation is recommended.

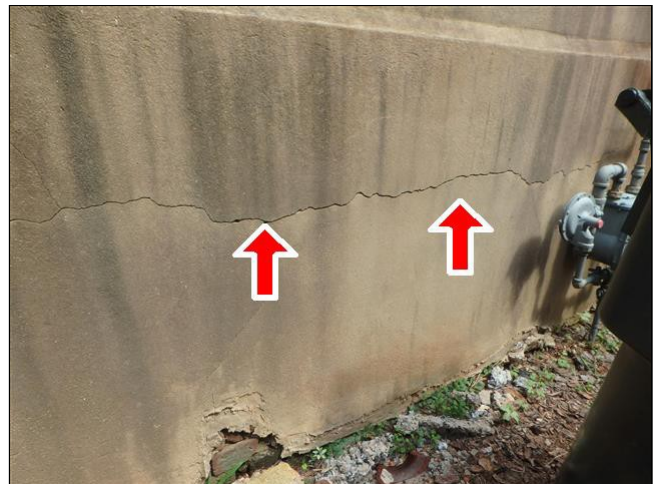
3.0 Item 2(Picture)

1. Hairline cracking is the masonry stucco coating present at front. Item 1(Picture) This is an indication of moisture behind coating. Repairs are recommended.
2. 1/4 cracking is the masonry stucco coating present at rear of building. Item 2(Picture) This is an indication of past movement. Repairs are recommended.

We recommend contacting a licensed contractor regarding these conditions and have repairs made as deemed appropriate.

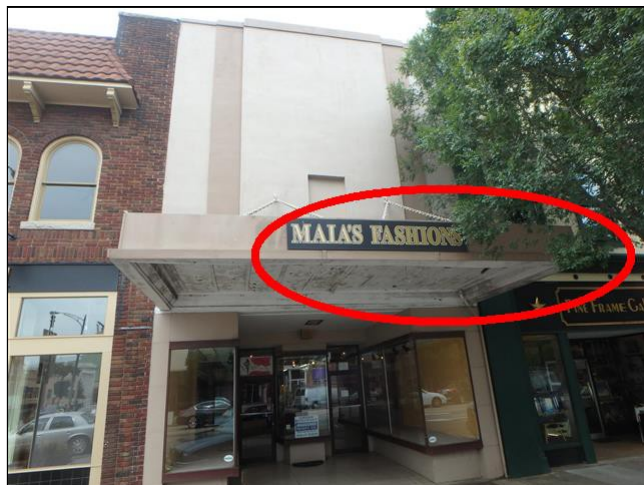
3.2 Item 2(Picture)

1. The canopy on the front of building shows signs of improper and framing damage present as result. Item 1(Picture) Item 2(Picture) Item 3(Picture) Item 4(Picture) Item 5(Picture) Visible signs of water damage is present at interior of building indicate that general replacement is likely.

Repairs are needed.

We recommend contacting a licensed contractor for complete evaluation of canopy and have repairs made as deemed appropriate..

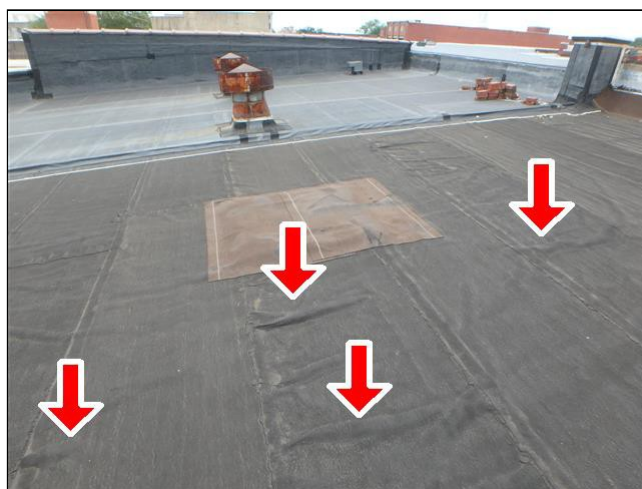
4.0 Item 2(Picture)

2. Blistering present. Item 2(Picture) Item 3(Picture) Blisters form when there are pockets of air or moisture trapped between layers of your roof's membrane or between the membrane and the roof deck. As the sun heats the roof, those pockets expand and stretch the membrane. In severe cases, the membrane will actually crack when the pressure becomes too great. Repairs are needed.

We recommend contacting a licensed commercial roofing company to evaluate entire roof and have repairs made as deemed appropriate.

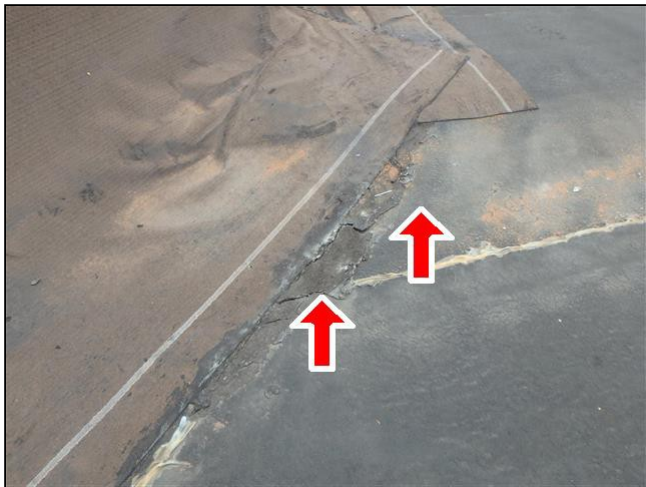
4.0 Item 3(Picture)

3. The roof seams are aged and cracked. Item 3(Picture) Item 4(Picture) Item 5(Picture)Item 6(Picture) Improper repair of seams present due to the use of caulking. Item 7(Picture) This can allow roof leaks to occur. Repairs are needed.

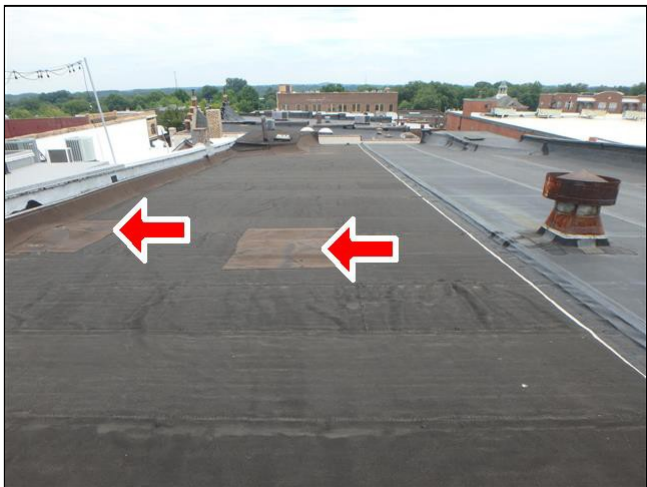
4.0 Item 8(Picture)

4. Multiple patches present. Item 8(Picture) Patching should be considered a temporary solution. Repairs are needed.
5. The Parapet walls at front of building has cracking present. Item 9(Picture) This will allow water intrusion to occur. Repairs are needed.

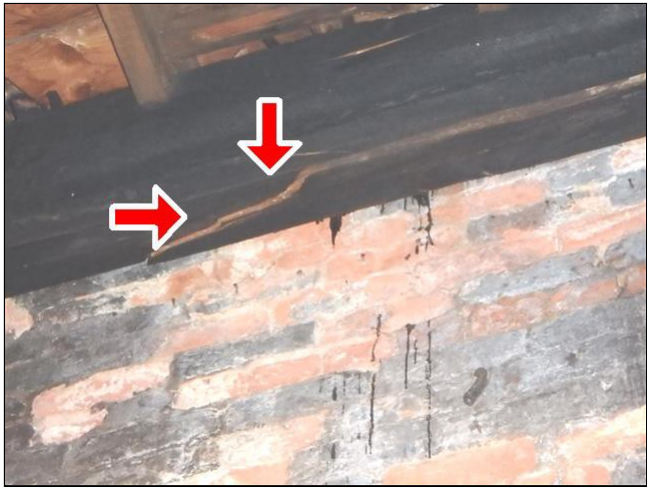
4.5 Item 2(Picture)

1. Rafters and sheathing inside attic indicates evidence of a previous fire. Item 1(Picture) Item 2(Picture) Item 3(Picture) The rear support beam is split/cracked near center of roof line. No signs of repairs to beam are present. Structural failure could occur if not addressed. Repairs are needed.
2. Visible signs of water intrusion in the attic are present from water stains on wood slats in numerous areas. Item 4(Picture) Item 5(Picture) Item 6(Picture) Due to recent weather conditions we were unable to determine if leaks are active. Please note: children's plastic pool present to likely catch water is present. Item 7(Picture) Further investigation is needed.

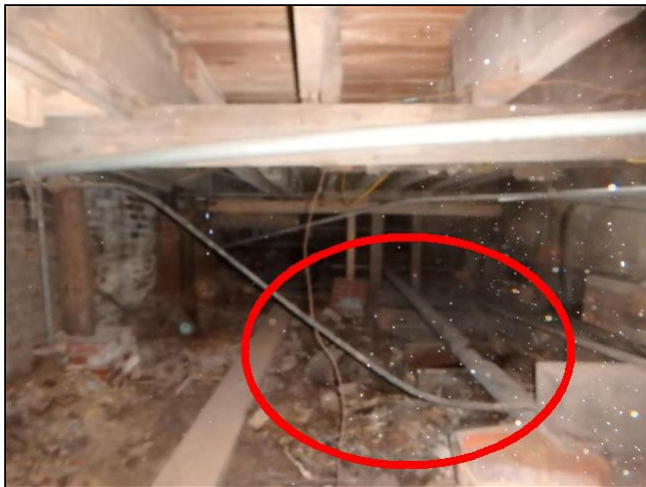
5.8 Item 1(Picture)

1. Wood debris is in contact with the crawl space dirt floor in numerous areas throughout the crawl space. Item 1(Picture) Item 2(Picture) Item3(Picture) Item 4(Picture) Item 5(Picture) Item 6(Picture) Item 7(Picture) This can attract wood destroying organism. Evidence of past or present termite activity is present. Removal is needed.

We recommend contacting a licensed contractor regarding these conditions and have repairs made as deemed appropriate.

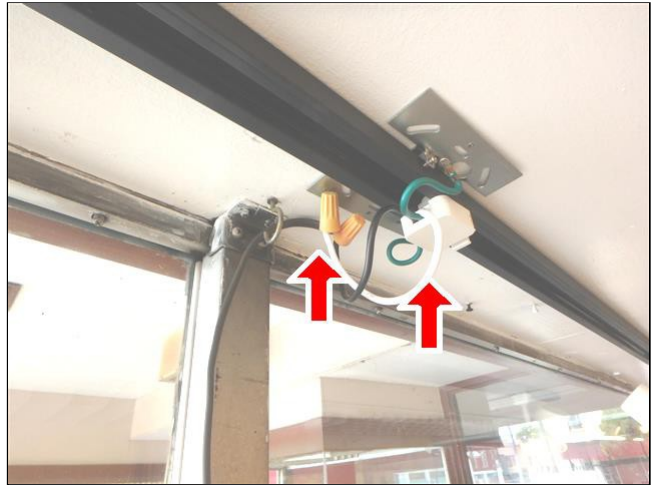
6.4 Item 2(Picture) Exposed Branch Wiring.

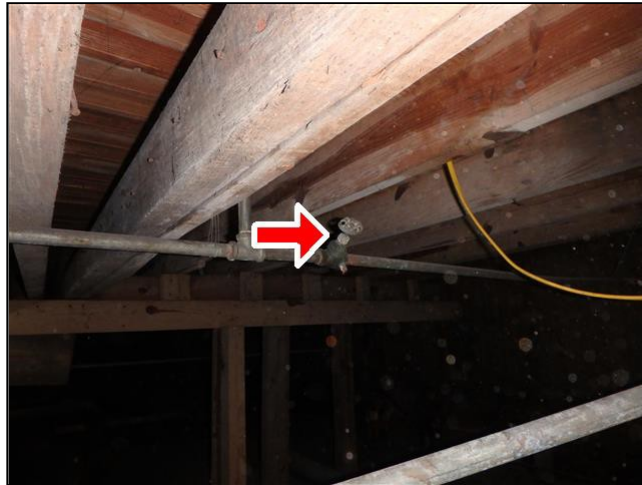
7.0 Item 1(Picture)

The main shut off is the silver knob located underneath in the crawlspace. Item 1(Picture) This is for your information.

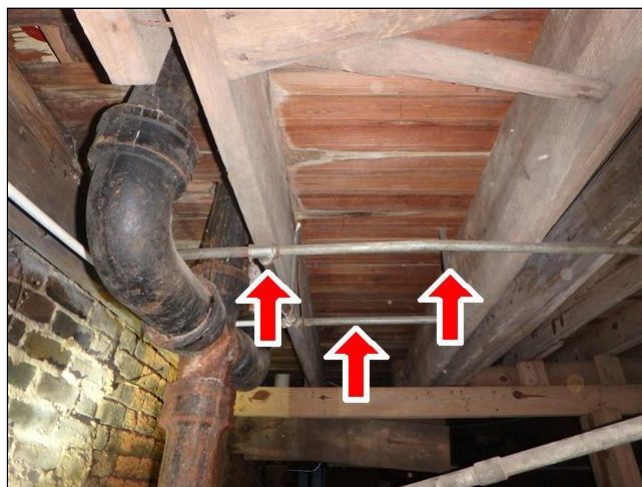
7.3 Item 2(Picture)

1. The hot and cold galvanized main water and supply lines throughout the building has rust present in water supply. Item 1(Picture) Item 2(Picture) General replacement of the galvanized supply piping throughout the building is likely do the conditions present as the water pressure over-all is poor and would not pass "functional flow." Item 1(Picture) The reason for weak volume or pressure is old galvanized piping that is corroded inside. Repairs are needed.

We recommend contacting a licensed plumber regarding these conditions and have the entire plumbing supply and distribution system evaluated and have repairs/replacements made as deemed appropriate

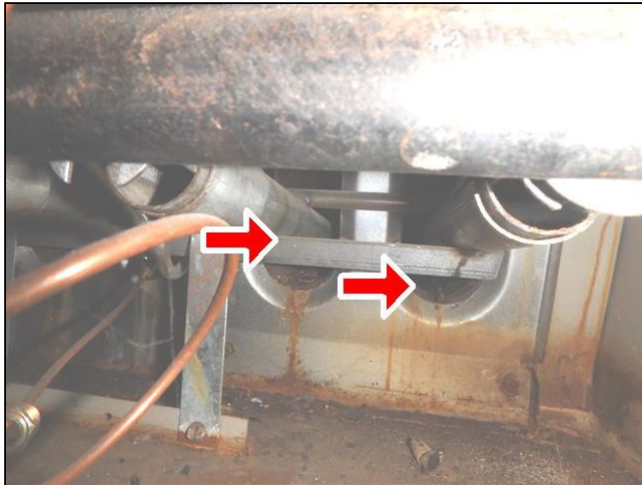
8.0 Item 3(Picture)

1. The furnace combustion chamber shows is rusted with rust particles and flakes on the burners and at the bottom of the chambers. Item 1(Picture) Item 2(Picture) Item 3(Picture) Item 4(Picture)  
This is a typical sign of a possibly failed heating system / heat exchanger. General replacement of furnace likely due to age and condition.
2. The ignitor for the gas furnace is not installed properly. Item 5(Picture)

We recommend contacting a properly licensed (HVAC) heating and air contractor regarding these conditions and have repairs made as deemed appropriate

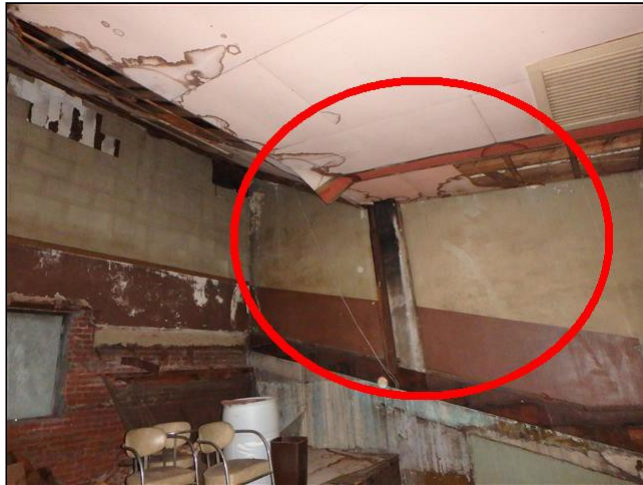
10.0 Item 3(Picture)

1. The ceiling tile on the ceiling reveals a water stain indicating a leak did or still exists at the interior and both upper and lower ceilings. Item 1(Picture) Item 2(Picture) Item 3(Picture) Item 4(Picture) Due to recent dry weather, we are unable to determine if the leak still exists. Further investigation is needed.

We recommend contacting a licensed roofing contractor regarding these conditions and have repairs made as deemed appropriate..

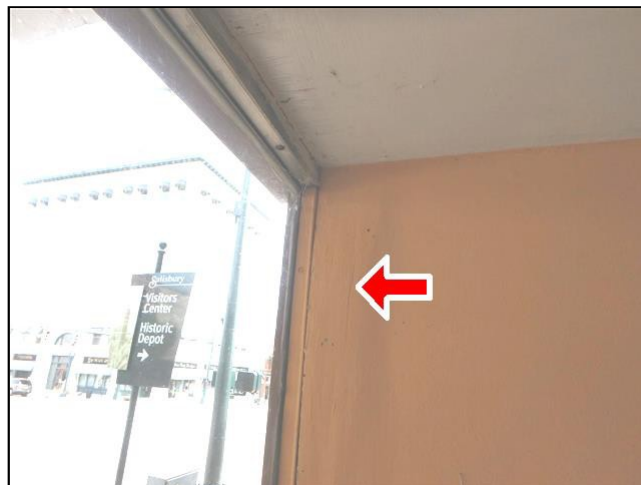
10.1 Item 3(Picture)

1. The paneling on the wall shows wet stains indicating moisture or intrusion did or still may occur at the front of store. Item 1(Picture) Item 2(Picture) Item 3(Picture) Due to recent dry weather, we are unable to determine if the leak still exists. Further investigation is needed.

We recommend contacting a roofing contractor regarding these conditions and have repairs made as deemed appropriate..

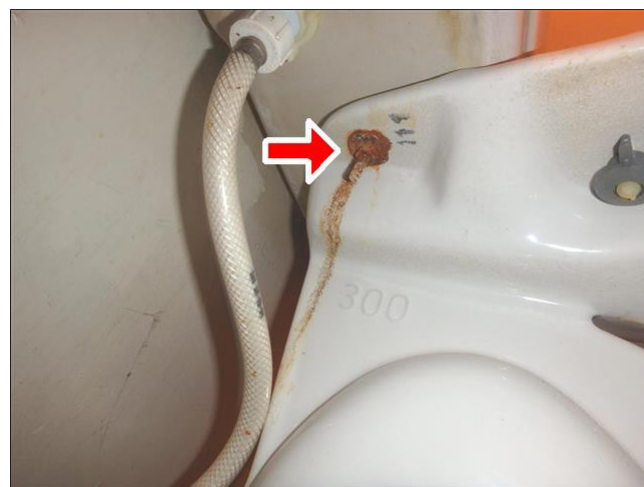
11.5 Item 2(Picture)

1. The toilet tank lid is missing at the right side 1/2 bath. Repairs are needed.
2. The toilet tank at the right side half bath has active leaks at bolts. Item 2(Picture) Repairs are needed to prevent water damage to structure.
3. The toilet will not flush at the right side half bathroom. Item 3(Picture) The Flush Valve, Flapper & or Tank Lever likely need replacing. Repairs are needed.
4. Both half bathroom sink stopper is missing or does not function as intended. Item 4(Picture) Item 5(Picture) A Repair or Replacement is needed.
5. The toilet tank at the right side half bath has active leaks at bolts. Item 6(Picture) Repairs are needed to prevent water damage to structure

We recommend contacting a qualified licensed plumber regarding these conditions and have repairs made as deemed appropriate..

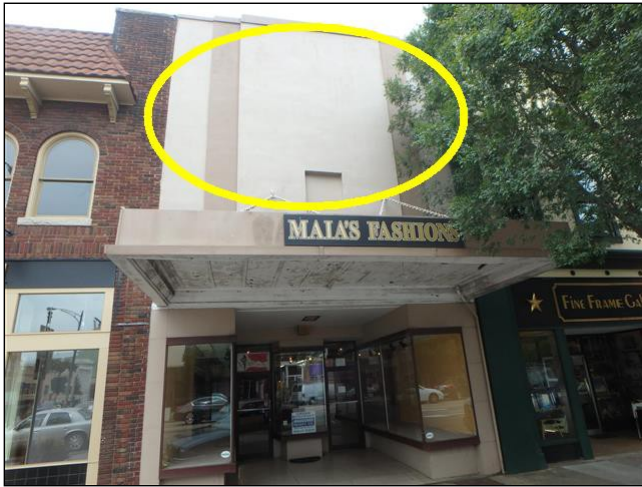
3.0 Item 1(Picture)

1. Hairline cracking is the masonry stucco coating present at front. Item 1(Picture) This is an indication of moisture behind coating. Repairs are recommended.
2. 1/4 cracking is the masonry stucco coating present at rear of building. Item 2(Picture) This is an indication of past movement. Repairs are recommended.

We recommend contacting a licensed contractor regarding these conditions and have repairs made as deemed appropriate.

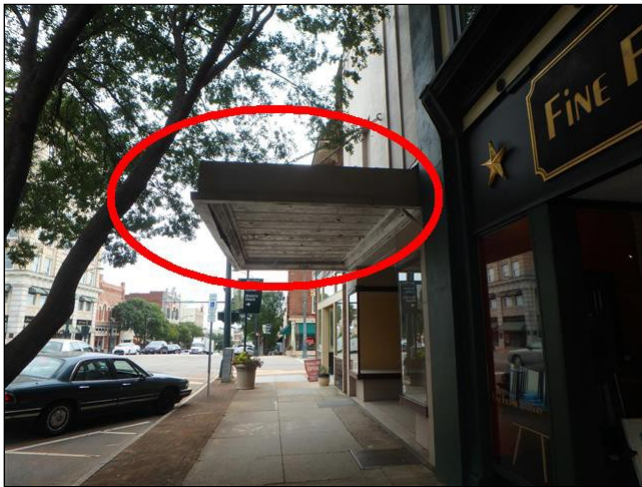
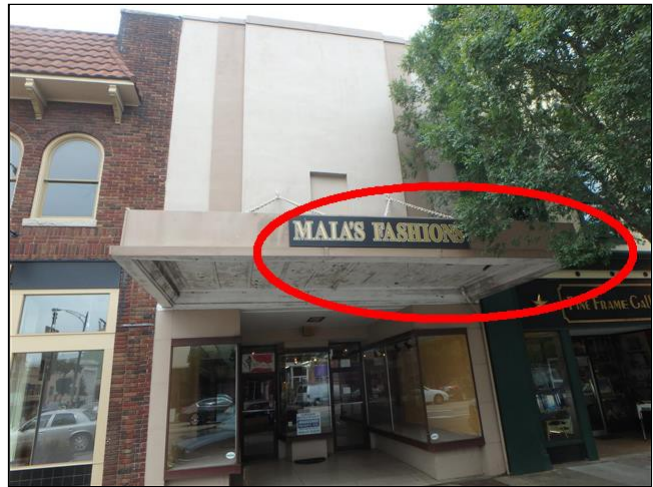
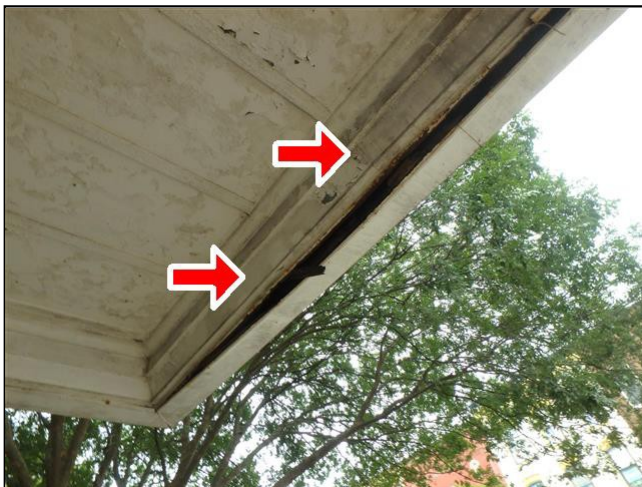
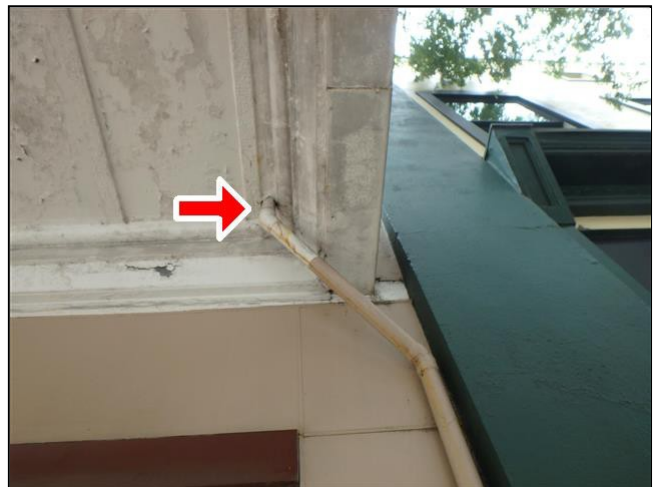
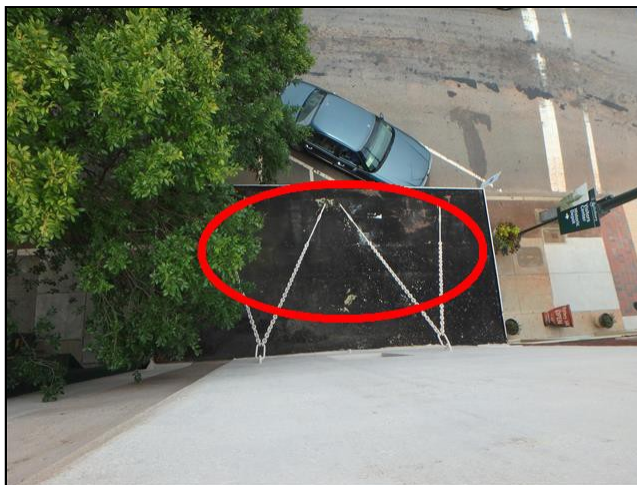
1. The canopy on the front of building shows signs of improper and framing damage present as result. Item 1(Picture) Item 2(Picture) Item 3(Picture) Item 4(Picture) Item 5(Picture) Visible signs of water damage is present at interior of building indicate that general replacement is likely. Repairs are needed.

We recommend contacting a licensed contractor for complete evaluation of canopy and have repairs made as deemed appropriate..

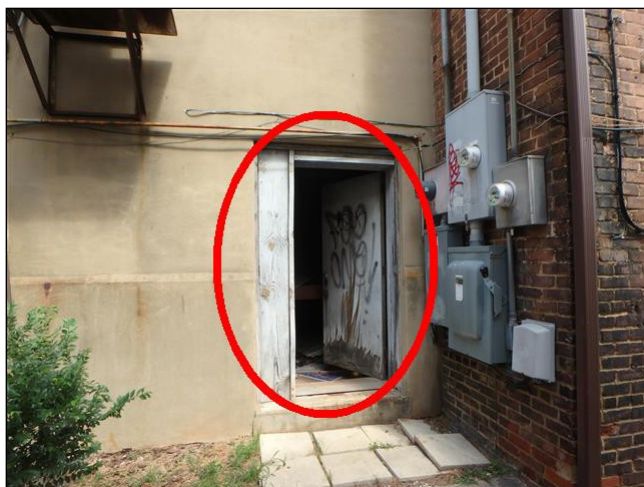
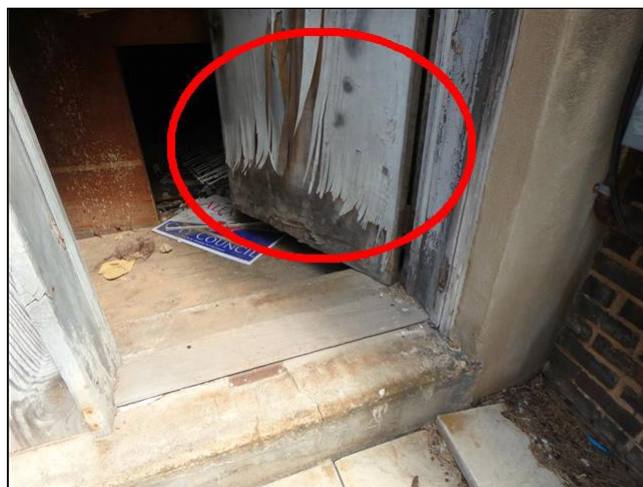
1. The entry door at rear of building is delaminating and has water damage present. Item 1(Picture) Item 2(Picture) Further deterioration may occur if not repaired. Repairs are needed.

We recommend contacting a licensed contractor regarding these conditions and have repairs made as deemed appropriate..

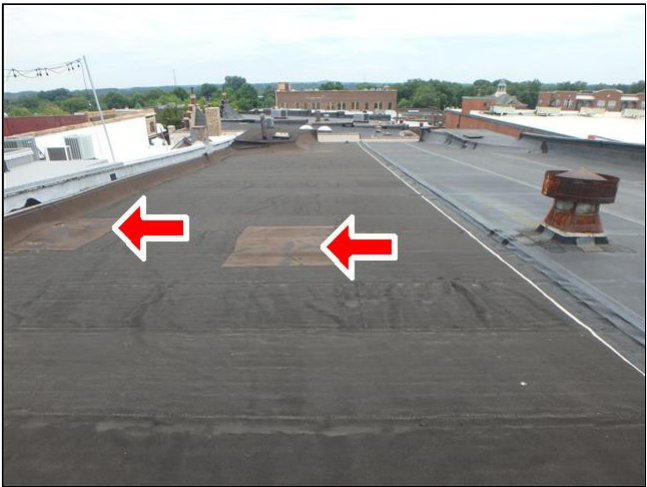
4.0 Item 8(Picture)

4. Multiple patches present. Item 8(Picture) Patching should be considered a temporary solution. Repairs are needed.
5. The Parapet walls at front of building has cracking present. Item 9(Picture) This will allow water intrusion to occur. Repairs are needed.

We recommend contacting a licensed commercial roofing company to evaluate entire roof and have repairs made as deemed appropriate.

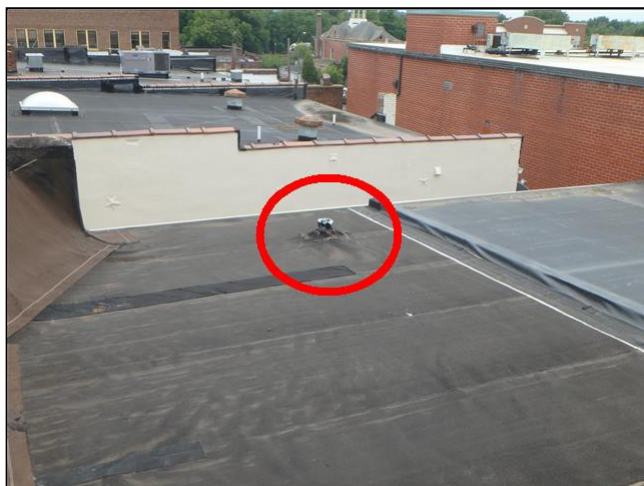
4.2 Item 1(Picture)

1. The (through roof) plumbing vent pipes need to have their flashings/boots repaired/replaced. Item 1(Picture) Split, damage and or uplifted boots will allow water to penetrate into the roof framing/sheathing system and cause moisture damage. Thermal camera and water stains to roof sheathing indicated that active leaks is present. Item 2(Picture) Repairs are needed.

We recommend contacting a licensed commercial roofing company to evaluate entire roof and have repairs made as deemed appropriate.

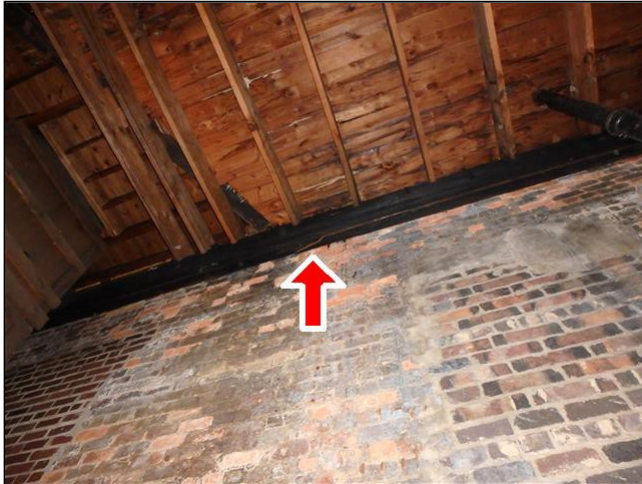
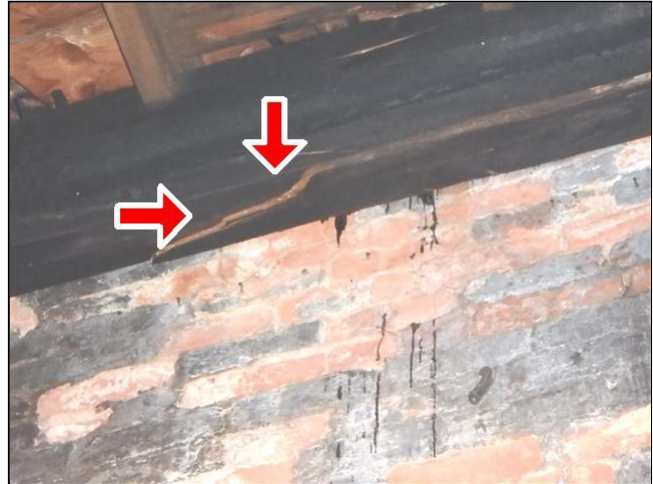
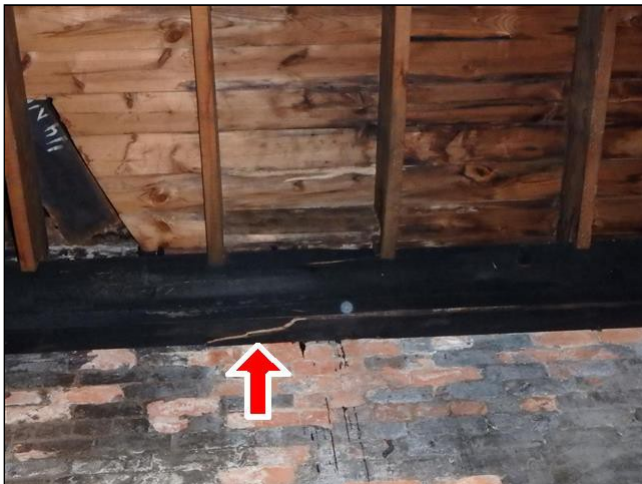
1. Rafters and sheathing inside attic indicates evidence of a previous fire. Item 1(Picture) Item 2(Picture) Item 3(Picture) The rear support beam is split/cracked near center of roof line. No signs of repairs to beam are present. Structural failure could occur if not addressed. Repairs are needed.
2. Visible signs of water intrusion in the attic are present from water stains on wood slats in numerous areas. Item 4(Picture) Item 5(Picture) Item 6(Picture) Due to recent weather

We recommend contacting a nc licensed commercial contractor regarding these conditions and have repairs made as deemed appropriate.

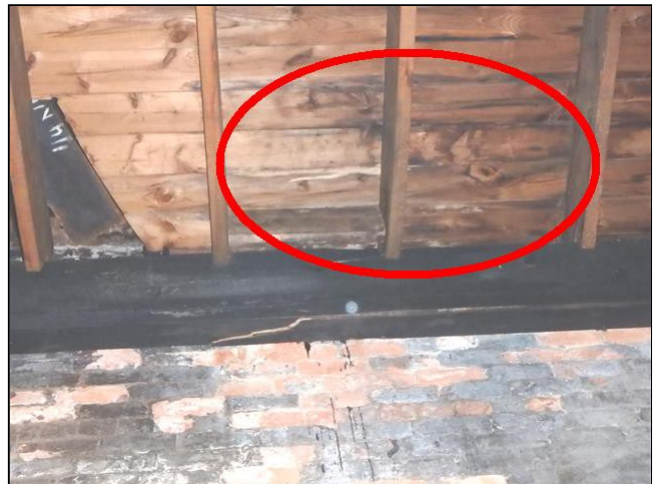
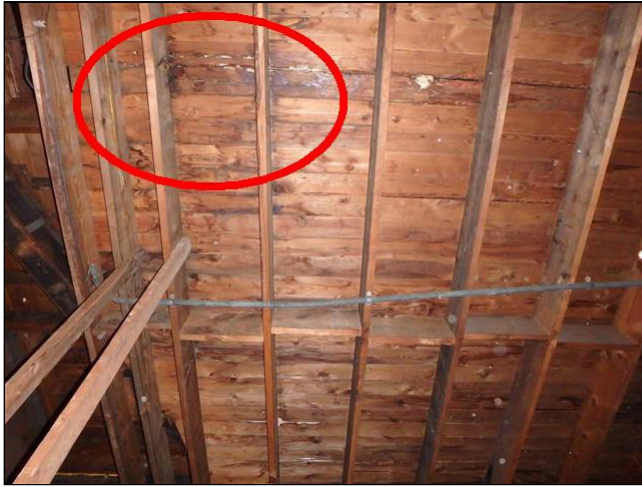
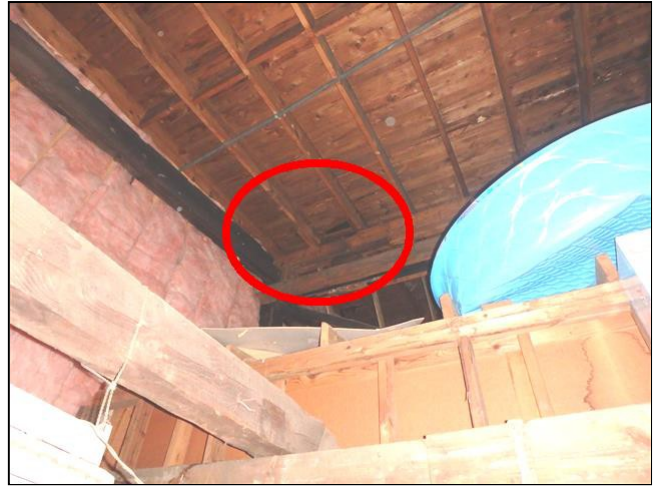
conditions we were unable to determine if leaks are active. Please note: children's plastic pool present to likely catch water is present. Item 7(Picture) Further investigation is needed.

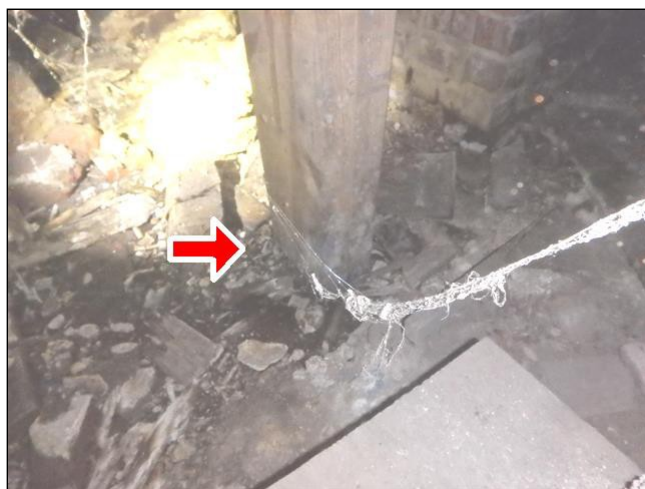
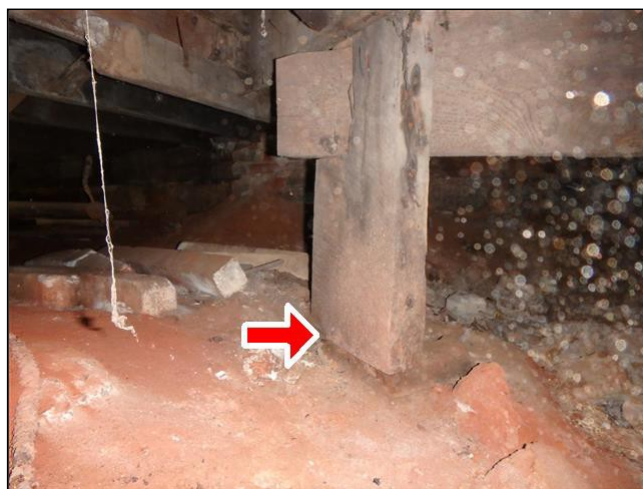
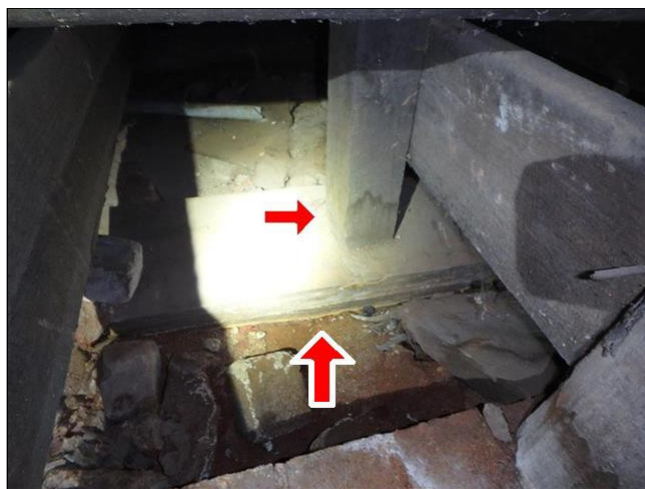
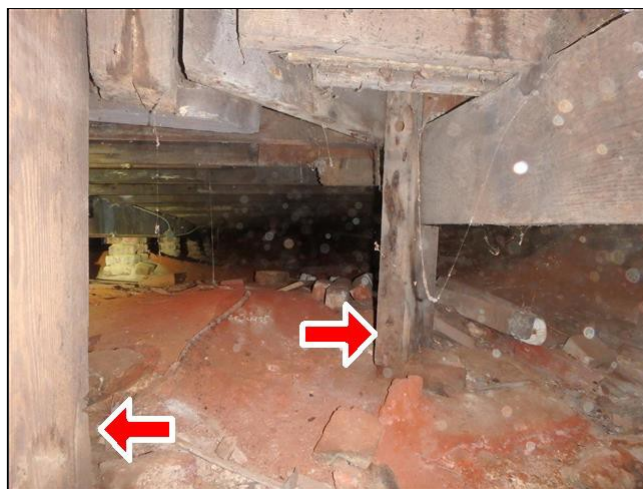
1. The wood supports in contact with crawl space dirt floor as a result deterioration is present. Item 1(Picture) Item 2(Picture) Item 3(Picture) Item 4(Picture) Wood to soil contact is not recommended as the can allow wood destroying insect activity and deterioration to occur. Best practice is to use masonry piers set on concrete footings. Further evaluation and repairs are needed.

A licensed general contractor should be consulted to determine the extent of the damage and necessary repairs.

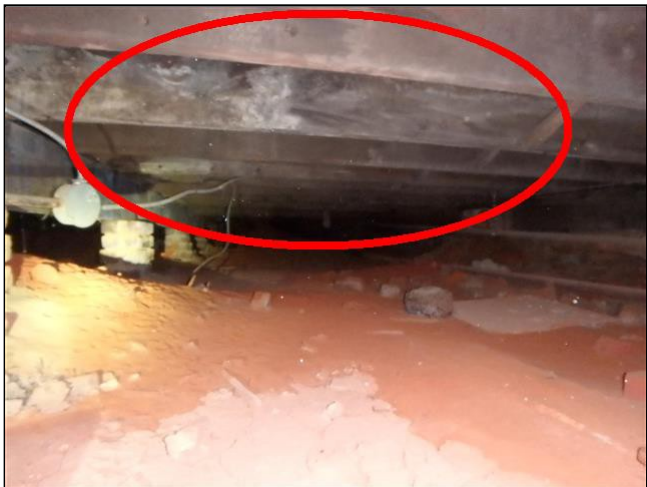
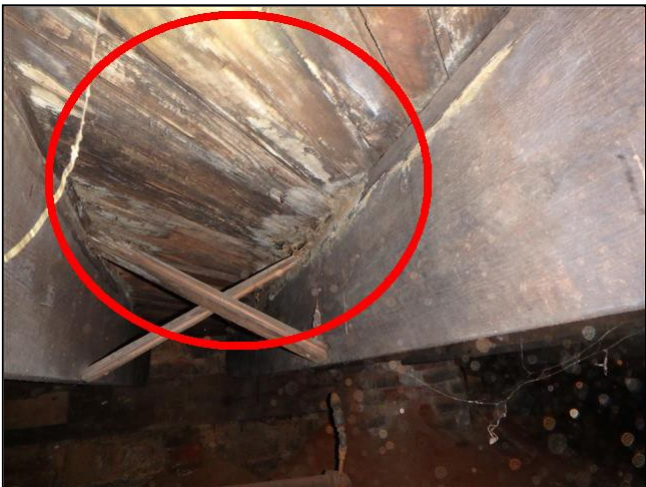
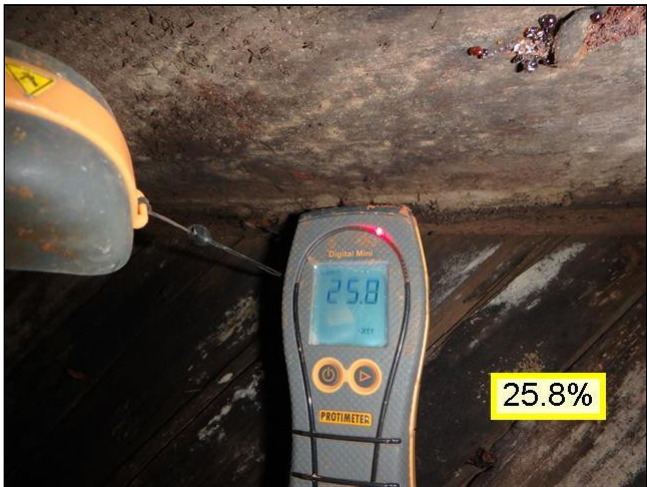
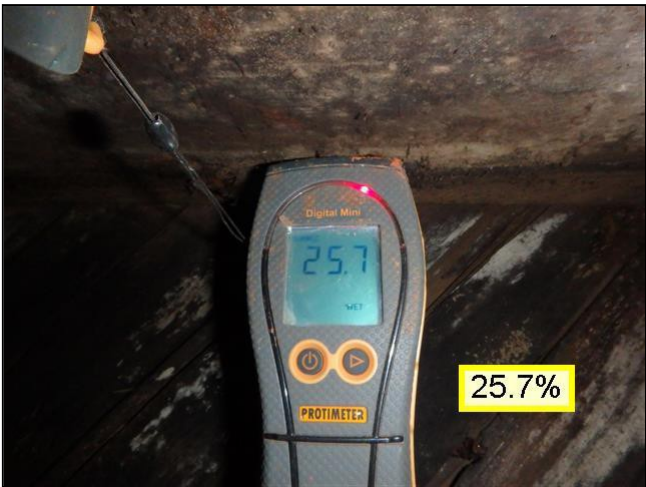
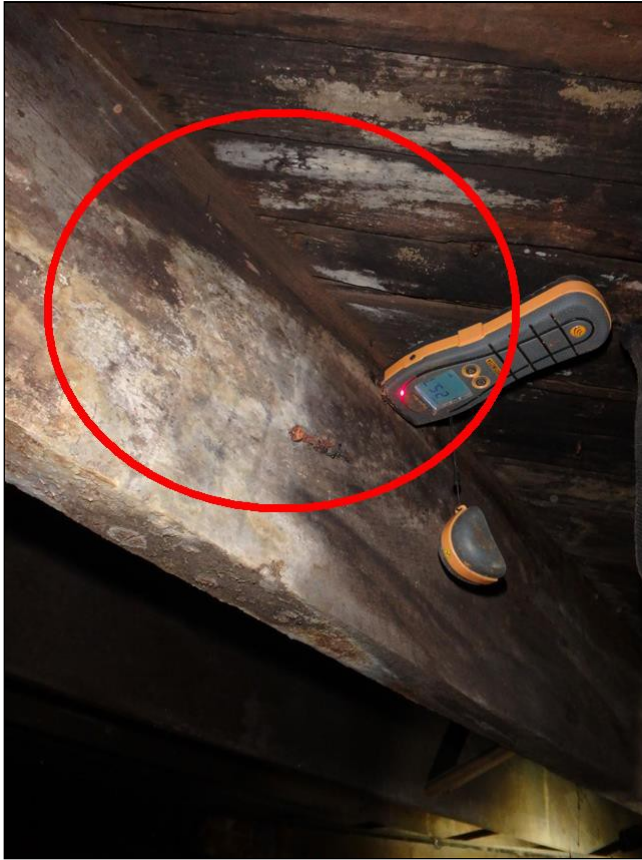
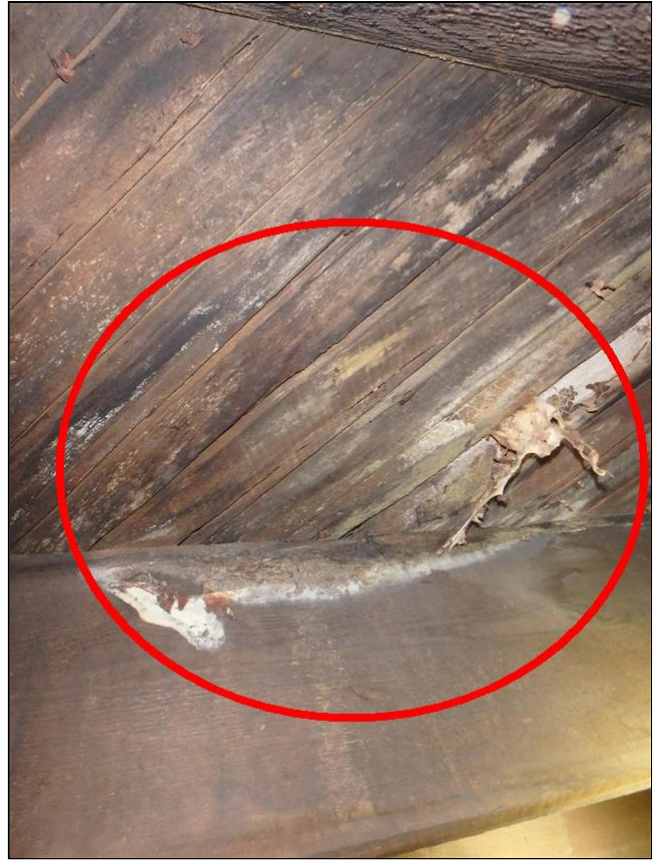
1. In the crawl space area along the rear and center of building the wood floor joist and subflooring for the floor system were noticeably deteriorated and found to be soft and decayed when probed. This type of damage indicates that the wood components have been subjected to excessive moisture. Moisture meter readings were from 20% to 26% in crawl space. Deterioration of the floor joists can result in movement or sagging of the floor system.

A licensed general contractor should be consulted to determine the extent of the damage, the source of the water penetration, and necessary repairs.

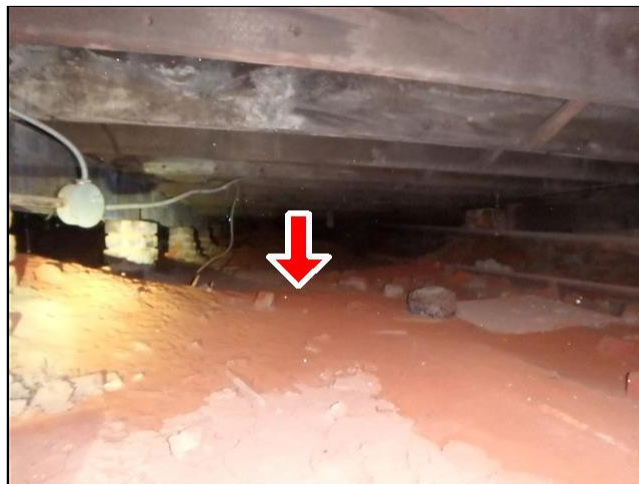
5.6 Item 1(Picture)

1. The vapor barrier (plastic) on the crawlspace ground is missing. Item 1(Picture) A vapor barrier provides added protection to the floor system from moisture or dampness that can enter from ground.

We recommend contacting a licensed contractor regarding these conditions and have repairs made as deemed appropriate..

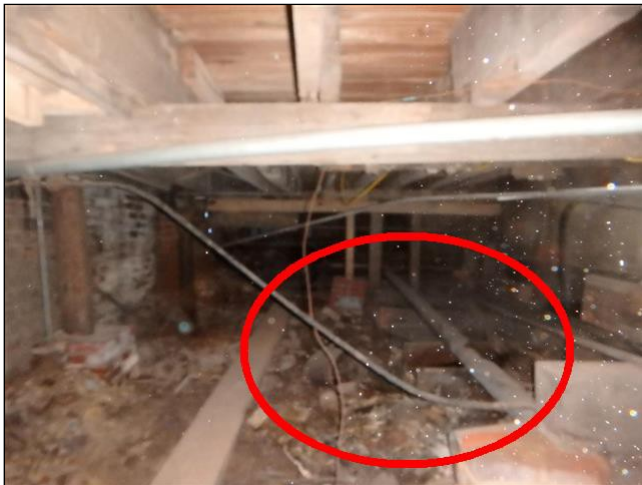
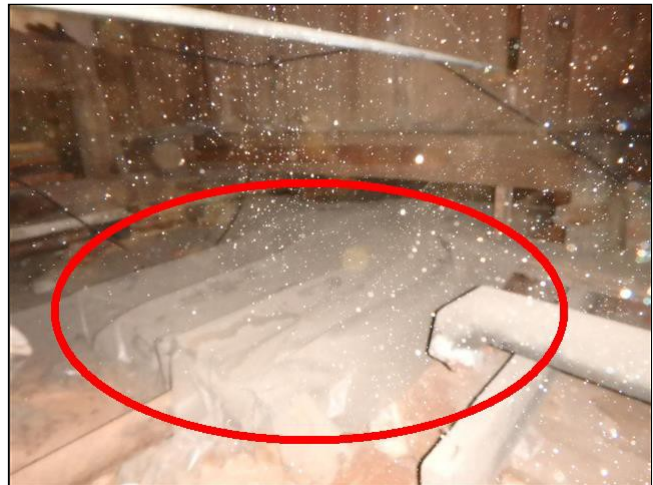
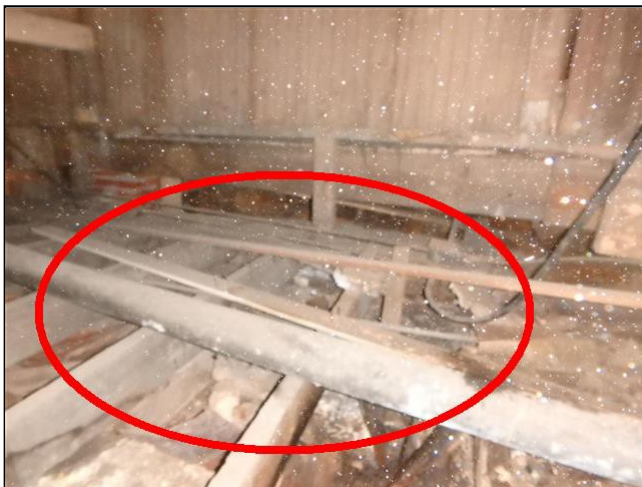
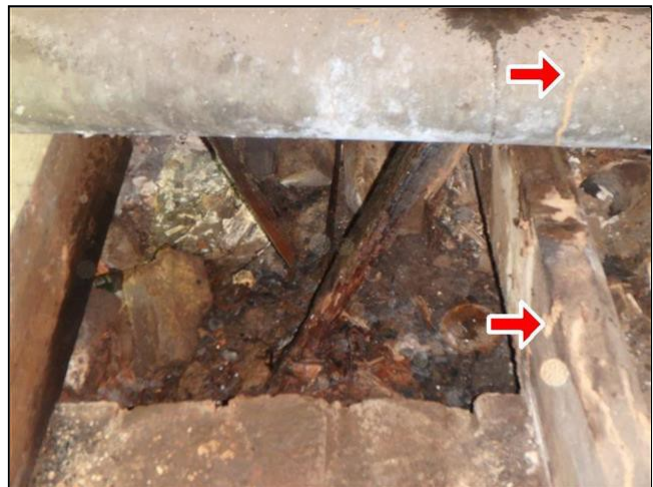
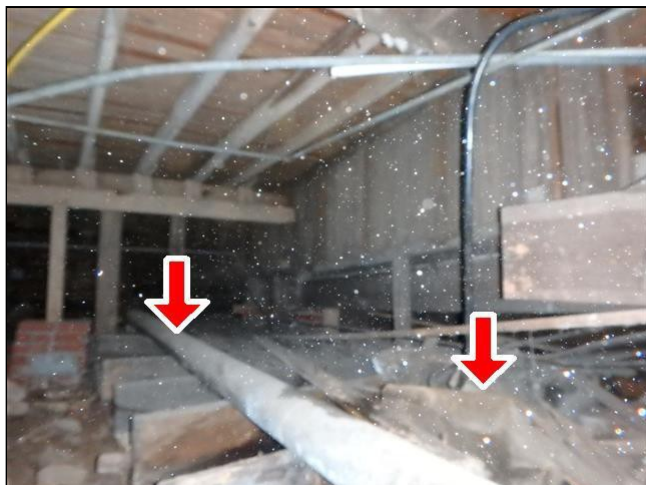
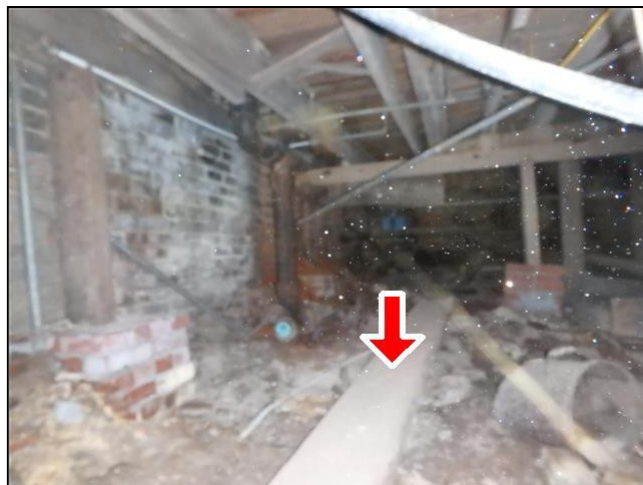
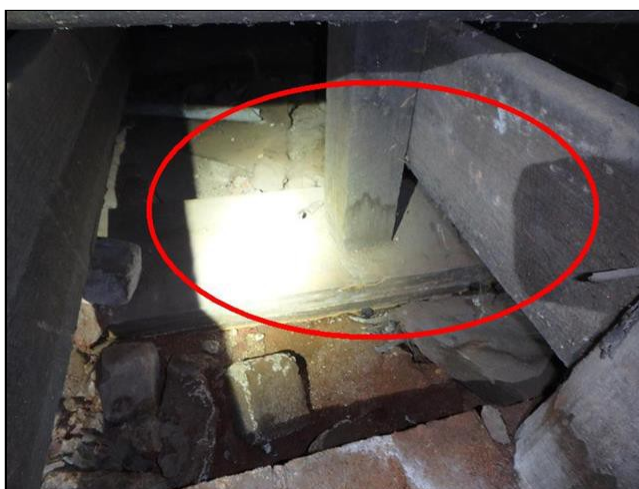
1. Wood debris is in contact with the crawl space dirt floor in numerous areas throughout the crawl space. Item 1(Picture) Item 2(Picture) Item3(Picture) Item 4(Picture) Item 5(Picture) Item 6(Picture) Item 7(Picture) This can attract wood destroying organism. Evidence of past or present termite activity is present. Removal is needed.

We recommend contacting a licensed contractor regarding these conditions and have repairs made as deemed appropriate.

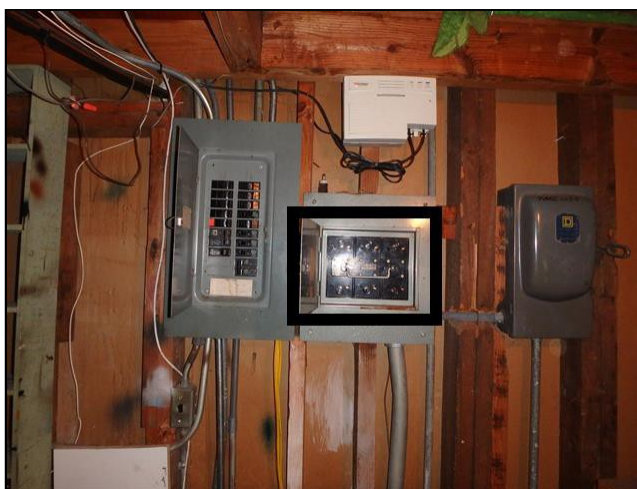
**6.0** The main panel box is located at the storage room at rear of building..Item 1(Picture)

6.0 Item 1(Picture) Main Service Disconnect

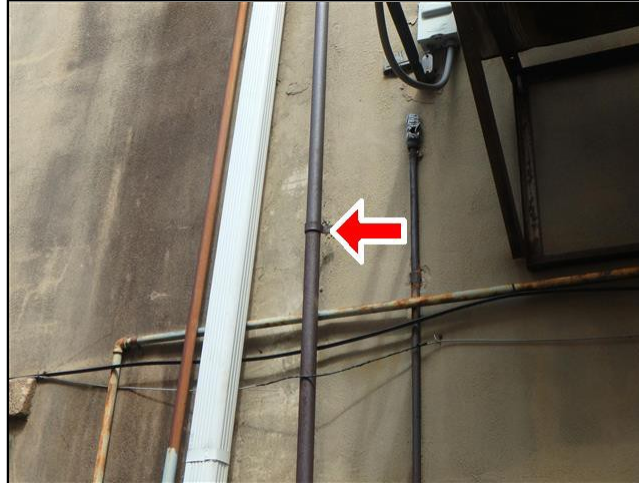
6.1 Item 1(Picture)

1. The wall anchor for the service mast not secured to structure. Item 1(Picture) This can allow electrical failure to occur. Repairs are needed.

We recommend contacting the local utility company regarding these conditions and have repairs made as deemed appropriate.

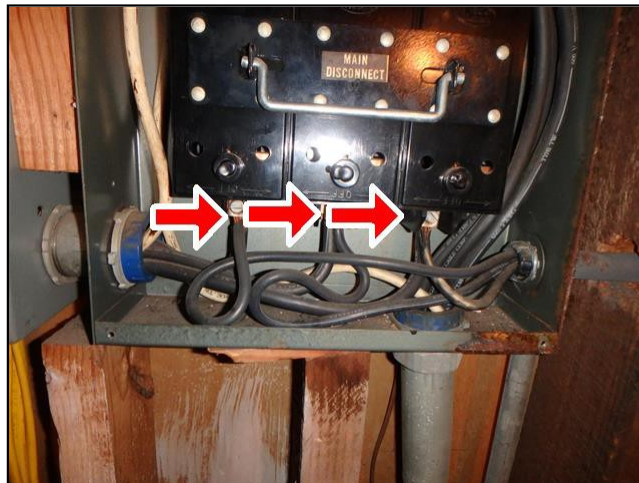
6.2 Item 1(Picture)

1. The main fuse service lugs are double tapped. Item 1(Picture) While often done, this is not permitted unless the device is so labeled. Double tapping often leads to overloaded circuits and loose connections that can overheat. Repairs are needed.

We recommend contacting a licensed electrician regarding these conditions and have repairs made as deemed appropriate.

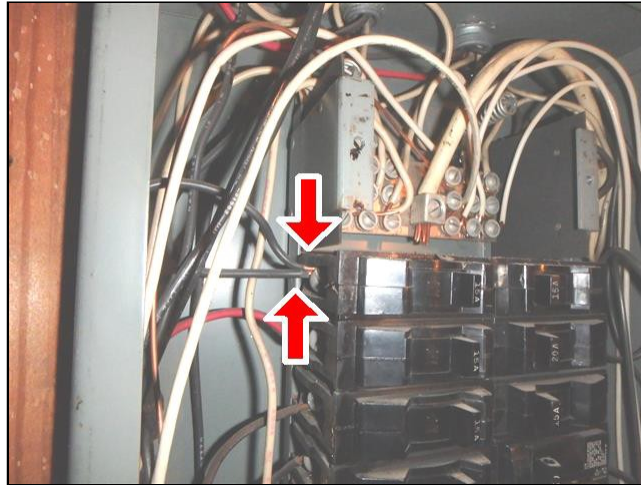
6.3 Item 1(Picture)

1. Two wires were observed to be connected to one or more circuit breakers in the panel. Item 1(Picture) While often done, this is not permitted unless the device is so labeled. Double tapping often leads to overloaded circuits and loose connections that can overheat. Repairs are needed.

We recommend contacting a licensed electrician regarding these conditions and have repairs made as deemed appropriate.

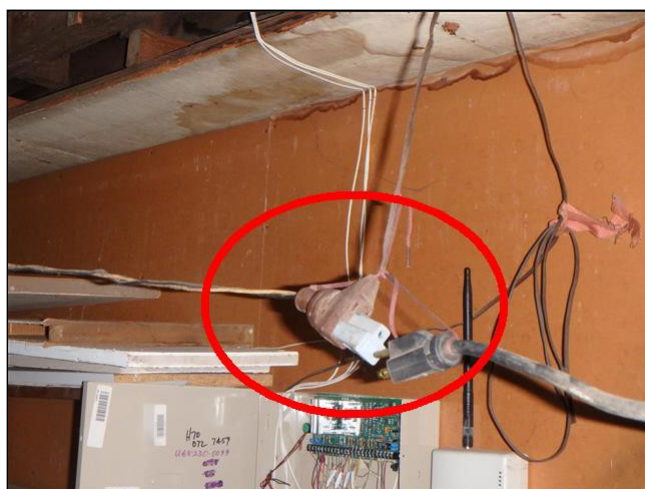
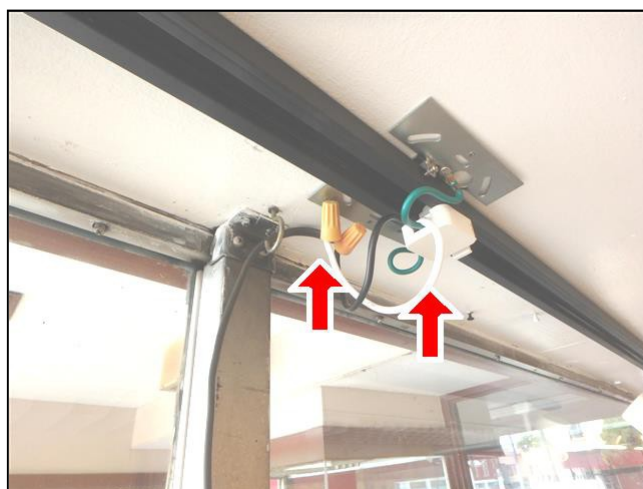
1. Extension cord used as permanent wiring at the rear upper storage room and front display area. Item 1(Picture) Item 2(Picture) Extension cords are not considered safe to use as permanent wiring. Exposed wiring is considered unsafe until repaired. (Fire Safety Issue) Repairs are needed.
2. The fluorescent light fixtures at the front display area were not operable at time of inspection. Item 3(Picture) Item 4(Picture) Item 5(Picture) Evidence suggest they have been disconnected. Further investigation and repairs are recommended.
3. One "three-prong" outlet is broken or damaged. Item 6(Picture) Electrical issues are considered a hazard until repaired. Repairs are needed.
4. Exposed romex branch wiring present at show room and below electrical panel. Item 7(Picture) Commercial structures are generally required to in conduit. Further investigation and repairs are needed.

6.4 Item 2(Picture) Exposed Branch Wiring.

We recommend contacting a licensed electrician regarding these conditions and have repairs made as deemed appropriate..

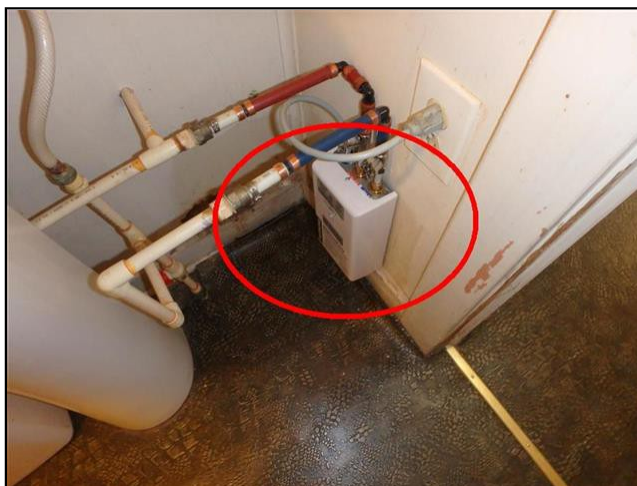
7.2 Item 1(Picture)

1. The water heater did not work (no hot water). Item 1(Picture) Circuit breaker was already "on" before we inspected. Failure likely due to the condition of the supply lines in the crawl space. Further investigation and repairs are needed.

We recommend contacting a qualified licensed plumber regarding these conditions and have repairs made as deemed appropriate..

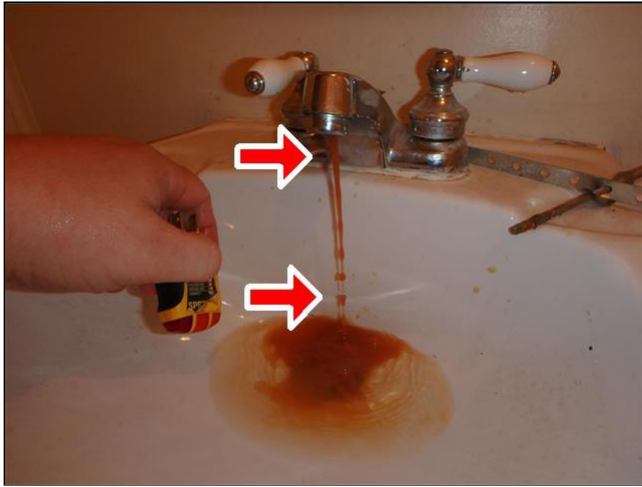
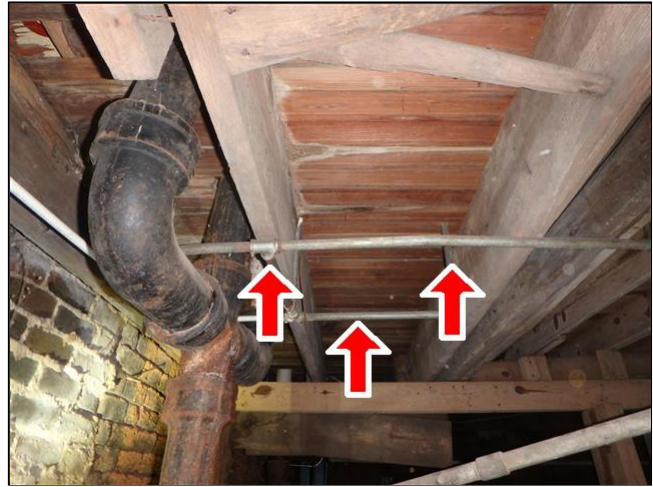
1. The hot and cold galvanized main water and supply lines throughout the building has rust present in water supply. Item 1(Picture) Item 2(Picture) General replacement of the galvanized supply piping throughout the building is likely do the conditions present as the water pressure over-all is poor and would not pass "functional flow." Item 1(Picture) The reason for weak volume or pressure is old galvanized piping that is corroded inside. Repairs are needed.

We recommend contacting a licensed plumber regarding these conditions and have the entire plumbing supply and distribution system evaluated and have repairs/replacements made as deemed appropriate
