Table of Contents

**AHI Residential & Commercial Inspections, Inc**

Sample Commercial

123 Sample Inspection Rd  
Sample City NC

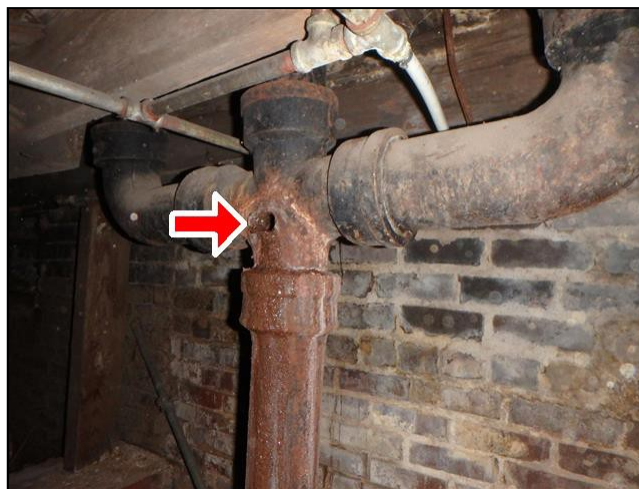
7.4 Item 1(Picture)

1. The cast iron main waste line for the half bathroom's are damaged and has active sewage leaks. Item 1(Picture) As a result raw sewage leaks are present in crawl space. While the repair cost strain and potential for further damage to your property is a troublesome thought, even more so is the risk of health problems severe leaks can cause, not limited to pathogens, mold, etc. REPAIRS ARE NEEDED.

We recommend contacting a licensed plumber regarding these conditions and have the entire plumbing waste line system evaluated and have repairs/replacements made as deemed appropriate

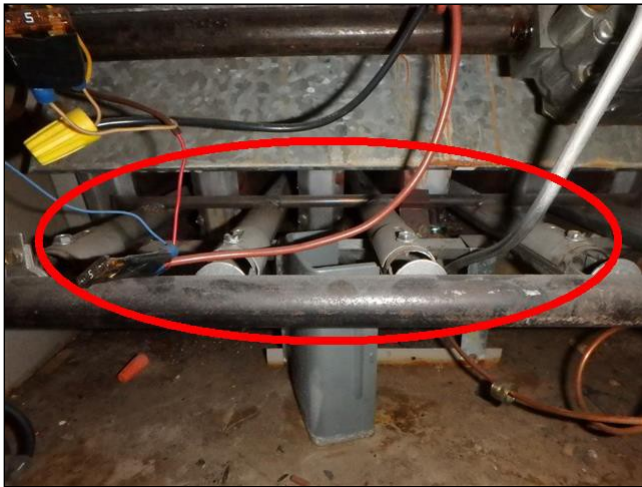
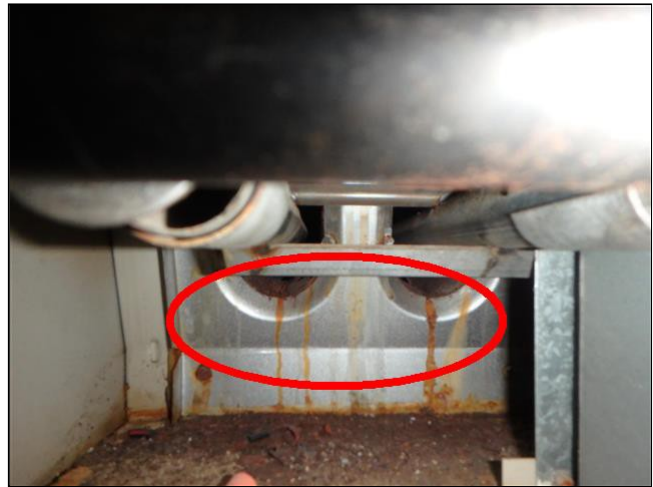
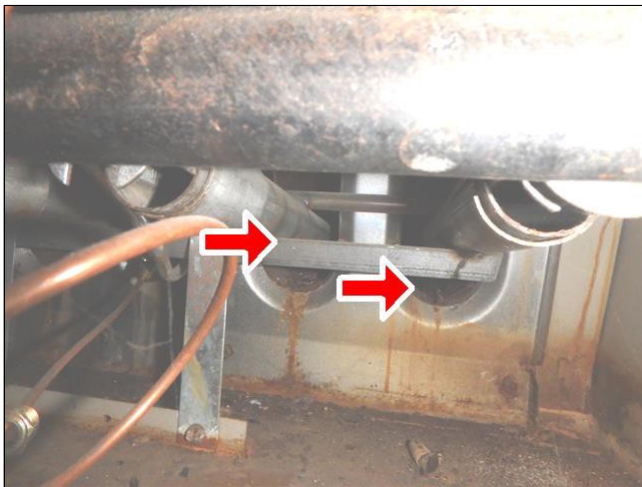
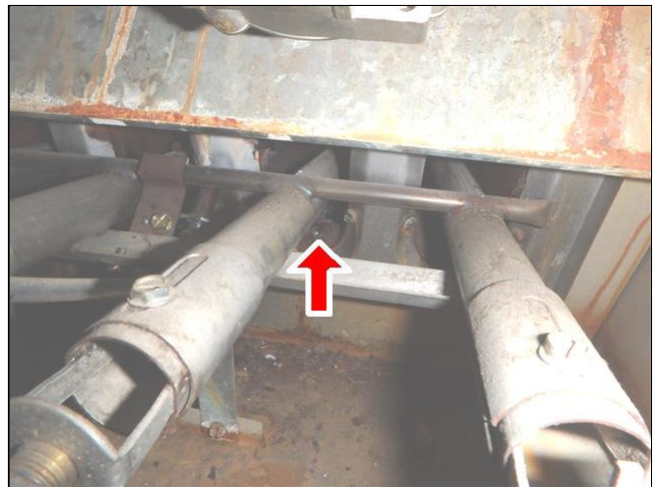
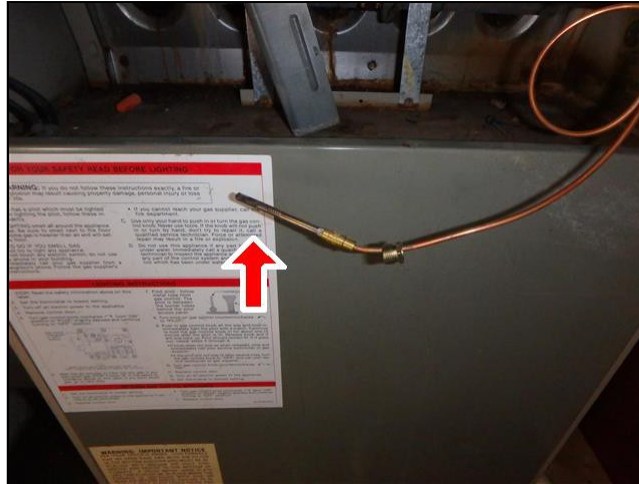
1. The furnace combustion chamber shows is rusted with rust particles and flakes on the burners and at the bottom of the chambers. Item 1(Picture) Item 2(Picture) Item 3(Picture) Item 4(Picture) This is a typical sign of a possibly failed heating system / heat exchanger. General replacement of furnace likely due to age and condition.
2. The ignitor for the gas furnace is not installed properly. Item 5(Picture)

We recommend contacting a properly licensed (HVAC) heating and air contractor regarding these conditions and have repairs made as deemed appropriate

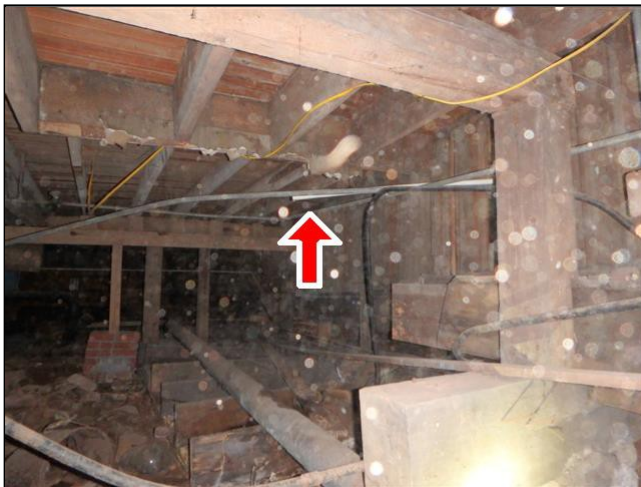
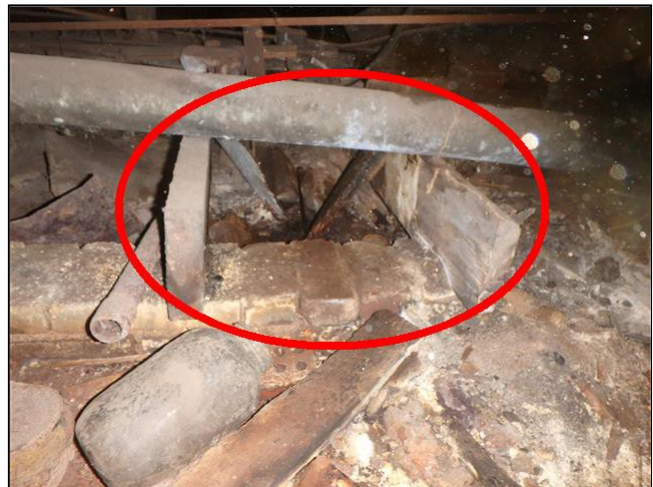
1. The primary condensate drain line is routed to the crawl space and is dumping water onto the crawl space dirt floor. Item 1(Picture) Item 2(Picture) This is contributing to elevated moisture conditions in the crawl space. (See Section 1.4) Repairs are needed.  
1.

We recommend contacting a licensed HVAC contractor regarding these conditions and have repairs made as deemed appropriate.

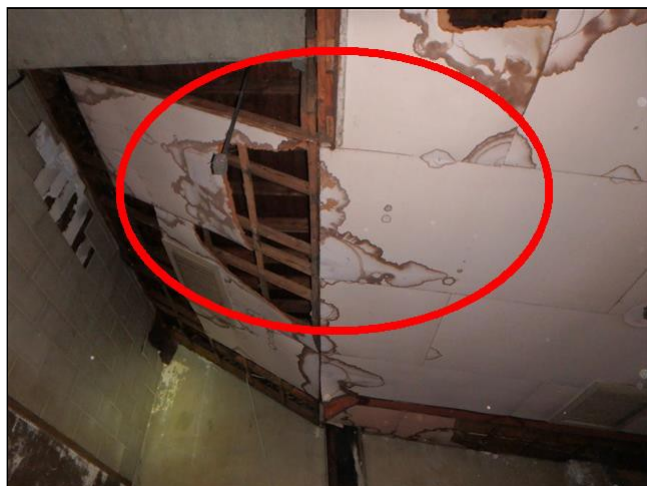
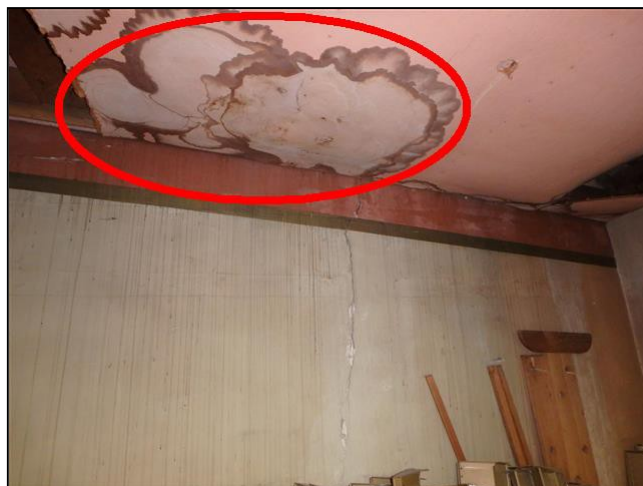
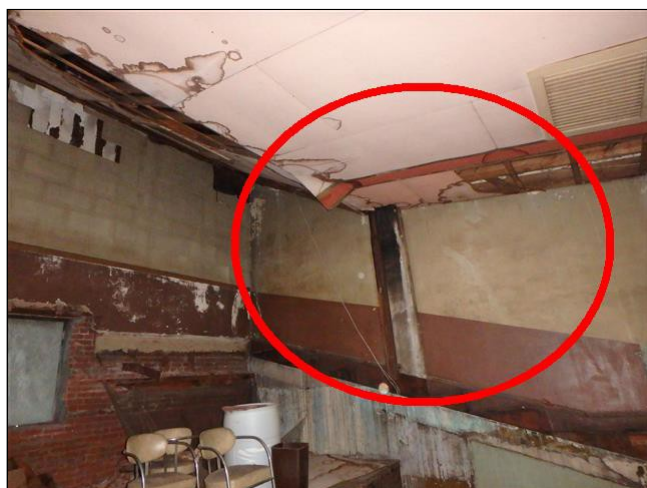
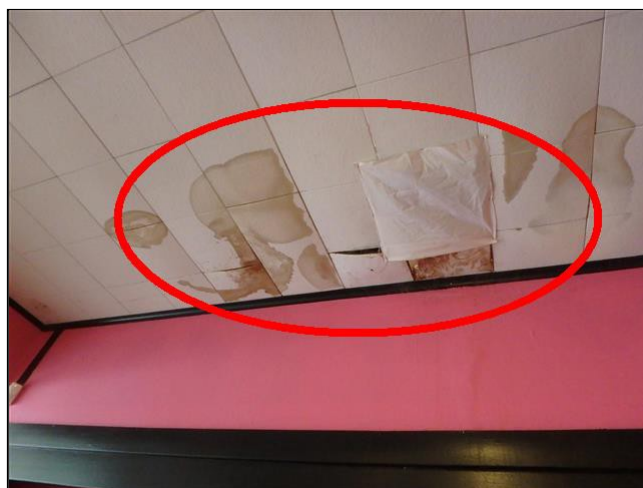
1. The ceiling tile on the ceiling reveals a water stain indicating a leak did or still exists at the interior and both upper and lower ceilings. Item 1(Picture) Item 2(Picture) Item 3(Picture) Item 4(Picture) Due to recent dry weather, we are unable to determine if the leak still exists. Further investigation is needed.

We recommend contacting a licensed roofing contractor regarding these conditions and have repairs made as deemed appropriate..

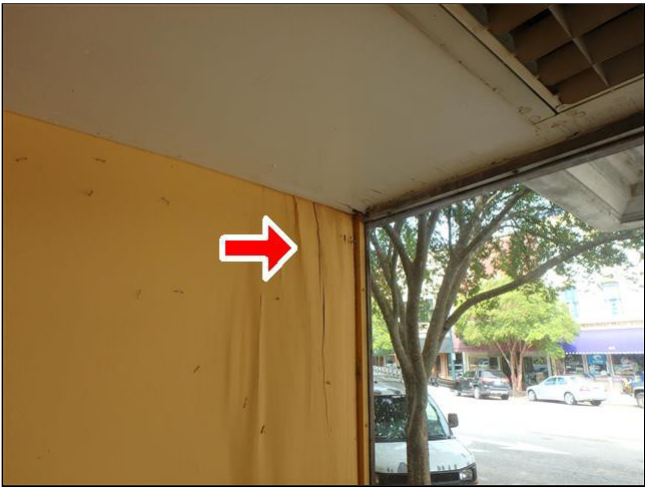
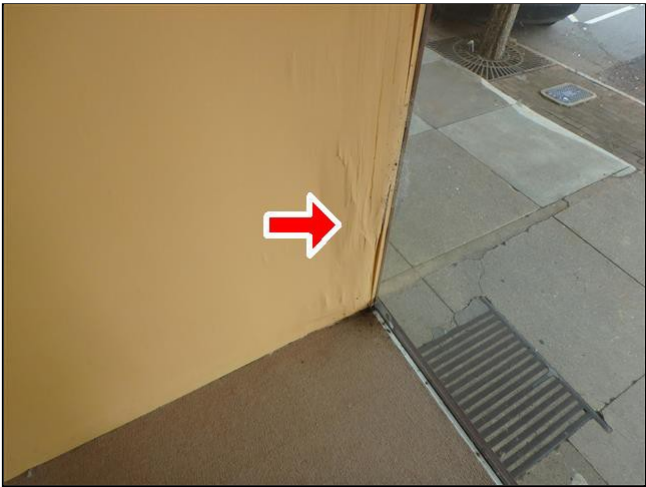
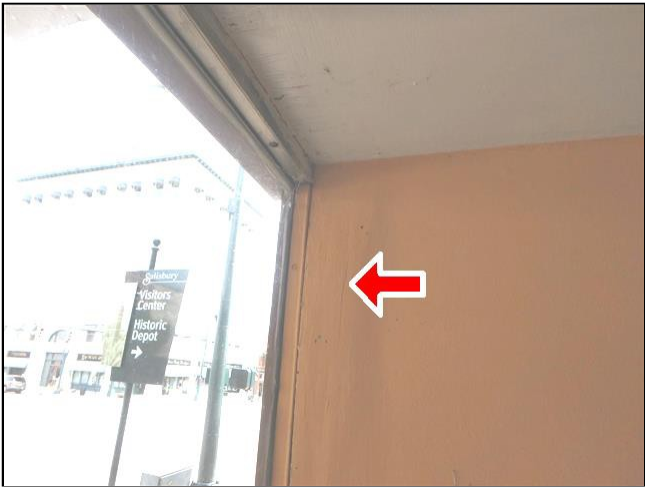
1. The paneling on the wall shows wet stains indicating moisture or intrusion did or still may occur at the front of store. Item 1(Picture) Item 2(Picture) Item 3(Picture) Due to recent dry weather, we are unable to determine if the leak still exists. Further investigation is needed.

We recommend contacting a roofing contractor regarding these conditions and have repairs made as

deemed appropriate..

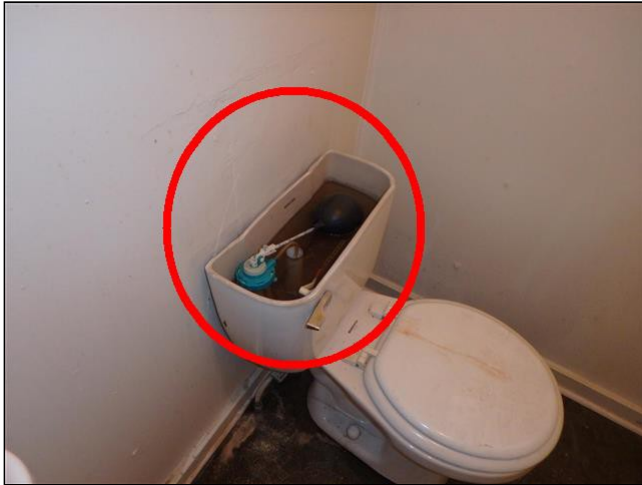
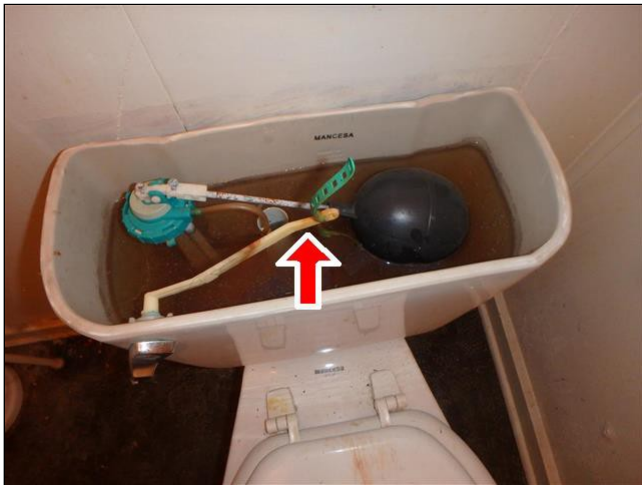
1. The toilet tank lid is missing at the right side 1/2 bath. Repairs are needed.
2. The toilet tank at the right side half bath has active leaks at bolts. Item 2(Picture) Repairs are needed to prevent water damage to structure.
3. The toilet will not flush at the right side half bathroom. Item 3(Picture) The Flush Valve, Flapper & or Tank Lever likely need replacing. Repairs are needed.

We recommend contacting a qualified licensed plumber regarding these conditions and have repairs made as deemed appropriate..

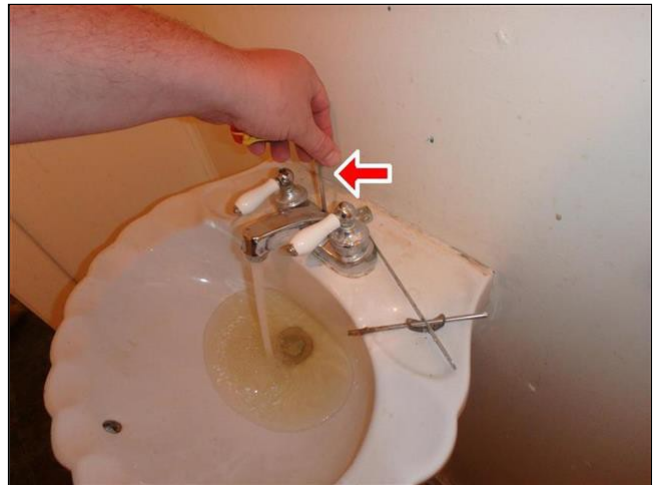
11.5 Item 4(Picture) Right Side

4. Both half bathroom sink stopper is missing or does not function as intended. Item 4(Picture)  
Item 5(Picture) A Repair or Replacement is needed.
5. The toilet tank at the right side half bath has active leaks at bolts. Item 6(Picture) Repairs are needed to prevent water damage to structure
