# Inspection Report

Mrs. Jane Doe

Sample Final Inspection

**AHI Residential & Commercial Inspections, Inc**

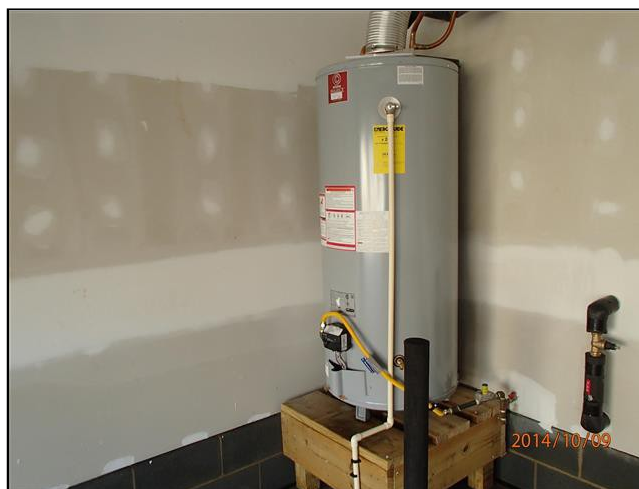
Gas Water Heater

**5.0** The main shut off is the red lever located in the garage beside the water heater. Item 1(Picture) This is for your information.
