# Inspection Report

**Prepared For:**  
Sample Pre-Drywall

**Property Address:**  
Sample Rd  
Sample City NC 22222

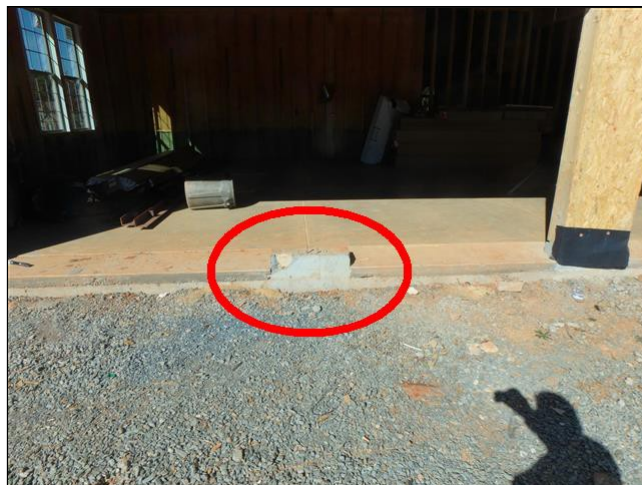
4.1 Item 2(Picture)

1. Evidence suggest garage door placement has changed, the slab has been poured with foundation bolts. Item 1(Picture) Item 2(Picture) As a result there is now an obstruction present in the garage doorway. Repairs are needed.

We recommend contacting a licensed contractor regarding these conditions and have repairs made as deemed appropriate.

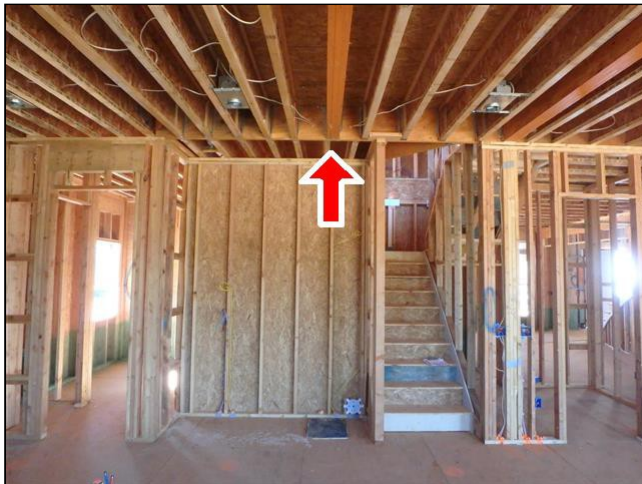
4.4 Item 3(Picture)

2. The LVL beam for second floor at the kitchen not sitting on an interior bearing wall / or support. Item 3(Picture) Item 4(Picture) Engineered Floor system layout was not provided to us or used by us (this inspector) to determine if the layout locations and installations are correct. Improper end bearing of beams could allow movement or failure to occur if the floor system. Further evaluation is needed.
3. The Simpson Strong-tie hangers for "I" joists for living room "I" Joists are not nailed properly, as missing nails present. Item 5(Picture) Item 6(Picture) Item 7(Picture) See Video [http://youtu.be/gIK\\_dgXUWQU](http://youtu.be/gIK_dgXUWQU) per the manufacture incorrect installation can cause failure. "I" Joist should not be nailed they are required to have hangers. Repairs are needed. Repairs are needed.

A licensed general contractor should be consulted to determine the necessary repairs. If the repair is beyond the scope of the NC Building code, the contractor should consult a professional structural engineer.

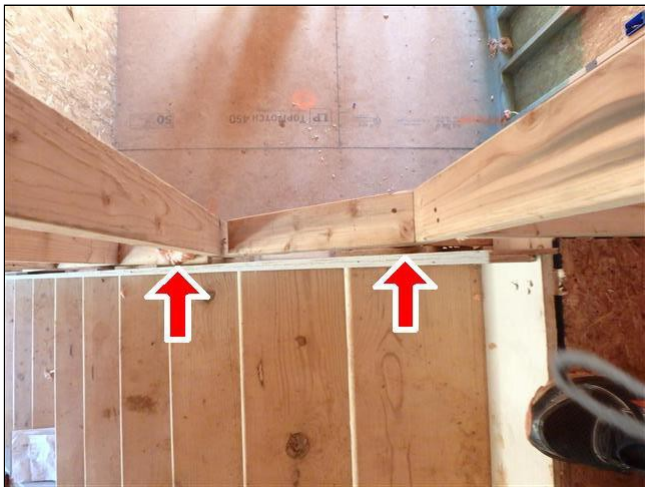
4.5 Item 4(Picture)

1. The fire blocking is incomplete and or missing at stairs. Item 1(Picture) Item 2(Picture) Item 3(Picture) Item 4(Picture) Item 5(Picture) Stairways are another space that fire blocking is required. The main reason for fire blocking at stairways is to protect the strength of the stairway so it will remain strong as long as possible during a fire so people can get out of the basement or down from up stairs. Install wood blocking in the cells between studs along the side of the stair stringer. Repair are needed.

We recommend contacting a licensed contractor regarding these conditions and have repairs made as deemed appropriate.

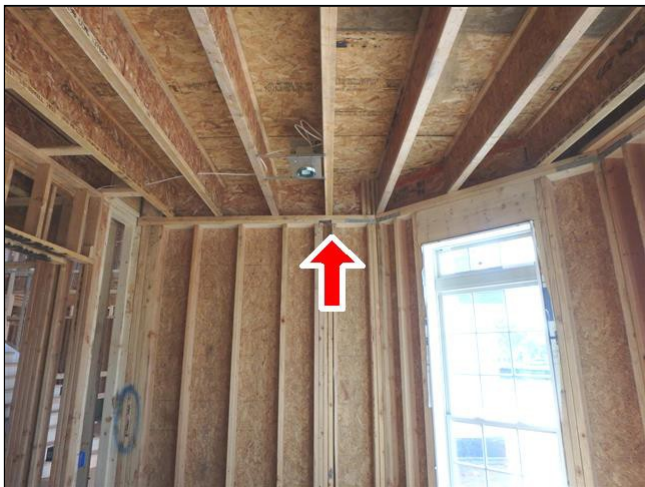
4.5 Item 6(Picture)

2. The top plate for 2x4 wall is damaged / missing between 1st floor front study/office and covered porch. Item 6(Picture) This is a load point for the front covered porch roof. Floor movement could occur in not addressed. Repairs are needed.

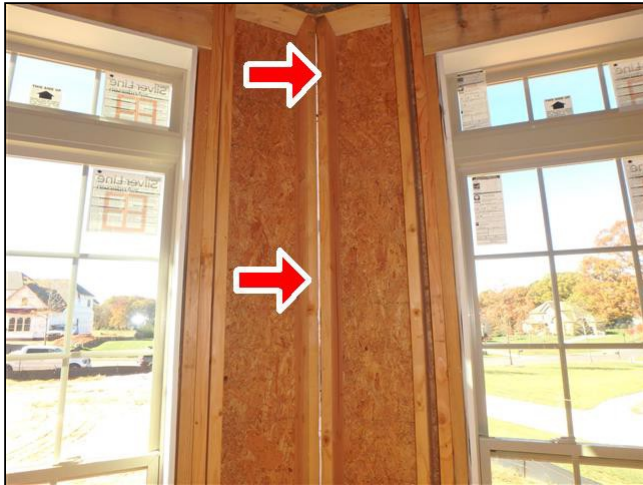
4.5 Item 7(Picture)

3. Visible daylight present in numerous areas due to lack of sealant / spray foam.Item 7(Picture) Item 8(Picture) Item 9(Picture) This should be addressed prior to installing installation. Current conditions will allow air infiltration to occur. Repairs are needed.

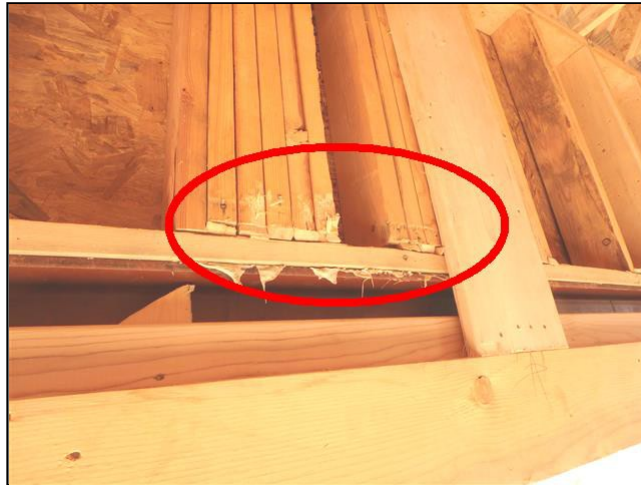
4.8 Item 3(Picture)

1. The steel posts for steel header at garage door opening doesn't appear to be welded. Item 1(Picture) Item 2(Picture) This could allow movement to occur once a load is applied by the brick. Further investigation and repairs are needed.
2. The 2x6 framing above garage door has been installed undersized, shims have been added to try and correct framing detail. Item 3(Picture) This is not best practice. Repairs are recommended.

We recommend contacting a licensed contractor regarding these conditions and have repairs made as deemed appropriate.

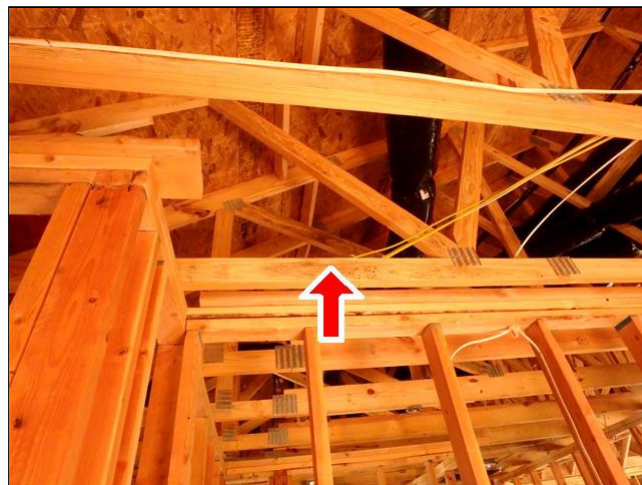
4.10 Item 7(Picture)

1. Discoloration and some type of light growth of a Simple Mold (Microbial) is present on attic trusses. Item 6(Picture) Item 7(Picture) Item 8(Picture) Item 9(Picture) Item 10(Picture) Evidence suggest that this condition is from past or present elevated moisture conditions. We did not inspect, test or determine if this type of substance is or is not a health hazard. Further investigation is needed.

We recommend you contact a properly licensed expert for testing, investigation and or correction as deemed appropriate.

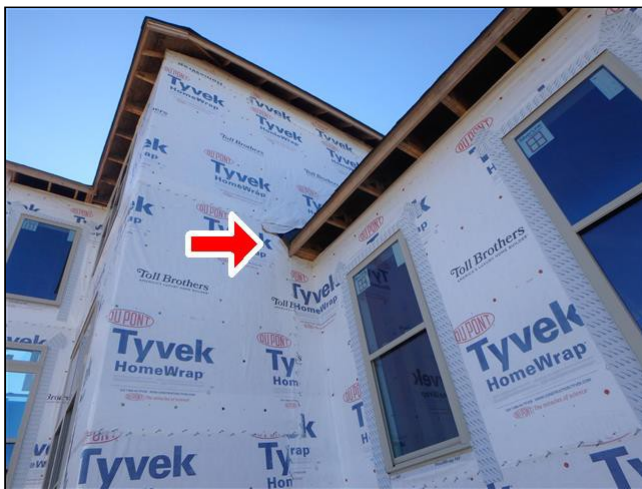
6.0 Item 3(Picture)

1. The House wrap is not installed per manufactures recommendation at the front, sides and rear of home as damage is present. As exposed osb sheathing and damage areas are present. Item 1(Picture) Item 2(Picture) Item 3(Picture) Item 4(Picture) Item 5(Picture) Item 6(Picture) It is recommended that all house wrap issues be addressed prior to the installation of the siding. (See Web-link below for more information) Repairs are needed prior to the installation of siding.
2. The exterior sheathing below master bedroom windows is damaged. Item 4(Picture) Item 5(Picture) Improper installation of plywood and flashing could allow water intrusion to occur. Repairs are needed.

We recommend contacting a licensed contractor regarding these conditions and have repairs made as deemed appropriate.

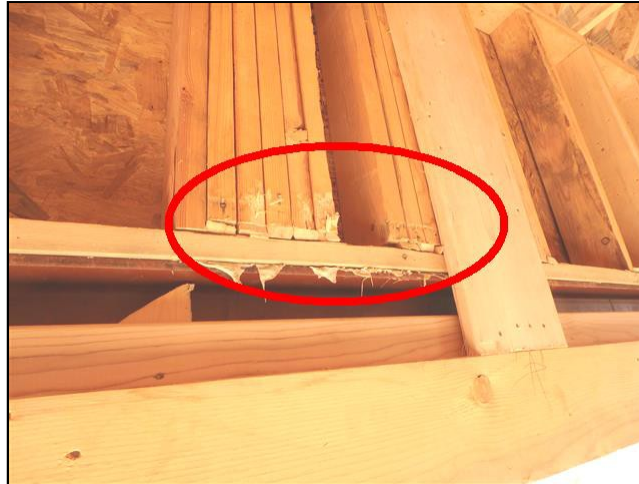
4.8 Item 3(Picture)

1. The steel posts for steel header at garage door opening doesn't appear to be welded. Item 1(Picture) Item 2(Picture) This could allow movement to occur once a load is applied by the brick. Further investigation and repairs are needed.
2. The 2x6 framing above garage door has been installed undersized, shims have been added to try and correct framing detail. Item 3(Picture) This is not best practice. Repairs are recommended.

We recommend contacting a licensed contractor regarding these conditions and have repairs made as deemed appropriate.

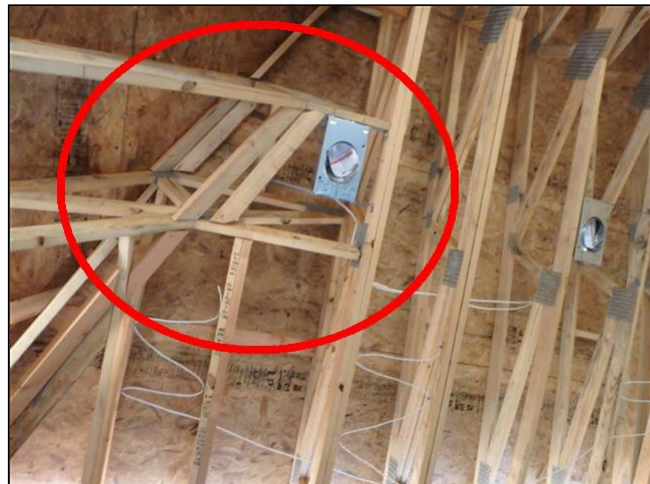
4.10 Item 2(Picture)

1. Several hurricane clips at second floor right side master bathroom for the roof trusses has missing nails that secure the truss to the exterior wall. Item 1(Picture) These clips secure the roof framing to the structure to resist uplift from high winds. Hurricane clips are required for roof truss systems. Repairs are needed.
2. The hip roof truss system has been nailed at the study. Item 2(Picture) Item 3(Picture) Item 4(Picture) Item 5(Picture) This is not best practice. Nailing is not as strong or reliable as nailing. See Web Link: <http://seblog.strongtie.com/2016/11/new-hanger-strengthens-jack-rafter-connections/> Repairs are recommended.

We recommend contacting a licensed contractor regarding these conditions and have repairs made as deemed appropriate.

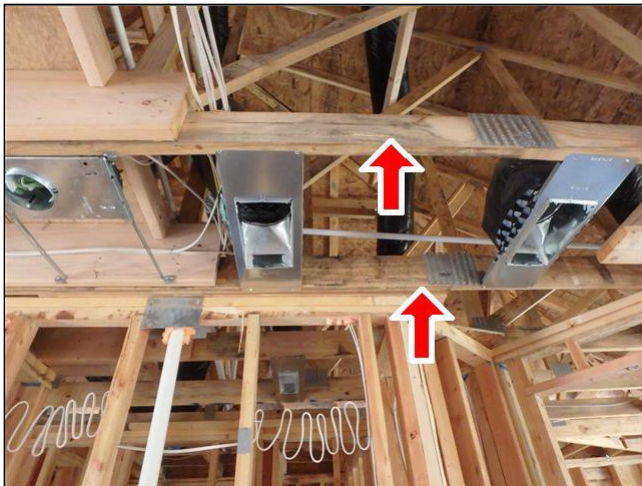
4.10 Item 8(Picture)

1. Discoloration and some type of light growth of a Simple Mold (Microbial) is present on attic trusses. Item 6(Picture) Item 7(Picture) Item 8(Picture) Item 9(Picture) Item 10(Picture)  
Evidence suggest that this condition is from past or present elevated moisture conditions. We did not inspect, test or determine if this type of substance is or is not a health hazard. Further investigation is needed.

We recommend you contact a properly licensed expert for testing, investigation and or correction as deemed appropriate.

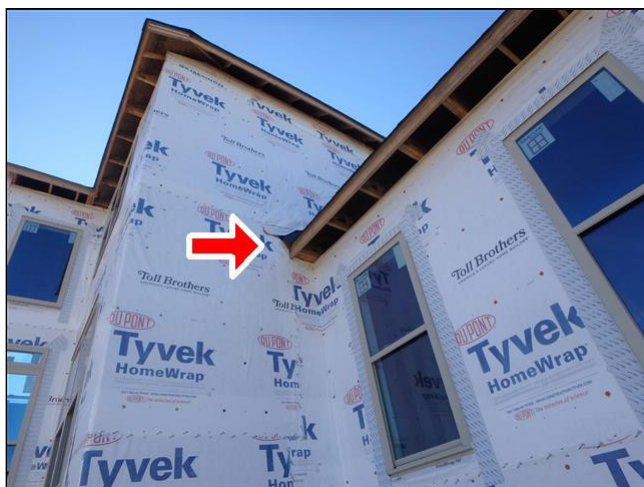
6.0 Item 3(Picture)

1. The House wrap is not installed per manufactures recommendation at the front, sides and rear of home as damage is present. As exposed osb sheathing and damage areas are present. Item 1(Picture) Item 2(Picture) Item 3(Picture) Item 4(Picture) Item 5(Picture) Item 6(Picture) It is recommended that all house wrap issues be addressed prior to the installation of the siding. (See Web-link below for more information) Repairs are needed prior to the installation of siding.
2. The exterior sheathing below master bedroom windows is damaged. Item 4(Picture) Item 5(Picture) Improper installation of plywood and flashing could allow water intrusion to occur. Repairs are needed.

We recommend contacting a licensed contractor regarding these conditions and have repairs made as deemed appropriate.
