INSPECTION REPORT  
Sample  
NC

INSPECTED BY  
Hunter Griggs  
AHI Residential &  
Commercial  
Inspections  
NC 5086 SC 49764

INSPECTION DATE  
2/1/2026  
09:30 AM

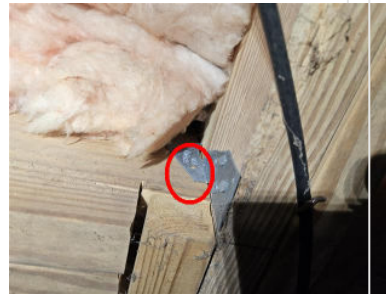
Item 4 - Item 2(Picture)

1. The joist hangers overhead at the crawlspace entrance are not correctly installed. All round holes on hangers should be filled to ensure proper support. Further evaluations and repairs are needed.

We recommend contacting a properly licensed contractor regarding these conditions and have repairs made as needed.

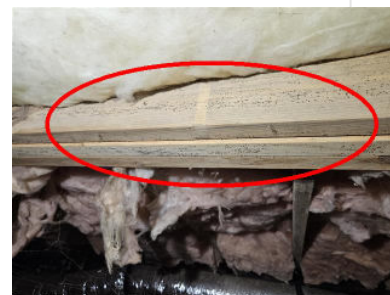
Item 5 - Item 2(Picture)

5. 1. Discoloration and some type of microbial growth is present on the structure in several areas throughout the crawl space/foundation. This type of substance commonly results in the building components becoming weakened and or compromised. Evidence suggests that this condition is from past and or present elevated moisture and humidity conditions. We did not inspect, test or determine if this type of substance is or is not a health hazard.

We recommend contacting a properly licensed water and humidity proofing/control contractor as well a certified mold testing and remediation company regarding these conditions. Repairs deemed appropriate by these specialist should be completed prior to closing.

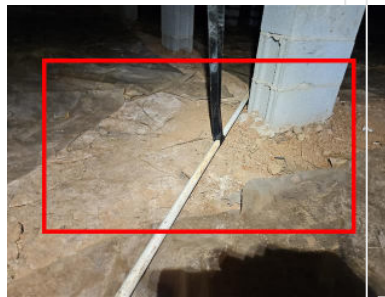
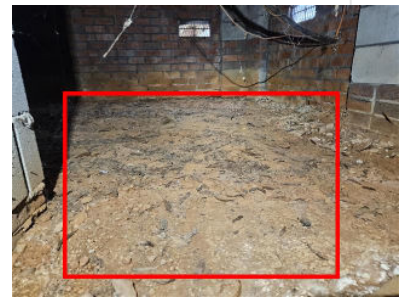
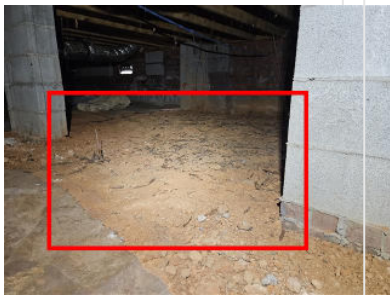
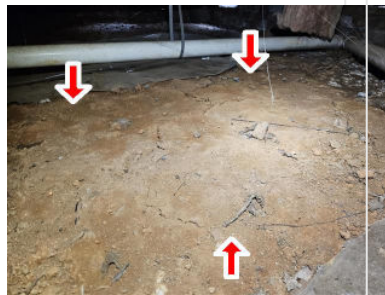
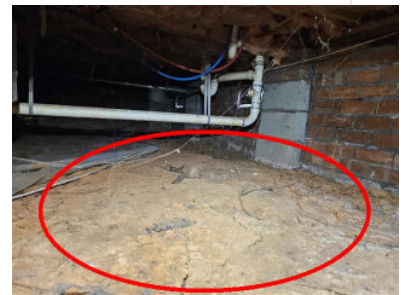
11. 1. The vapor barrier / diffusion retarder on the crawlspace ground is deteriorated in areas. Visible signs of current elevated moisture levels in the crawl space floor system was present at time of inspection. Moisture barriers keep under ground moisture from entering the crawl space area. This condition is conducive to high moisture content in wood structures, which in turn is conducive to wood destroying insects / mold growth / fungi growth and other potential concerns. We recommend a 6 mil thick plastic be properly spread throughout to cover 100 percent of the crawl space dirt floor.

We recommend contacting a properly licensed contractor regarding these conditions and have repairs made as deemed appropriate

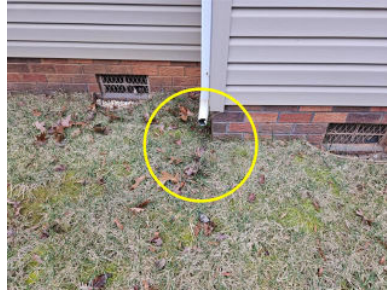
3.1 Item 1(Picture)

1. The downspouts terminating at the foundation wall are missing diverter / splash block / extension pipes at the rear of home. Providing an adequate roof drainage system, diverting all downspouts away from the foundation and providing adequate soil grading and ground cover at the foundation and throughout the site are primary remedial factors to consider for any water penetration concerns and foundation concerns. Repairs are recommended

We recommend contacting a licensed contractor regarding these conditions and have repairs made as deemed appropriate.

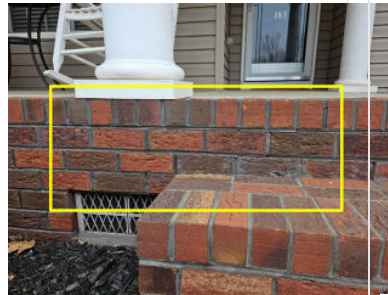
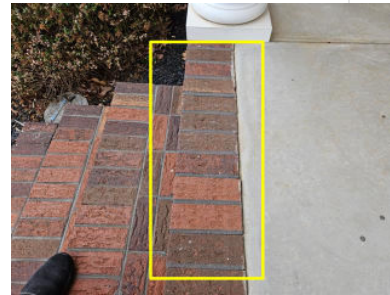
1. The brick at the exterior is damaged and cracking at the front porch. The wall(s) may need reinforcement in these areas as the damage may lead to further damage or cracking which can put undue stress on surrounding areas. Further evaluations and repairs are recommended.

We recommend contacting a properly licensed contractor regarding these conditions and have repairs made as deemed appropriate

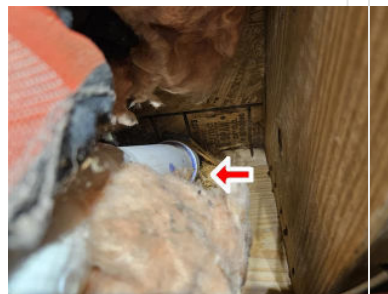
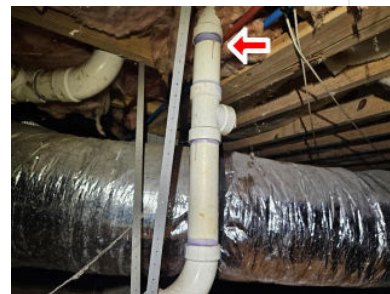
1. One of the center supports at the left side of the crawlspace has been cut by a tradesmen to make room for plumbing. Center support should be free of damage or modifications to prevent sagging or cracking. Further evaluations and repairs are needed.

We recommend contacting a properly licensed contractor regarding these conditions and have repairs made as needed.

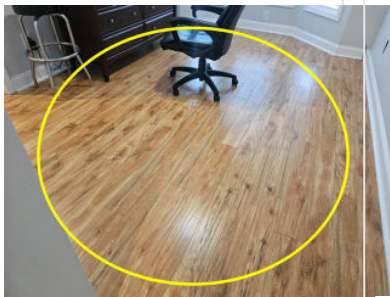
4.1 Item 6(Picture)  
Front Right Bedroom

- The subflooring at the several rooms is creaking and/or lifting/sagging. This could indicate that the subflooring has been installed too closely and/or is missing glue/fasteners. Further evaluations and repairs are recommended.

We recommend contacting a properly licensed contractor regarding these conditions and have repairs made as needed.

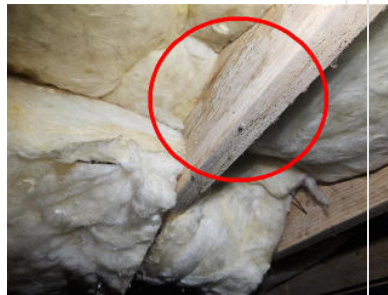
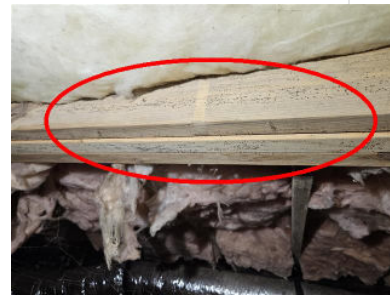
1. Discoloration and some type of microbial growth is present on the structure in several areas throughout the crawl space/foundation. This type of substance commonly results in the building components becoming weakened and or compromised. Evidence suggests that this condition is from past and or present elevated moisture and humidity conditions. We did not inspect, test or determine if this type of substance is or is not a health hazard.

We recommend contacting a properly licensed water and humidity proofing/control contractor as well a certified mold testing and remediation company regarding these conditions. Repairs deemed appropriate by these specialist should be completed prior to closing.

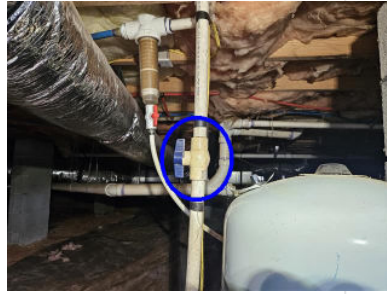
5.0 Item 1(Picture)

1. The main shut off is the blue lever located underneath in the crawlspace. This is for your information.

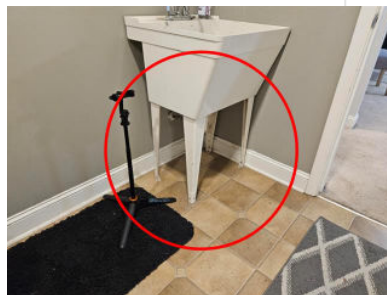
5.4 Item 1(Picture)

1. The utility sink is loose and not secured at the washer/dryer room. This can allow undue stress to occur on supply lines allowing leaks to occur. Repairs are needed.

We recommend contacting a qualified licensed plumber regarding these conditions and have repairs made as deemed appropriate..

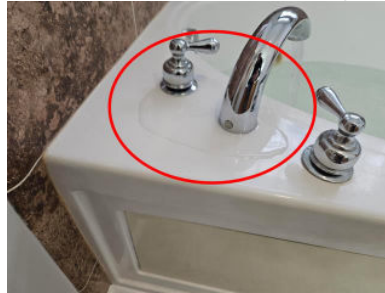
5.4 Item 2(Picture)

1. The cold control control knob leaks at the master bathroom when on. This is not considered up to today's standard and may allow water to pond onto the floor. Repairs are needed.

We recommend contacting a qualified licensed plumber regarding these conditions and have repairs made as deemed appropriate..

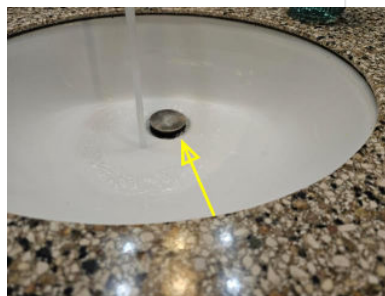
5.4 Item 3(Picture)

1. The hall bathroom sink stopper is does not function as intended. As a result you can not fill up the sink. A Repair or Replacement is needed.

We recommend contacting a licensed plumber regarding these conditions and have repairs made as deemed appropriate.

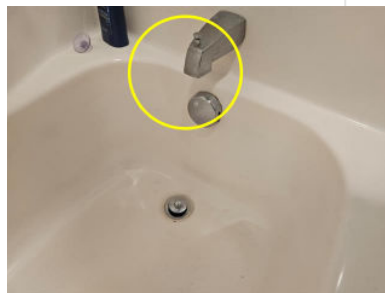
5.4 Item 4(Picture)

1. The tub spout leaks at the hall bathroom. This condition wastes water.. Repairs are recommended.

We recommend contacting a qualified licensed plumber regarding these conditions and have repairs made as deemed appropriate..

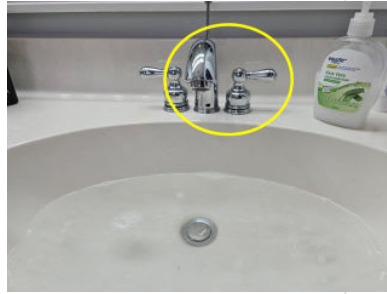
5.4 Item 5(Picture)

1. The cold side of the master bathroom sink faucet leaks at the master bathroom. This condition wastes water.. Repairs are recommended.

We recommend contacting a qualified licensed plumber regarding these conditions and have repairs made as deemed appropriate..

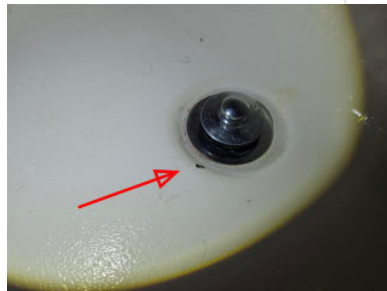
5.5 Item 1(Picture)

1. The hall bathroom fiberglass tub has chips and damage present. Damaged fiberglass tubs have been known to leak. This can cause water damage to the home. Further investigation and repairs are needed.

We recommend contacting a licensed plumbing contractor regarding these conditions and have repairs made as deemed appropriate.

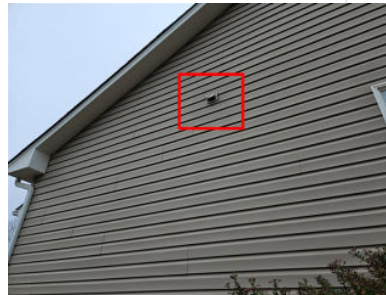
5.6 Item 1(Picture)  
Right

1. The exhaust fan hood is damaged at the rear exterior of home. This may allow insects or critters to enter home. Repairs are needed.

We recommend contacting a properly licensed contractor regarding these conditions and have repairs made as deemed appropriate.

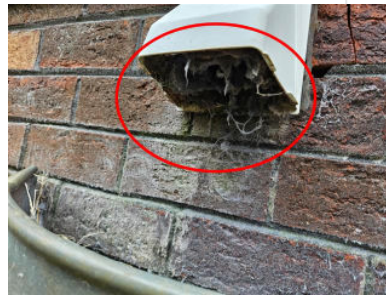
5.6 Item 2(Picture)

1. The dryer vent piping is clogged. Vent pipes should be cleaned regularly to prevent fire hazards.. Repairs are needed.

We recommend contacting a licensed HVAC contractor regarding these conditions and have repairs made as deemed appropriate.

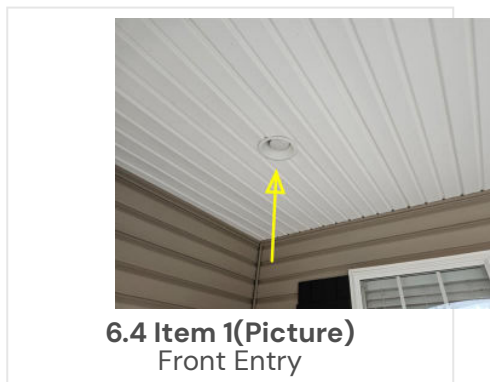
1. The front entry light fixture did not work. The repair could be as simple as replacing bulb(s). Further evaluation and repairs are recommended..

If replacing the bulb does not work we recommend contacting licensed electrician regarding these conditions and have repairs made so the unit functions as intended.

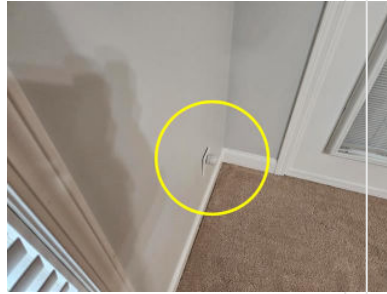
**6.4 Item 5(Picture)**  
Living Room

1. Several outlets loose in the wall at several rooms. Electrical issues are considered a hazard until repaired. Repairs are recommended.

We recommend contacting a licensed electrician regarding these conditions and have repairs made as deemed appropriate.

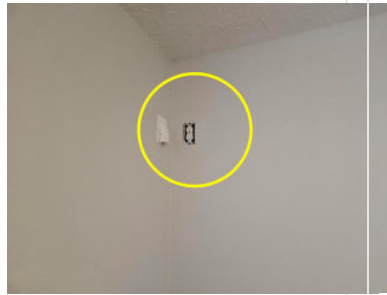
**6.4 Item 7(Picture)**  
Rear Right Bedroom

1. Two outlets are missing a cover plate. This is a safety concern. Repairs are recommended.

We recommend contacting a licensed electrician regarding these conditions and have repairs made as deemed appropriate.

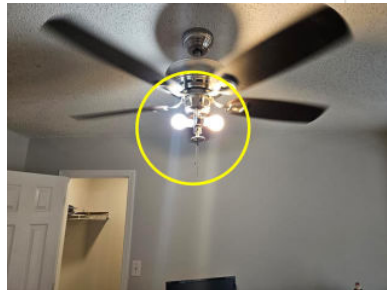
**6.4 Item 9(Picture)**

1. The front right bedroom light fixture is missing globe. This is for your information. Repairs are recommended.

We recommend contacting a licensed electrician regarding these conditions and have repairs made as deemed appropriate.

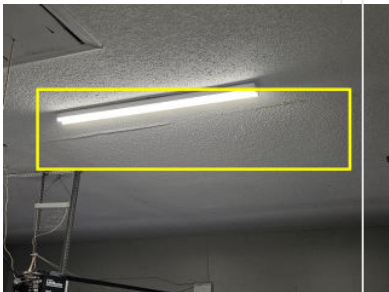
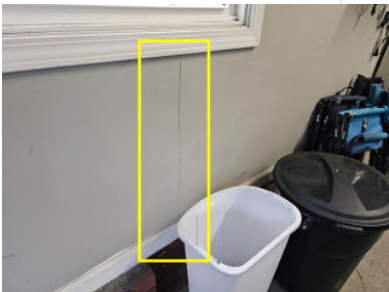
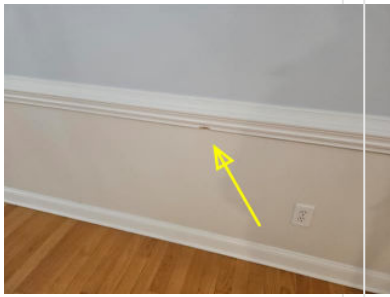
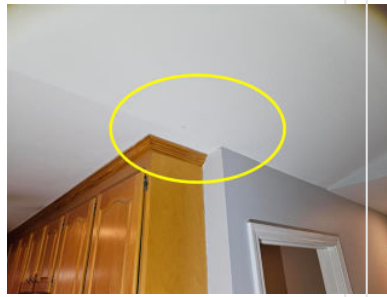
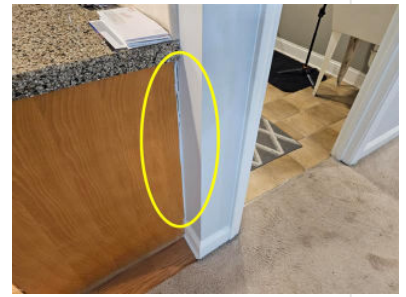
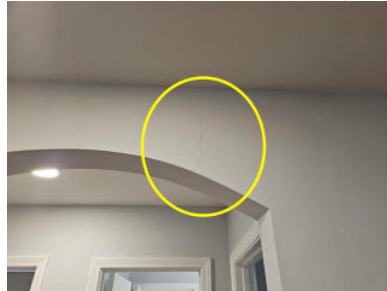
1. The home had numerous cosmetic defects present at the time of inspection. These items include but are not limited to; the walls, ceilings, floors, trim, doors, and/or cabinets. This is for your information.

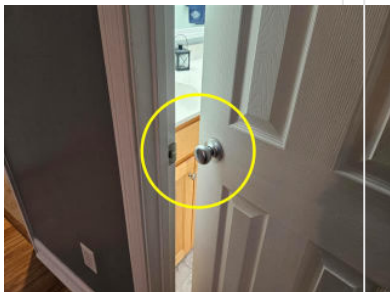
9.5 Item 1(Picture)  
Master Bathroom

1. The doors at several rooms will not latch properly. Evidence suggest that the door needs strike and latch adjustment to shut properly. This is a small repair.

We recommend contacting a qualified individual regarding these conditions and have repairs made as deemed appropriate..

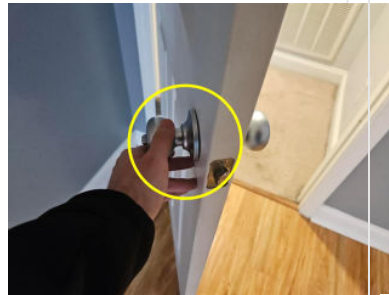
**9.5 Item 4(Picture)**  
Master Bedroom

1. The entry door at the Master Bedroom and Entry Closet has loose handle hardware. This is a maintenance issue and is for your information. Repairs are recommended.

We recommend contacting a qualified individual regarding these conditions and have repairs made as deemed appropriate..

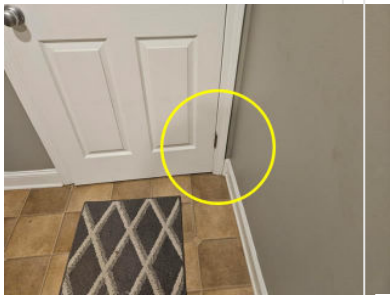
**9.5 Item 6(Picture)**  
Laundry Room

1. The entry door at several rooms rubs at the jamb when closing. Sometimes correcting the door opening can require door trim to be removed and painting touch up. Repairs are recommended.

We recommend contacting a qualified individual regarding these conditions and have repairs made as deemed appropriate..

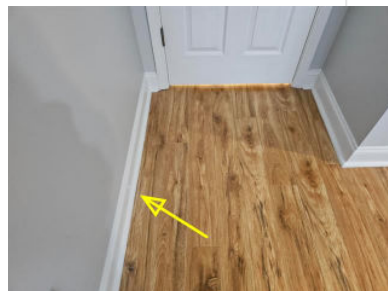
**9.5 Item 9(Picture)**

1. The entry door at the front right bedroom is missing doorstop. This is a maintenance issue and is for your information. Repairs are recommended.

We recommend contacting a qualified individual regarding these conditions and have repairs made as deemed appropriate..

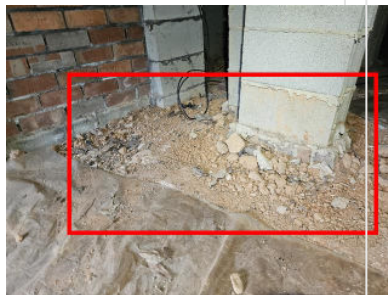
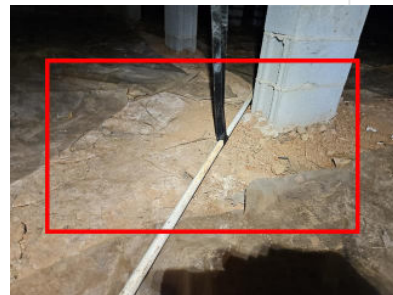
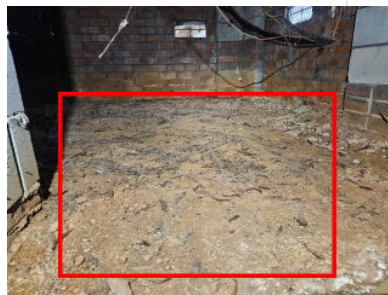
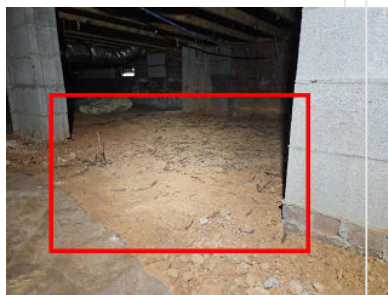
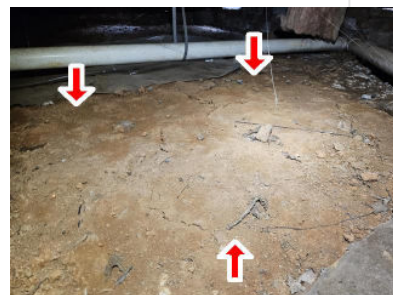
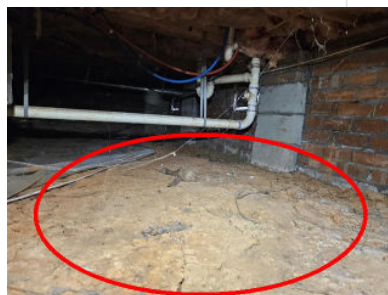
1. The vapor barrier / diffusion retarder on the crawlspace ground is deteriorated in areas. Visible signs of current elevated moisture levels in the crawl space floor system was present at time of inspection. Moisture barriers keep under ground moisture from entering the crawl space area. This condition is conducive to high moisture content in wood structures, which in turn is conducive to wood destroying insects / mold growth / fungi growth and other potential concerns. We recommend a 6 mil thick plastic be properly spread throughout to cover 100 percent of the crawl space dirt floor.

We recommend contacting a properly licensed contractor regarding these conditions and have repairs made as deemed appropriate

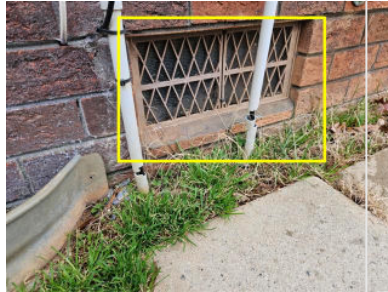
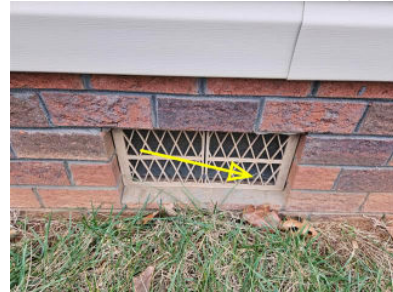
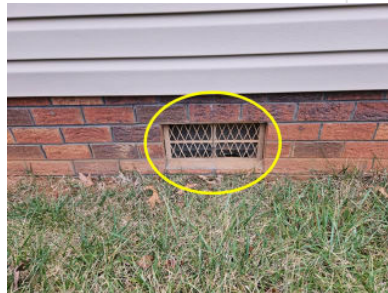
1. Several foundation vents have damaged screen at the exterior in areas. Rodents, reptiles or insects could enter into crawlspace. Repairs are recommended.

We recommend contacting a qualified individual regarding these conditions and have repairs made as deemed appropriate..

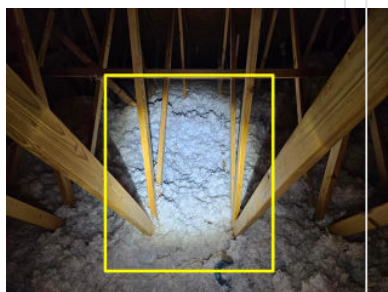
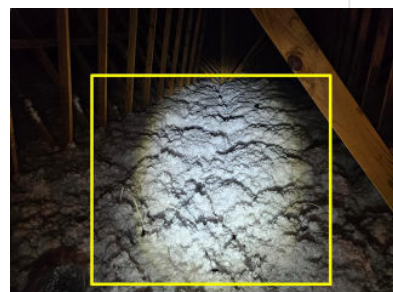
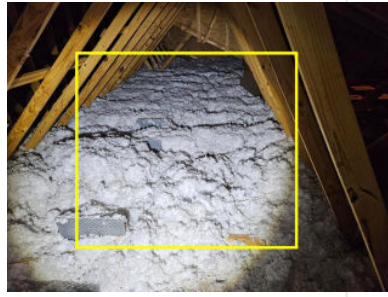
1. Fiberglass (loose-fill) insulation is compressed in areas of the attic due to foot traffic. As a result exposed framing is present in areas. The Epa recommends a min R-value of 30 for this area. This would require approximately 12 inches of blown insulation. Energy loss can occur if not addressed. Repairs are recommended..

We recommend contacting a properly licensed contractor regarding these conditions and have repairs made as deemed appropriate.

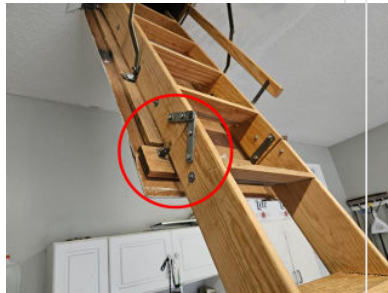
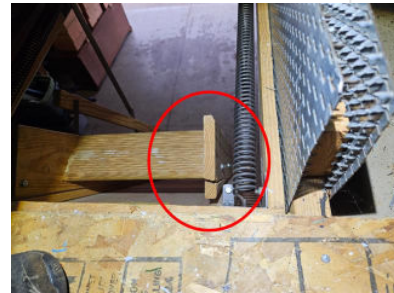
1. The pull down stairs has a damage panel and stairs. These steps move heavily when used, this is a safety concern. Repairs are needed.

We recommend contacting a properly licensed contractor regarding these conditions and have repairs made as deemed appropriate.

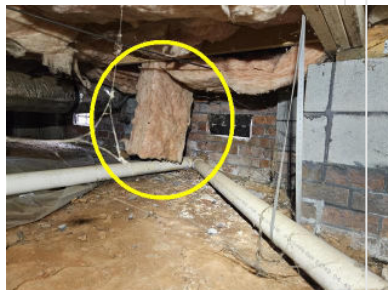
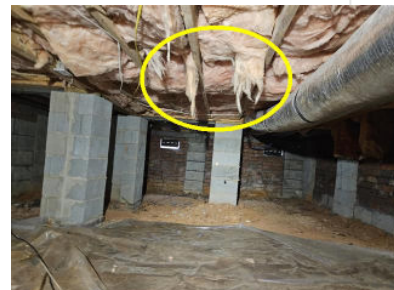
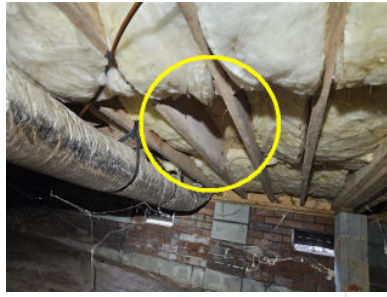
1. Evidence suggests that the crawl space floor insulation has been damaged by past or present rodent conditions. The insulation is coming apart and hanging loose and or missing at several areas throughout the crawl space. Damaged/deteriorated insulation results in decreased R values, which in return reduces the insulating factor, intended by the manufacture. The deteriorated/compromised/missing insulation needs to be replaced.

We recommend contacting a licensed contractor regarding these conditions and have repairs made as deemed appropriate.

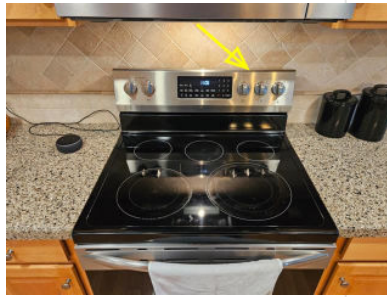
11.1 Item 1(Picture)

1. The range/oven needs to be properly attached/anchored to the structure as to keep it from tipping over when the oven door is opened and or oven racks are pulled out during use. Anti-tip devices became a UL requirement June 3, 1991. (Safety Issue). Repairs are recommended.

We recommend contacting a licensed contractor regarding these conditions and have repairs made as deemed appropriate.

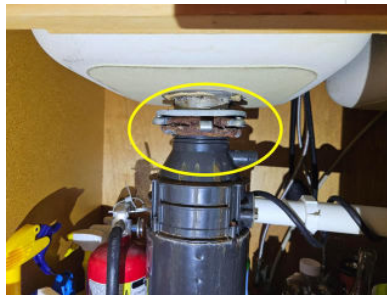
11.2 Item 1(Picture)

1. The connection at the disposal at the kitchen sink is heavily rusted. This can indicate a previous leak and/or elevated humidity. Monitoring is recommended.

We recommend contacting a properly licensed appliance repair contractor regarding these conditions and have repairs made as needed.

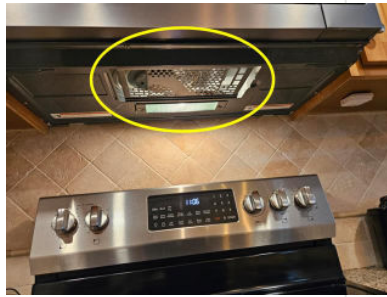
11.3 Item 1(Picture)

1. The range hood fan is missing the filter. This can allow grease build up to occur as a result. (safety concern) We recommend installing a new filter as recommended by the manufacture. Please note: Cleaning may be needed due to present conditions. Repairs are recommended.

We recommend contacting a licensed appliance repair company regarding these conditions and have repairs made as deemed appropriate.
